Flood Investigation Report Brotherton

This document has been prepared specifically for the purpose of meeting the requirements of Section 19 of the Flood and Water Management Act 2010.

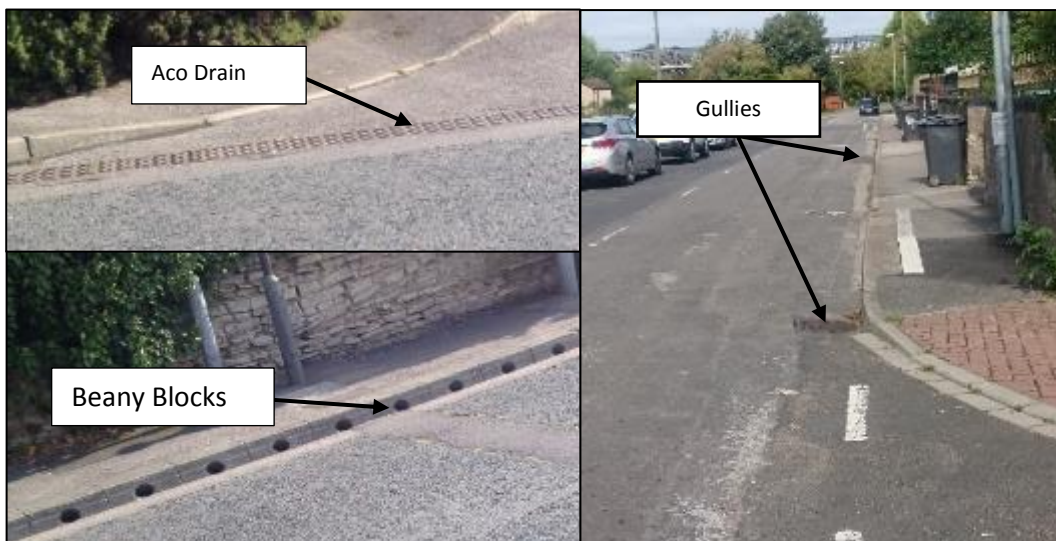
Figure 2.5 Photographs showing Marsh Croft and Low Street drainage systems

Marsh Croft highway drainage is via conventional road gullies set to collect the surface water runoff³. The carriageway width of Marsh Croft is single lane flanked by footways on each side. On Marsh Croft the footways are separated from the carriageway by continuous shallow rise override kerbs. This feature provides for two way movements of road vehicles by allowing road vehicles to be driven over the relevant footway. The key highway drainage features are shown on Figure 2.5 and 2.6.

Highway drainage for Low Street is via a combination of Beany Blocks and conventional road gully collection pots³, as shown in Figure 2.5. A series of speed control humps reduce vehicle speeds but some do not have edge treatment. Edge treatments are recessed sections at the edge of the speed hump to allow surface water to flow down the edge of the road.

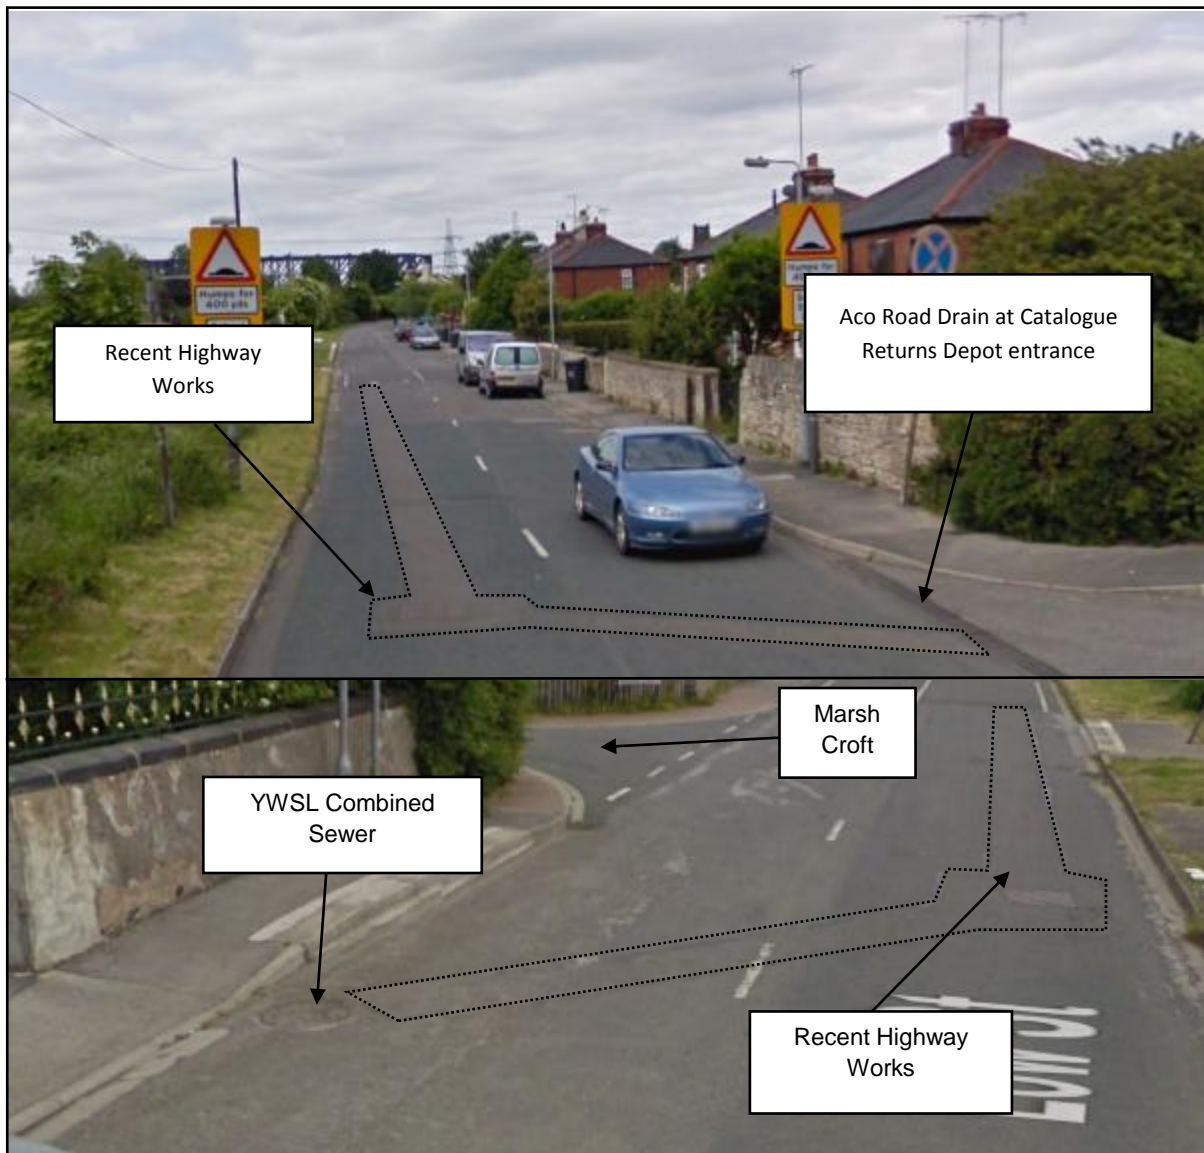
Figure 2.7 Photographs showing recent Highway works (Source: Google Maps)

It is unclear at this stage where the highway drainage system on Low Street discharges. The site inspection undertaken on the 7th of September 2016, identified some evidence of highway drainage works in close proximity to a series of beany blocks at the entrance of the Catalogue Returns Depot and the YWSL combined sewer, as shown in Figure 2.7.

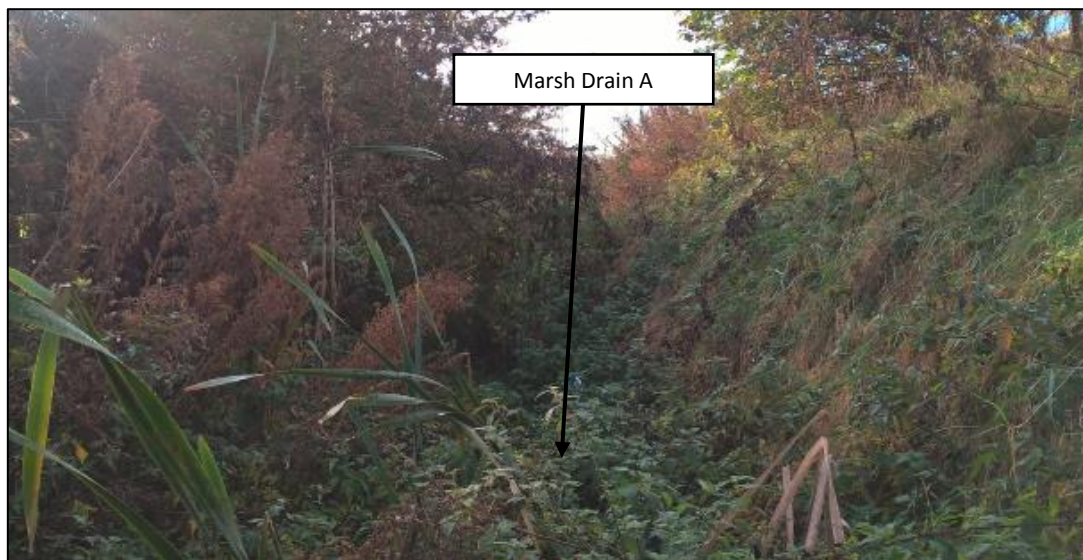
Figure 2.9 Photograph showing the current condition of Marsh Drain A

Marsh Drain A is currently very overgrown, as shown in Figure 2.9.

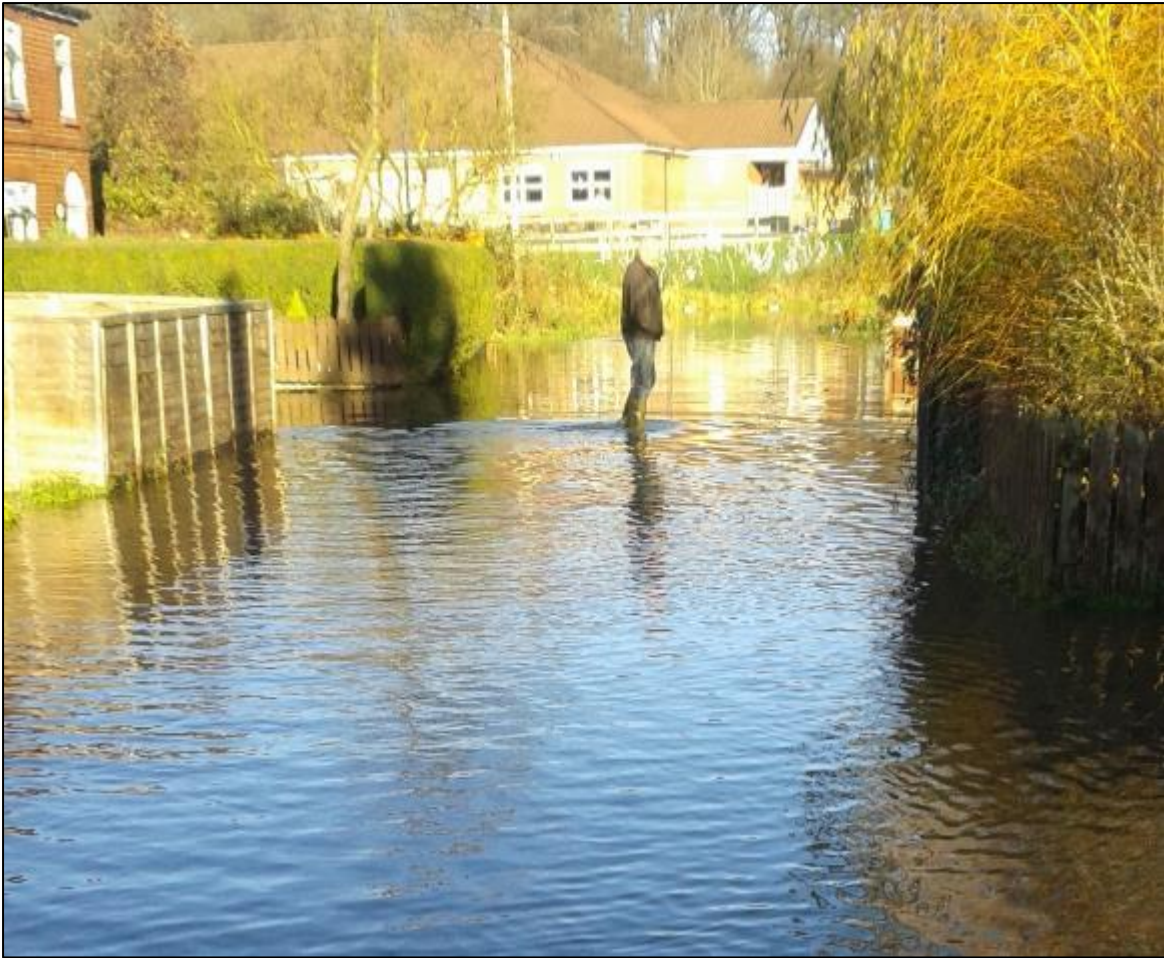
3.10 Photograph showing ponding on Marsh Croft

The sequence for flooding on Marsh Croft and Low Street is illustrated in Figure 3.7, 3.8 and 3.9, and the ponding on Marsh Croft is shown in Figure 3.10.

Surface water built up on Marsh Croft as a result of the highway drainage being overwhelmed and unable to discharge to the sewer. The kerbs on Marsh Croft are designed to allow for two way vehicle passage, therefore, are lower than standard road kerbs. In this instance, they were ineffective in containing surface water on the highway and consequently allowed excess surface water to overtop and spill into adjacent land as illustrated in Figure 3.11.

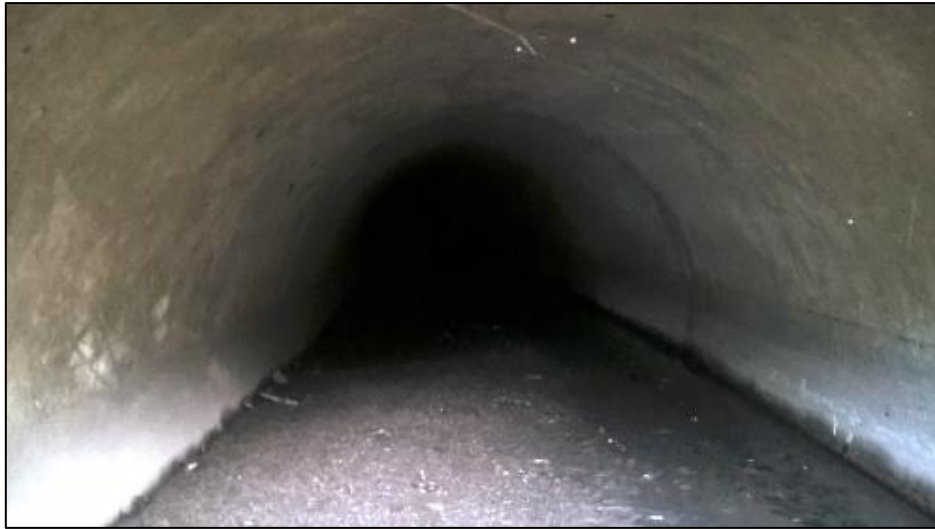
Figure 3.3 Photograph showing silted up culvert under A162

The surface water culvert running under the A162 is owned by Highways England. The culvert is known to contain a significant amount of silt¹¹ but its overall condition is unknown at this stage.

The ability of the surface water system to discharge into Marsh Drain A was impeded by the vegetation present in the channel, as shown in Figure 3.13, and the silt in the Culvert, as shown in Figure 3.14.
