North Yorkshire
County Council

Flood Investigation Report Knaresborough

Site Inspection: Thursday 8th September 2016

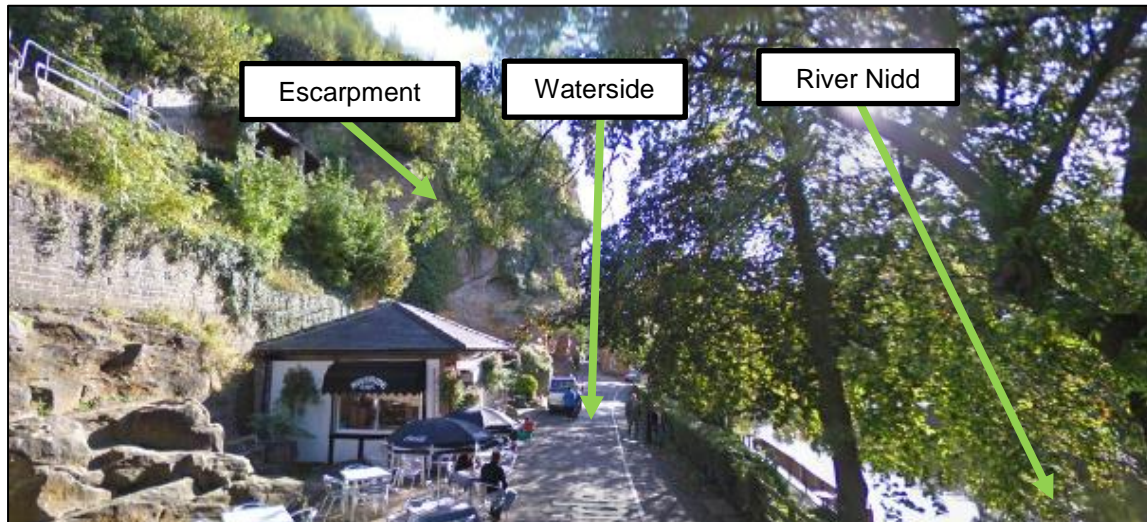
The built up area of Knaresborough exists at two elevations. The main town is at a high level above the River Nidd and generally flat. The narrow area close to the River Nidd is also flat and low lying as shown in Figure 2.3.

Figure 2.3 Photograph showing escarpment next to the River Nidd (Source: Google Maps)

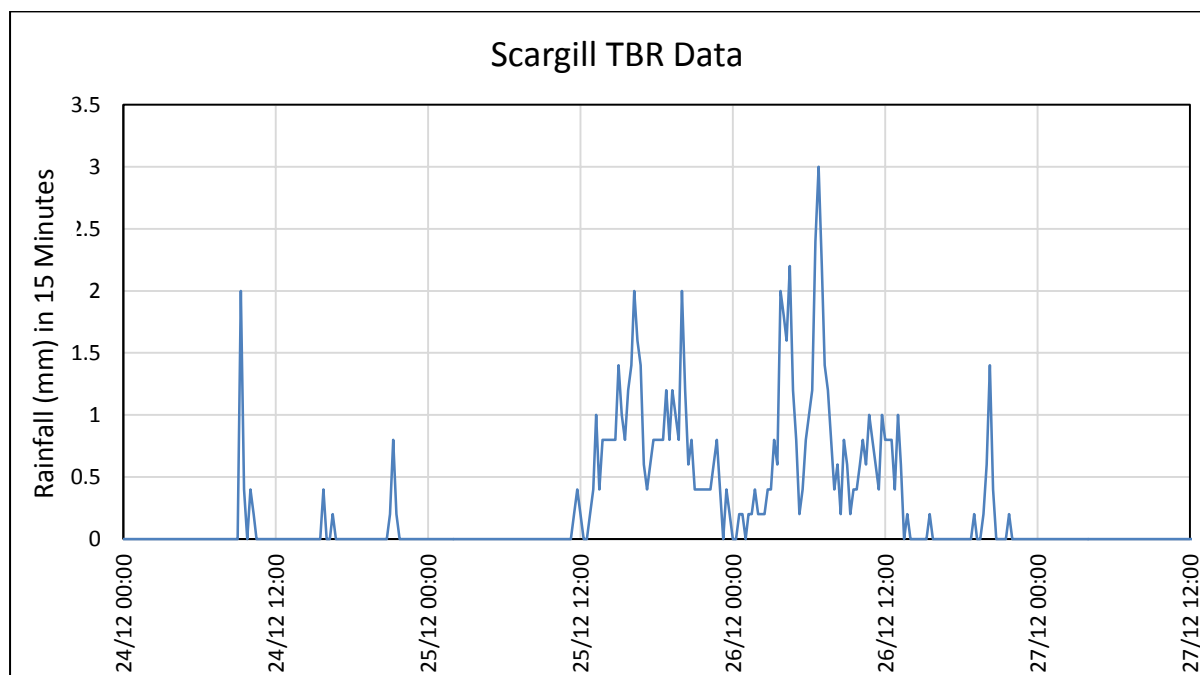
(TBR) rainfall data has been provided for Scargill (15 minute interval), as illustrated in Figure 3.3. The data from the Scargill TBR shows two significant rainfall events on the 25th and 26th December. The rainfall event on the 25th started at 12:00 and finished at 23:30 reaching successive peaks at 16:15 and 20:00. The rainfall event on the 26th started at 00:45 and finished at 13:00 reaching a peak at 06:45.

The return period for the accumulation of rainfall over the peak 24hour period was 20 years at Scargill.

Figure 3.3 Rainfall Data for Scargill on the 25th and 26th of December.

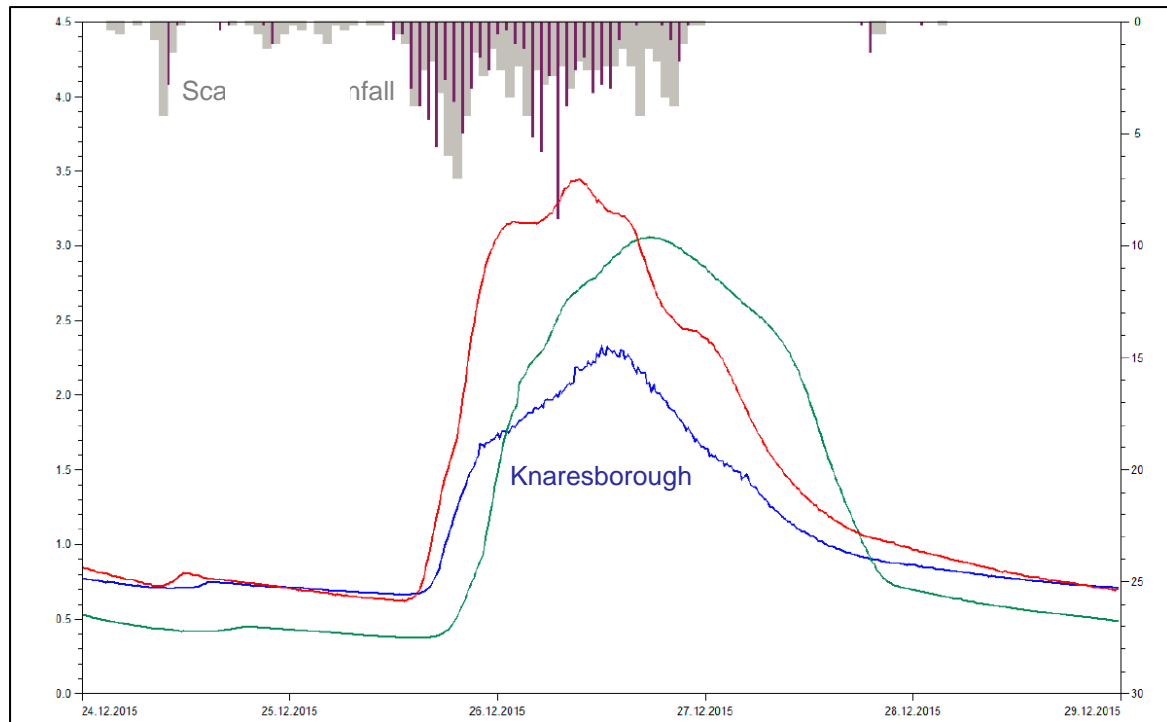
Following weeks of rainfall the River Nidd levels rose on 26th December 2015 to overtop its banks in Knaresborough. The highest recorded level at 2.33 metres occurred on 26th December 2015. The datum for the Knaresborough gauge is 36.86 metres AOD (Refer *Station 8121* in Knaresborough). Figure 3.4 shows the levels of the River Nidd in Knaresborough from the 24th to 29th December. Birstwith is 11km upstream and Hunsingore is 10km downstream of Knaresborough.

Figure 3.4 River levels and rainfall data for the River Nidd (Source: EA)

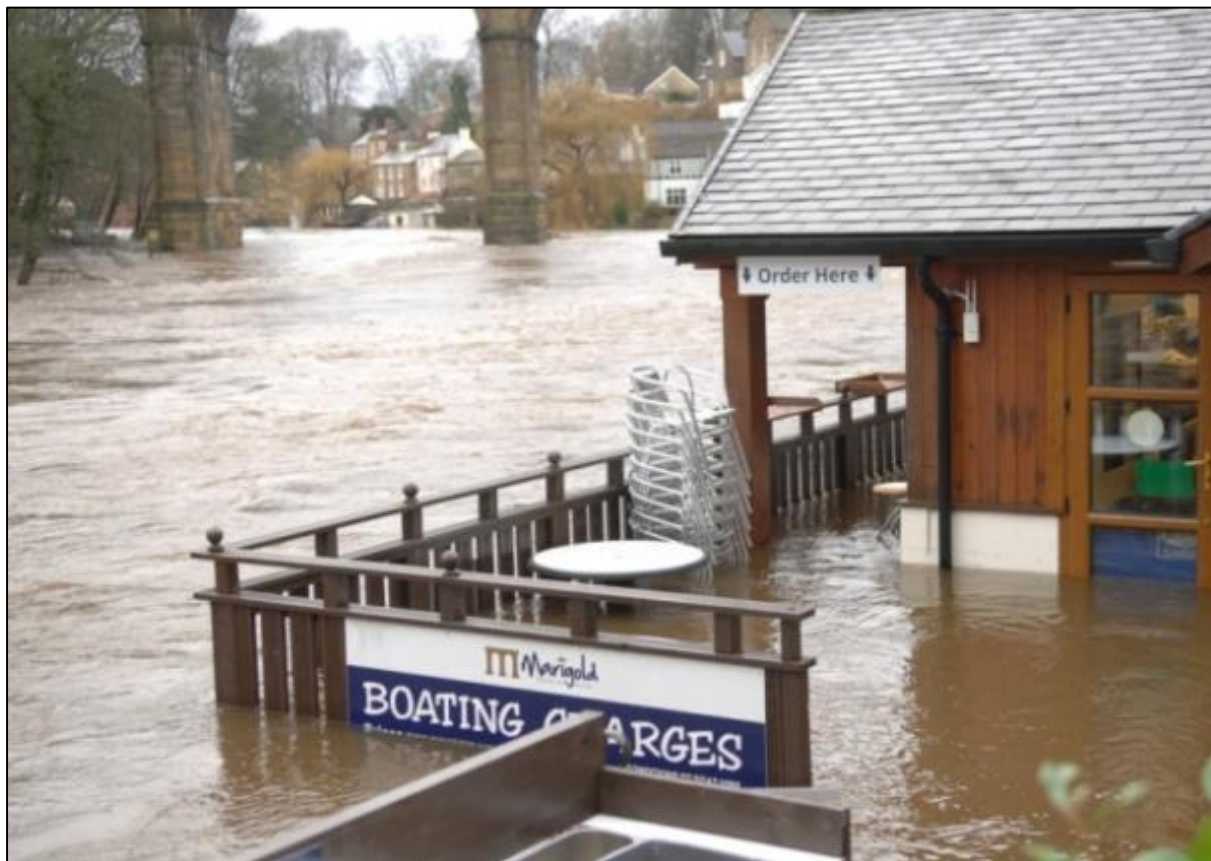
At the Boat Hire Yard and cafes located between the River and Waterside three properties have a history of flooding prior to the 2015 Boxing Day floods. The cause of flooding is the rising level of the River Nidd causing the river over spill at the Waterside properties.

Marigolds Café and the Boat Hire Yard were flooded, as shown in Figure 3.6, by overspill river water at 0430 hrs on Boxing Day 2015. Residents report that a flood warning was broadcast at 0400hrs but gave insufficient time for items in the café to be removed to safe places distant from inundation.

Figure 3.6 Photographs showing the Marigold Café flooding (Source: Harrogate Advertiser)

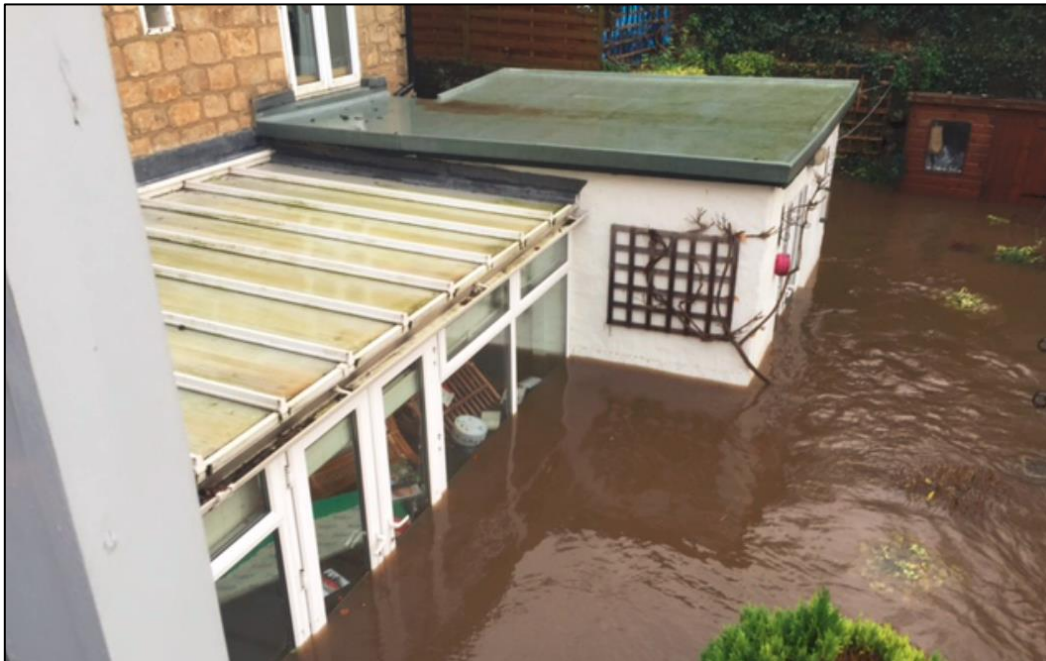
The vertical alignment of Abbey Road near its cross road junction with the B6163 / Waterside Road has a depression that causes the collection of surface water to form ponds when intense rainfall occurs. In addition the proximity of properties to the River Nidd meant they were directly affected as river levels rose.

Water was reported as coming over river facing boundary walls and coming up through the floor of one of these properties. The water level rose to approximately 1m inside the property. As evidenced during the site visit on Thursday 8th September 2016, the dwellings on the east side suffered extensive internal flood damage with repairs and resilience works seen ongoing on the day of the site visit some nine months later. One owner described having to spend 3 months in a Hotel before his dwelling became habitable following essential repair work. The owners have now raised the height of walls, constructed a new solid floor and added non

Figure 3.7 Photograph showing flooding to property in Knaresborough

return valves on their domestic drainage outlets as measures to protect their property against any future floods of similar intensity.

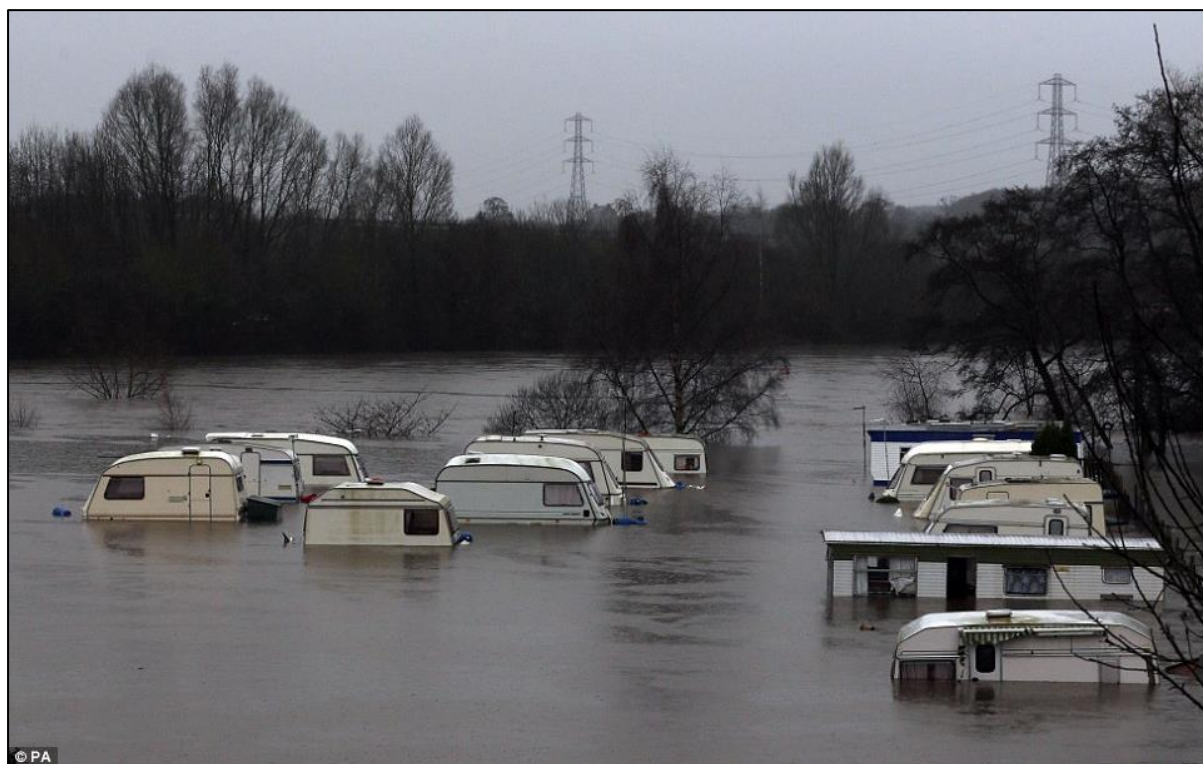
The flood flow paths entering the site are twofold, as shown in Figure 3.10. Firstly flow in the tributary The Rampart was restricted by the stronger flow in the River Nidd. As a result the flows in the tributary backed up overtopping at the point where the bank is lowest. Then overtopping the bank occurred, allowing river water to flood into the site. The flood level within the site reached approximately 1 m above the existing ground, as shown in Figure 3.11.

Figure 3.11 Photograph showing caravan flooding in Knaresborough East (Source: Daily Mail)

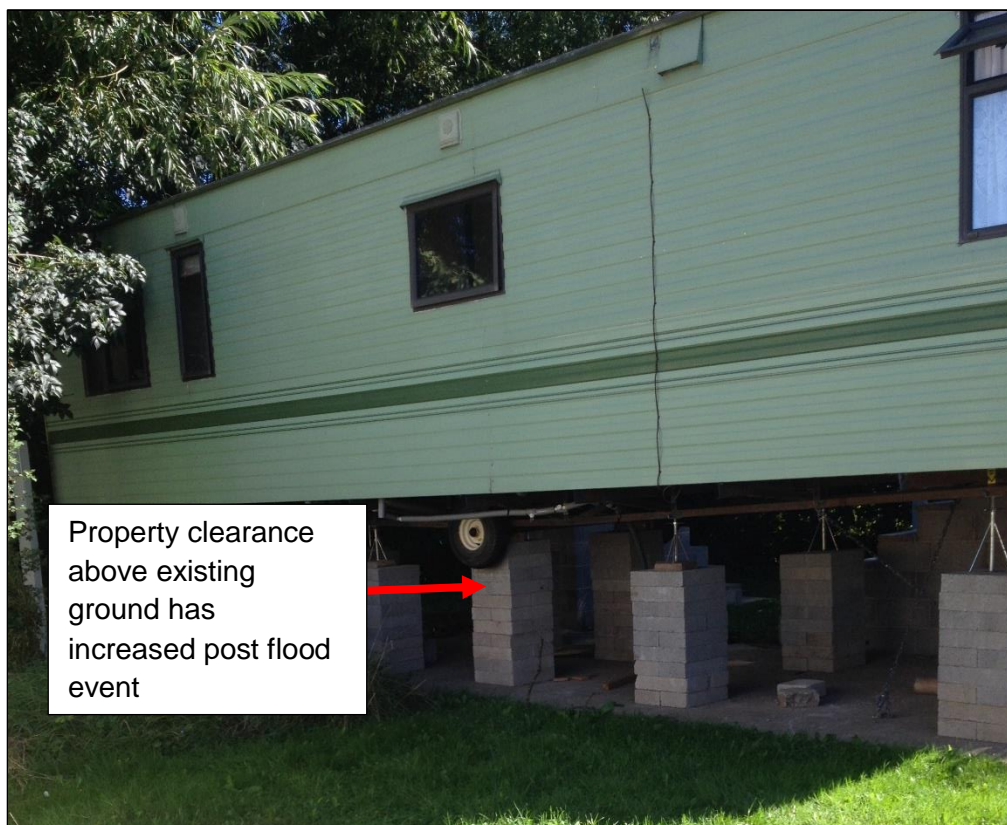
Figure 3.12 Photograph showing the increase in elevation of caravans in Knaresborough East

Because of the Boxing Day 2015 floods the caravans are in the process of being raised to a higher elevation (a further 400 mm (16 inches)) , as shown in Figure 3.12 to provide a free board of 75 mm (3 inches) Each caravan is accessed by newly created steps constructed from heavy blockwork. In addition the electrical connections for each property has been raised above flood level to sustain the electrical supply in future flood events.

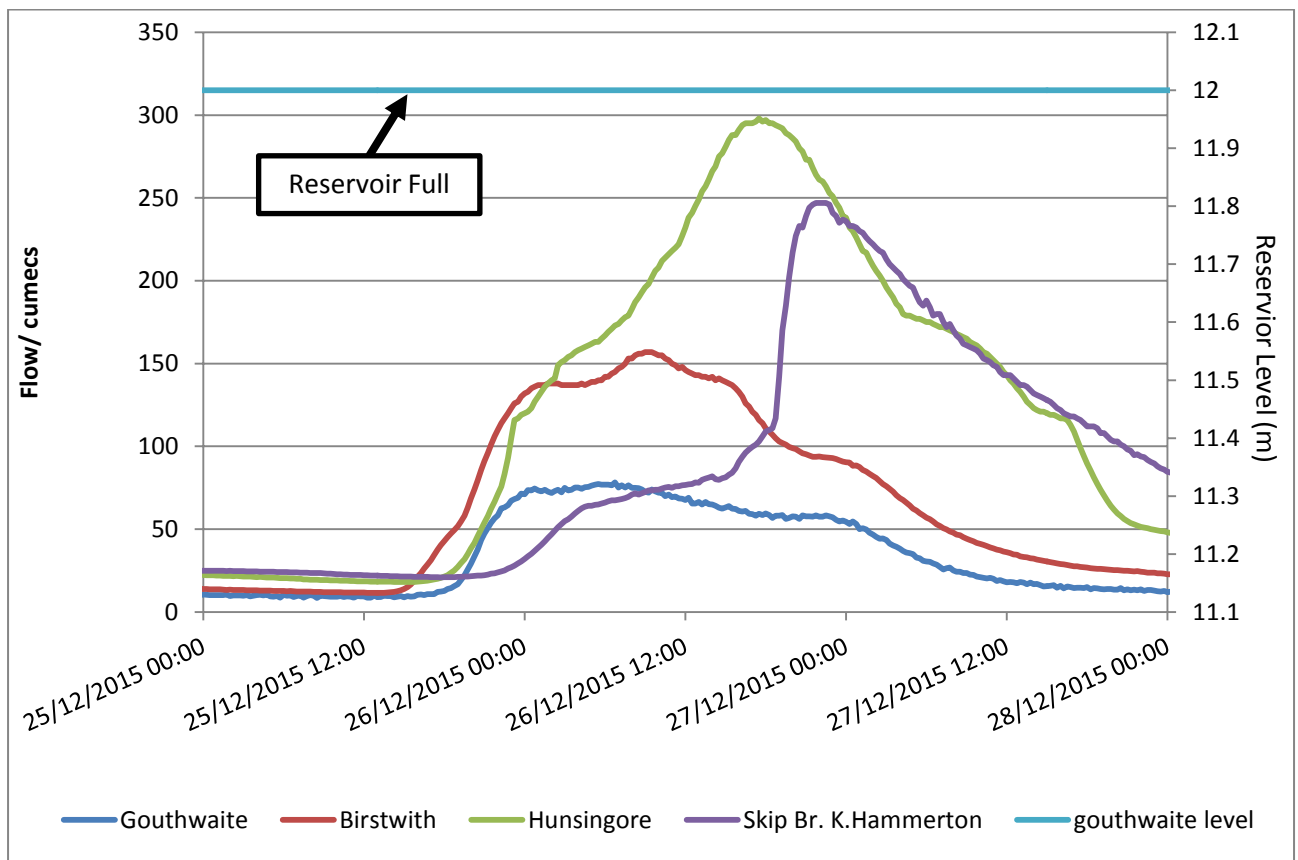
Information received from YWSL has confirmed that Gouthwaite was full and spilling prior to and throughout the flooding of Boxing Day in Knaresborough as shown in Figure 3.13

Figure 3.13 Flow gauges on the River Nidd and water levels at Gouthwaite reservoir (Source: YWSL)

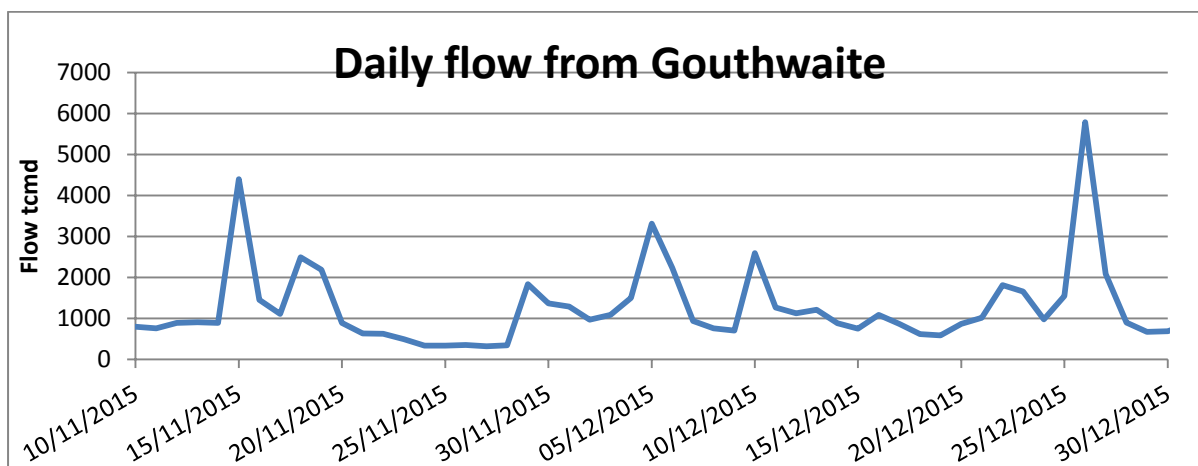
The high discharge flows from Gouthwaite for late December 2015, shown in Figure 3.14, reflect the fact that the reservoir was full and spilling over its fixed spillway. However, it is worth noting that even when a reservoir is full it will reduce the peak flow rate into the downstream river (compared to there being no reservoir at all) due to the attenuating effect arising from the large surface area of the reservoir.

Figure 3.14 Daily flows from Gouthwaite for November and December 2015 (Source: YWSL)

YWSL and EA were asked to consider whether it is possible to operate Gouthwaite Reservoir differently, in order to reduce flood risk to Knaresborough. The EA has subsequently completed a screening assessment of all reservoirs in Yorkshire to understand whether they could provide a flood risk benefit to downstream communities. The work completed by EA has concluded that there is very little potential for Gouthwaite to provide a benefit to Knaresborough and no further investigation is merited.
