# VERIFICATION REQUIREMENTS FOR COVER SYSTEMS

Technical Guidance for  
Developers,  
Landowners and  
Consultants

Yorkshire and Humberside  
Pollution Advisory Council

Version 3.2 – October 2014

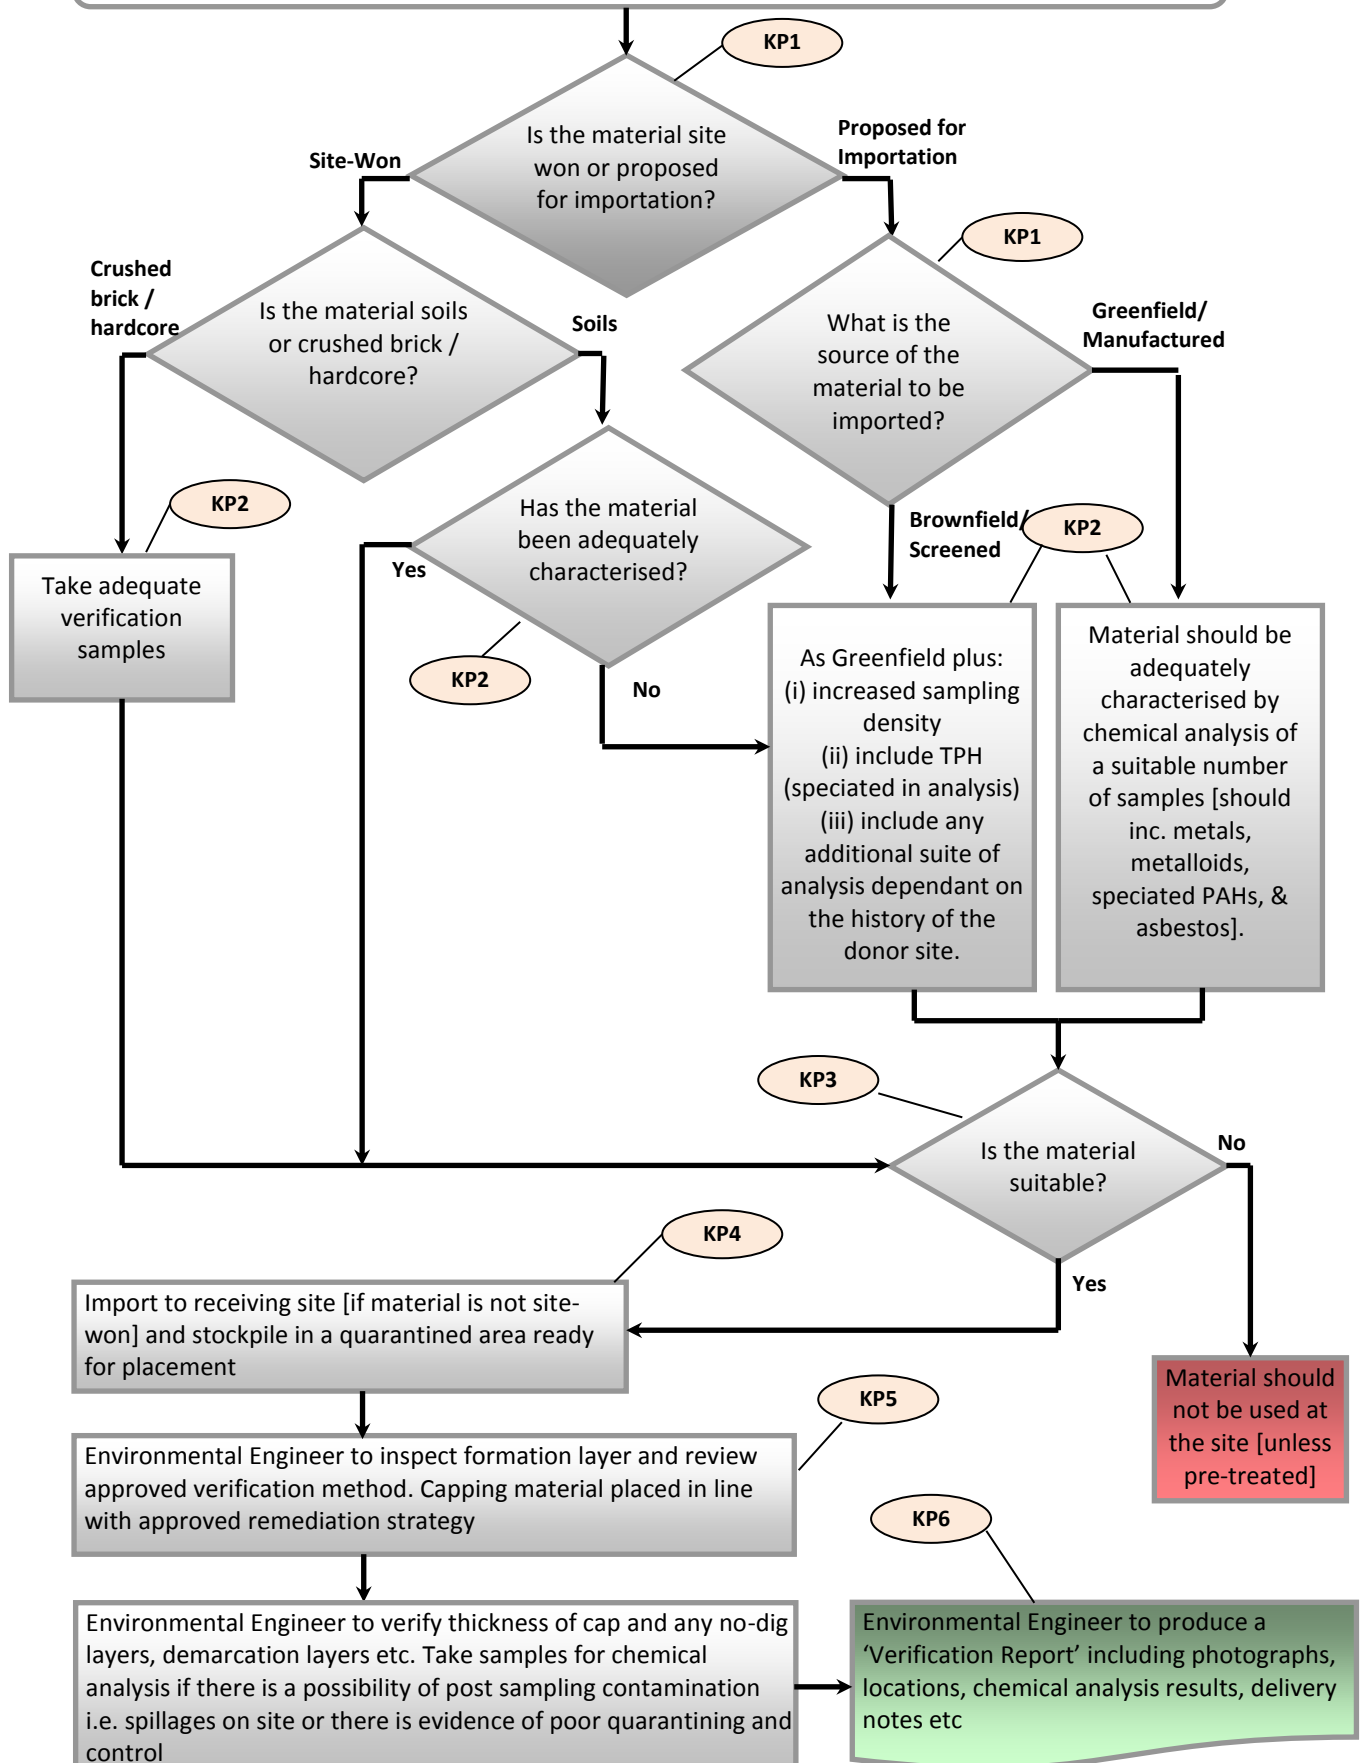
# Overview Flowchart

Agree 'Remediation Strategy' with regulator. Decision on the required depth of cover and any need for:  
 (i) Physical no-dig layer (ii) Capillary break layer (iii) Demarcation Layer

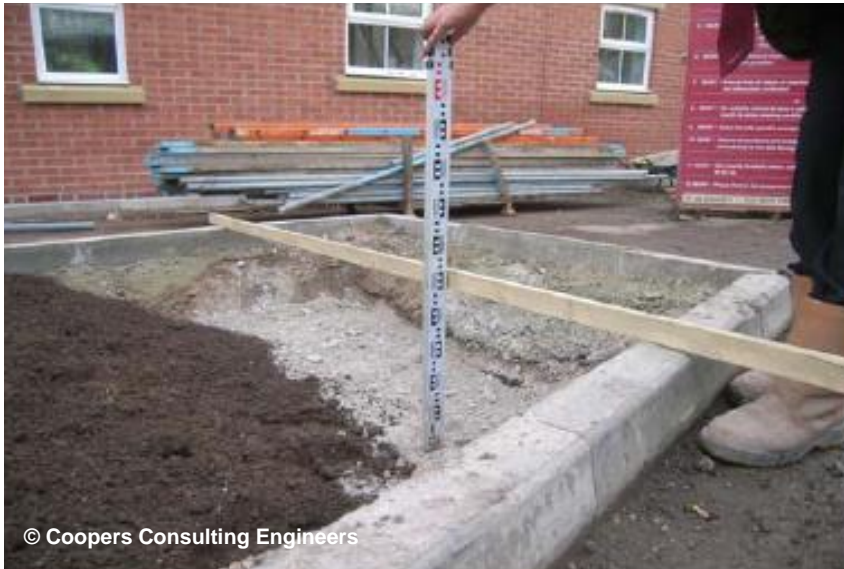
Photograph 1: Depth check of inert cover within area of public open space. Physical break layer and topsoil visible.

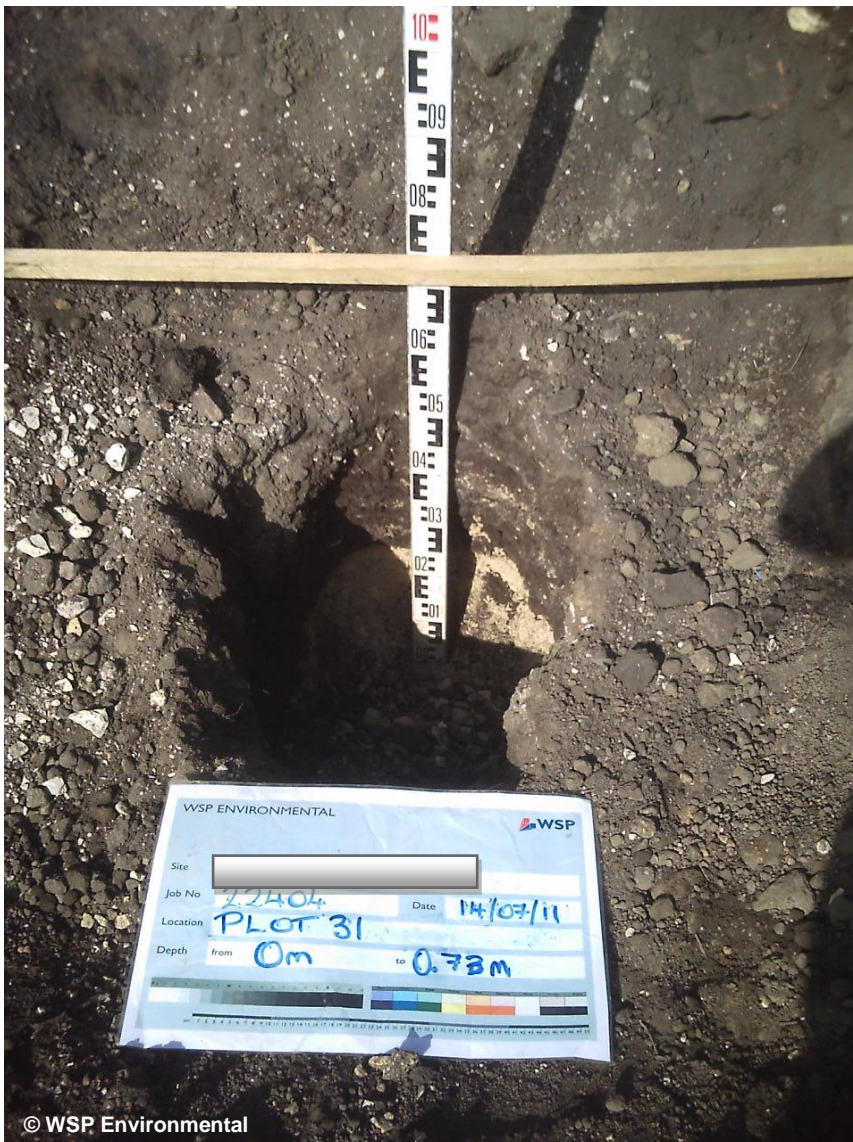
Photograph 2: Depth check of inert cover with Site & Location Information Board.

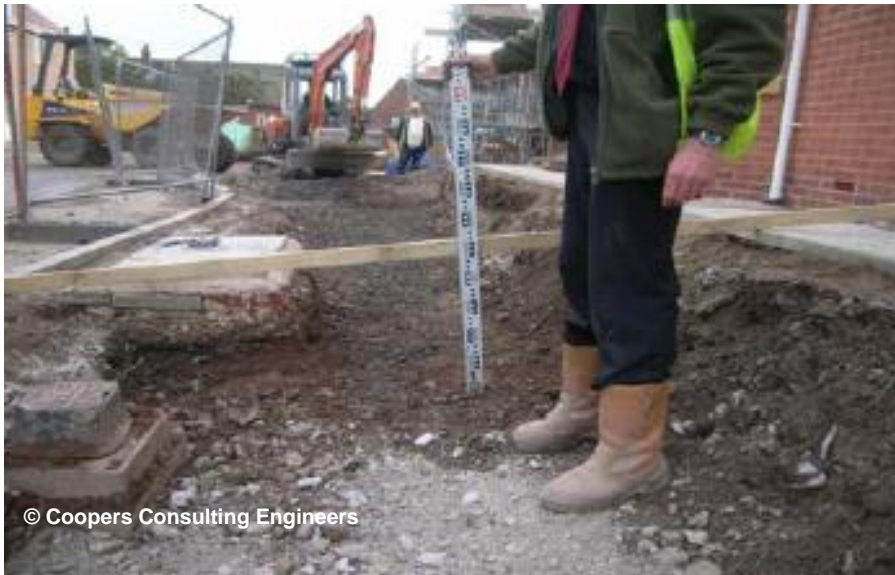
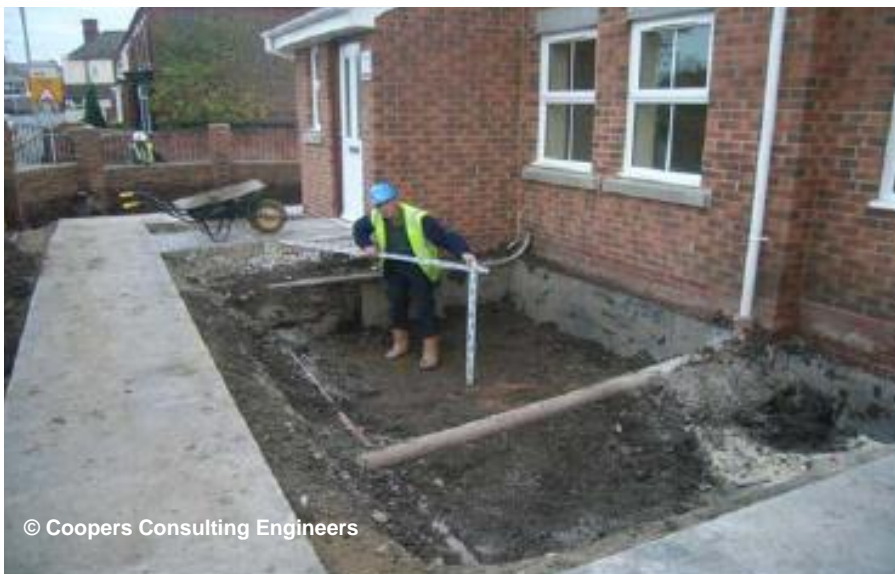
Photographs 3 & 4:  
Depth check of inert  
cover within areas of  
front gardens.

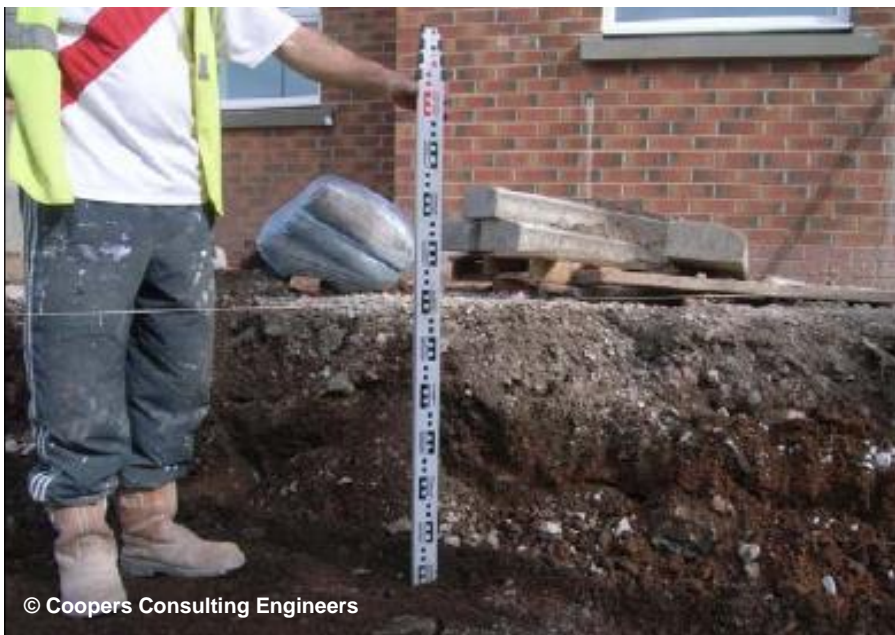
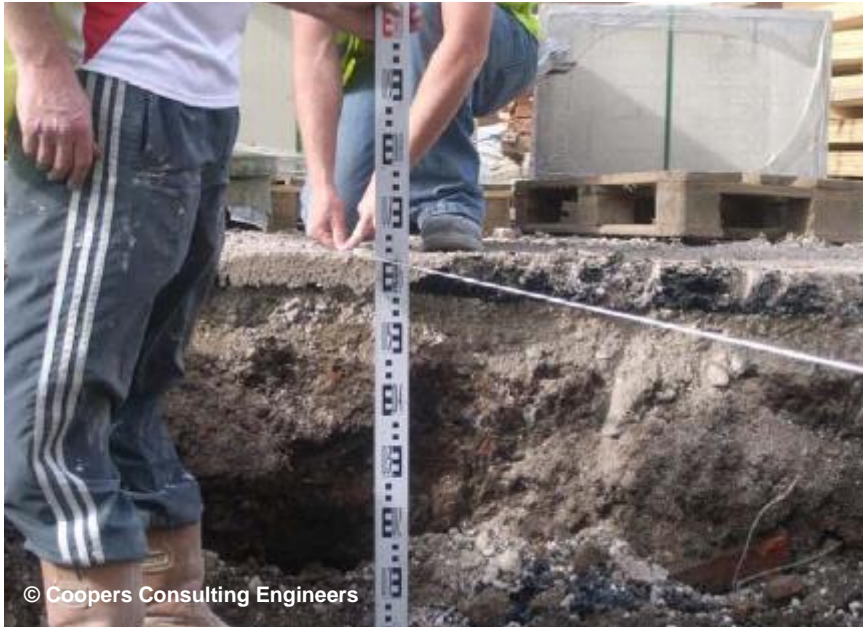
Photographs 5 and 6: Depth check of inert cover within rear gardens. Taut string line spans across excavation.

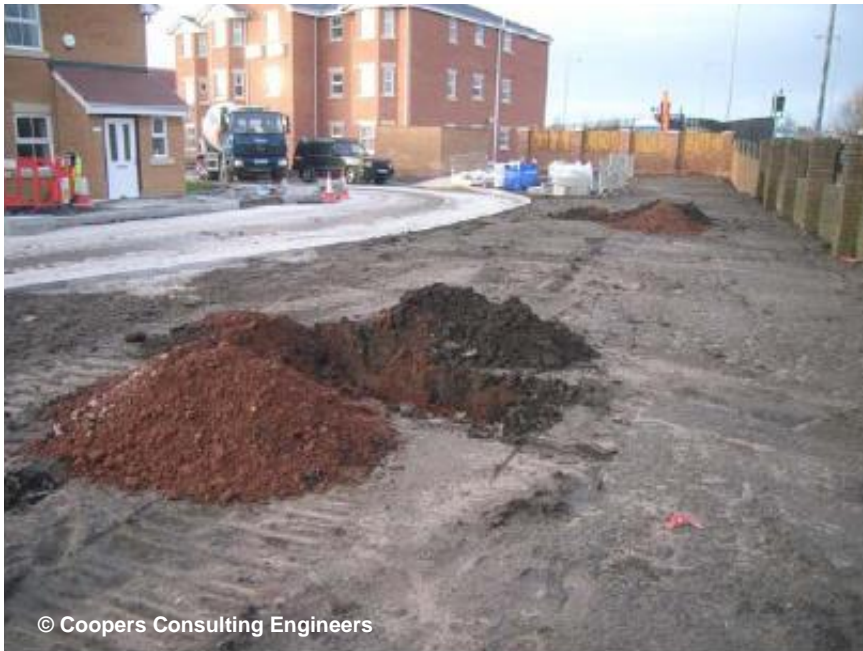
Photograph 7 shows the spatial location of the verification pit.

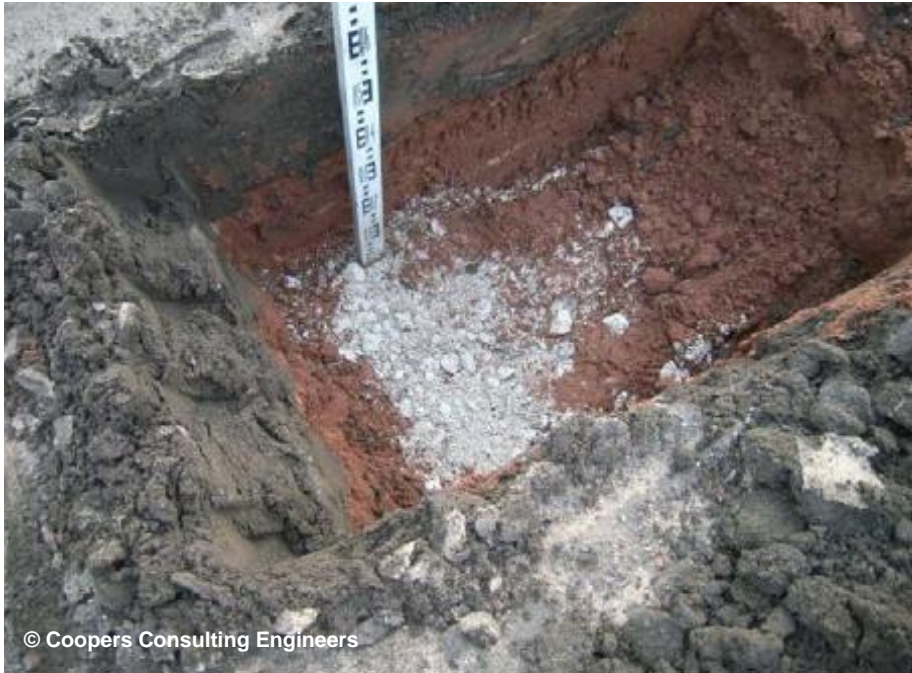
Photograph 8: Excavation within public open space and verification pit showing the presence of a remediation break layer at the base, a crushed sandstone inert fill overlain by topsoil.

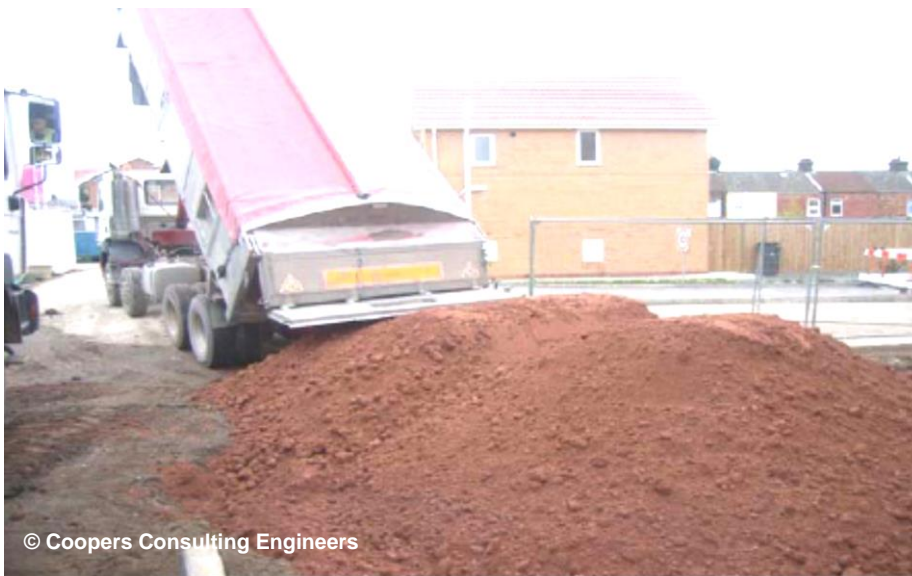
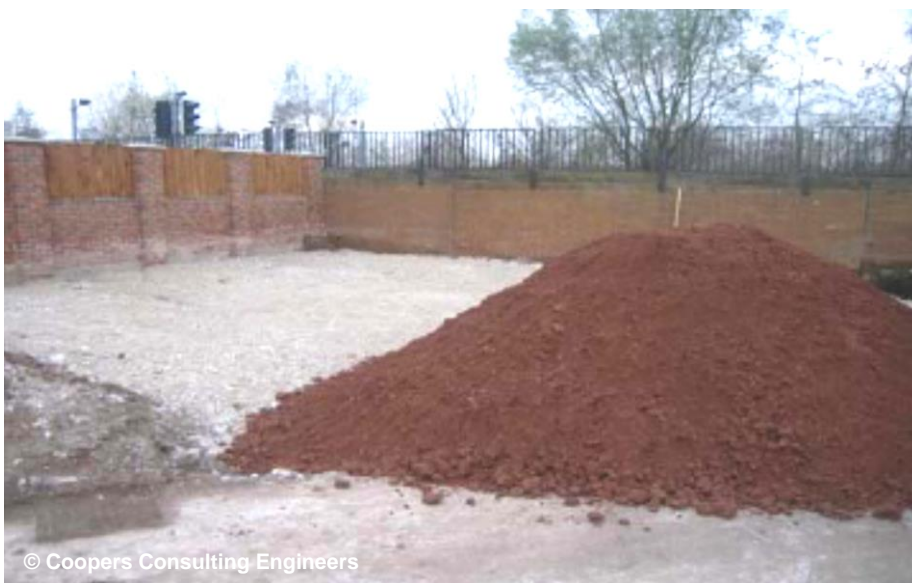
Photographs 9 and 10: Inert crushed sandstone being delivered with remediation break layer visible in Photograph 10. The spatial area of the remediation can be observed from these photographs (old terrace housing in Photograph 9 and traffic lights in photograph 10).

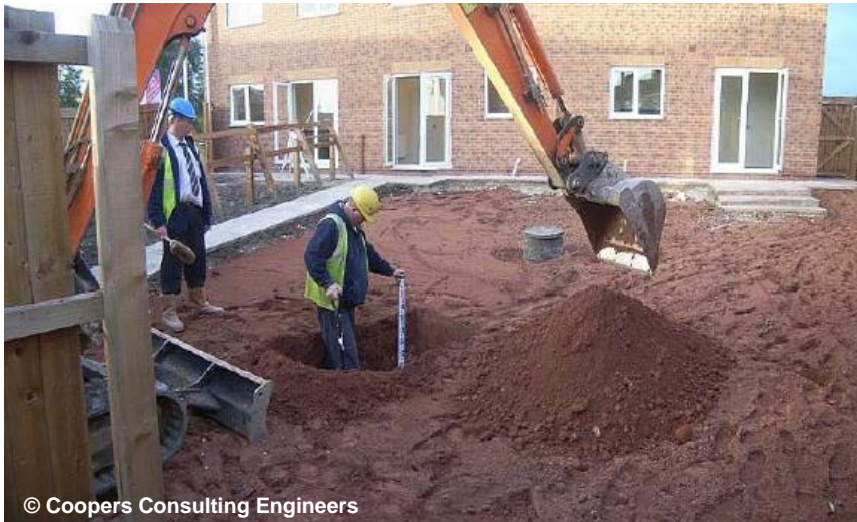
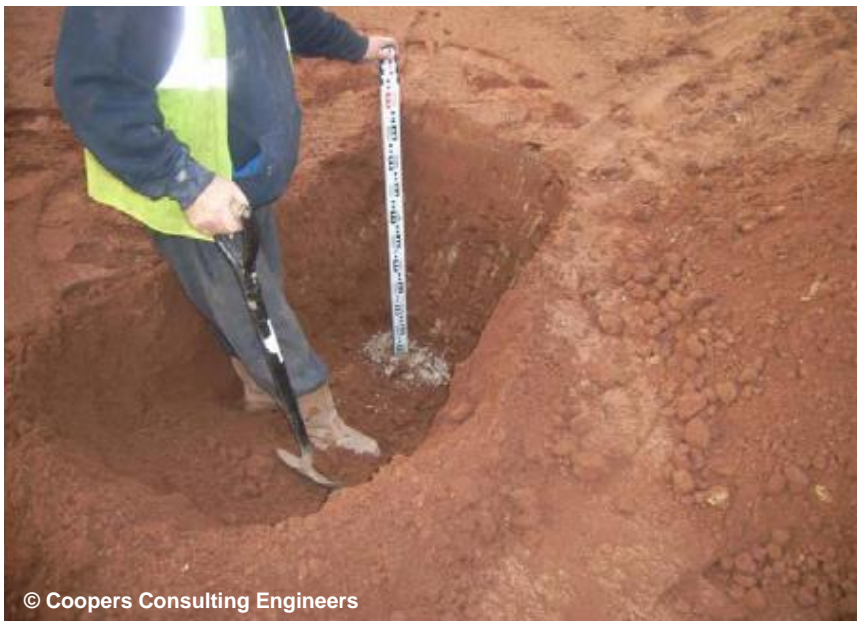
Photographs 11 and 12 show the remediation of the rear garden, with a significant depth (1.0m) of inert cover. Remediation break layer visible at the base of the excavation. Photograph 11 has been stitched to form a panoramic photograph and hence there is slight distortion
