GILLING WEST

Conservation Area Appraisal and Management Plan

Adopted April 4, 2018

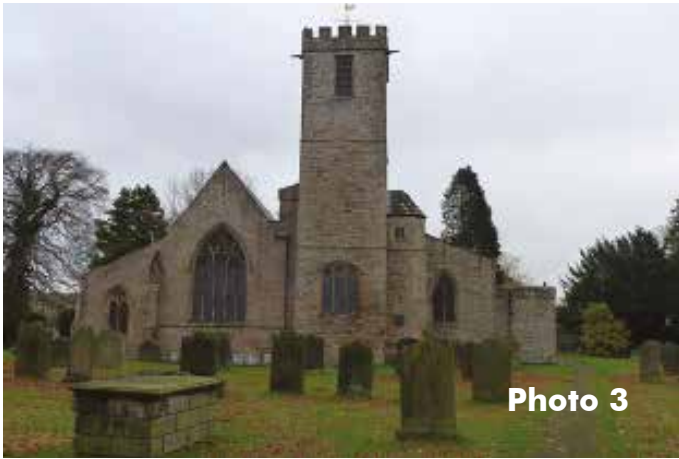
Photo 3

The oldest features in the Conservation Area are found at St Agatha's Church (**photo 3**). Here the porch shelters a number of pre-Conquest carved stones and a medieval grave cover (**photo 4**).

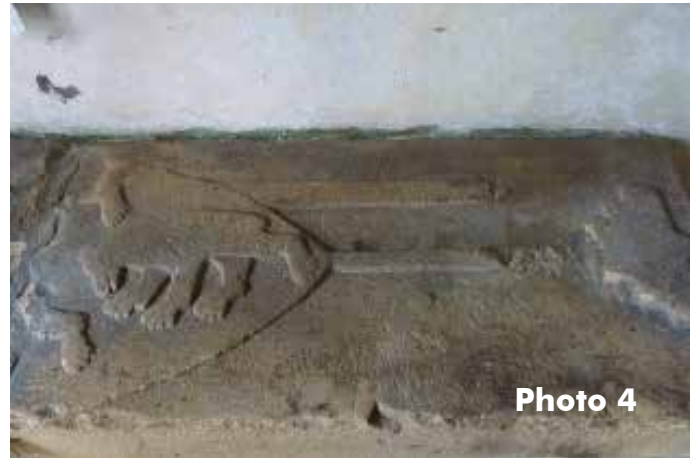
The pointed-arch outer doorway is made up of old fragments. The west tower probably belonged to the church at Gilling recorded in the Domesday Book as stylistically it belongs to the late 11th Century.

It was extended in the 15th Century and a five sided stair turret was added to the south side in the 19th Century. The nave and south aisle date from the 14th Century and the vestry is slightly later. The nave roof is 15th Century. The church was restored and extended in 1845 by Ignatius Bonomi. The church is built of rubble and has various traditional roofing materials of stone slate, welsh slate and lead.

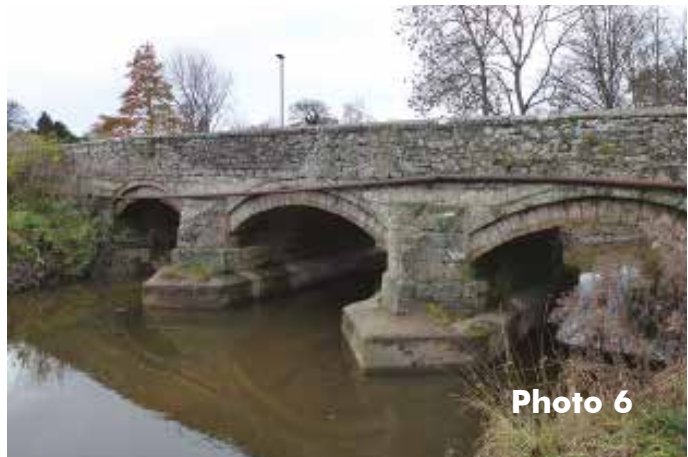
Photo 6

One of the other older features of the village is the bridge over Gilling Beck (**photo 6**) parts of which are from the 15th Century but major works were undertaken in 1799 and again in the 20th Century.

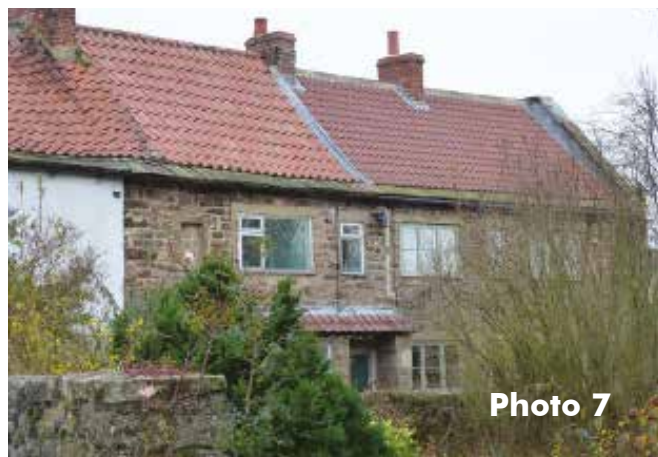
Photo 7

The Curtain (**photo 7**), now 2 houses, is probably from the 14th Century with many later alterations.

Thought originally to possibly have been a small unrecorded religious house, then a mail house when the Angel Inn was an important coaching inn and mailing station and subsequently was 3 cottages.

The modern conversion destroyed much of the building's character with large casement windows, but at the back is a pointed-arched window of 13th or 14th Century type and traces of other similar openings exist. The frontage shows evidence of 17th Century alterations in the chamfered fire-window and the tumbled verge of the east gable. The construction is of rubble stone with a roof of 20th Century pantiles with stone slates at the eaves.

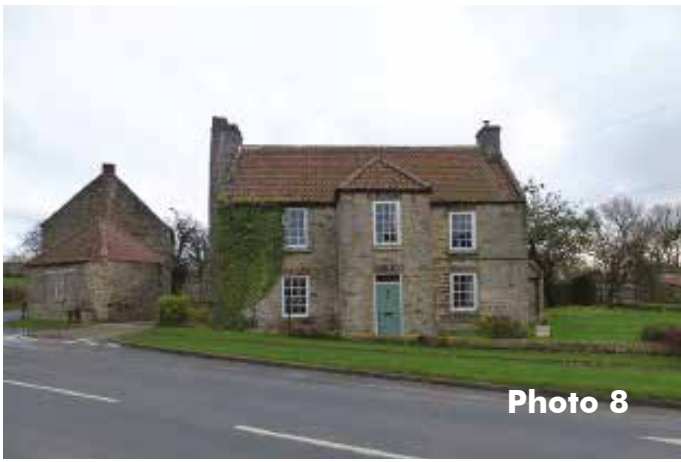
Photo 8

Chronologically the next buildings in Gilling West date from the late 17th Century these are The Old Parsonage at 122 High Street (**photo 8**) and the associated stables. These are located at the northern most point of the village. They are of rubble stonework with pantile roofs and openings have flat brick arches. Unusually for the village the Parsonage is of a cruciform plan with a central projecting 2 storey porch and matching rear stair turret. The windows are vertical sashes with glazing bars and end chimneystacks with the one to the left being external. The stables are of similar materials but include raised verges with reversed crowstepping detail, and external steps.

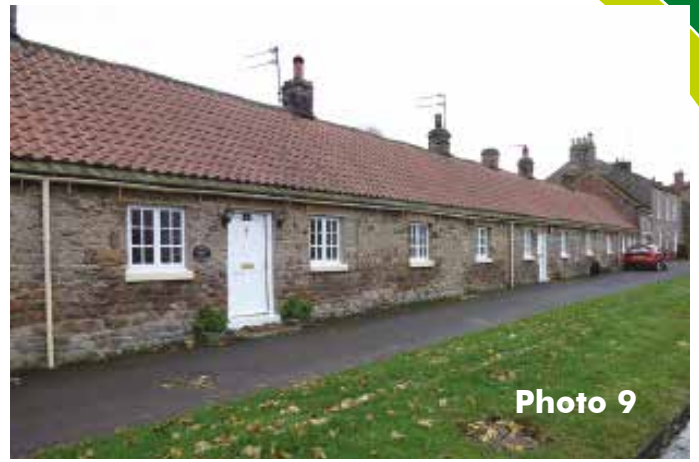
Photo 9

One marked form of architecture which certainly differs from the architecture of surrounding villages are the single storey properties (**photo 9**) built in small terraces, presumably as estate workers cottages. These are at 94, 98 and 104 High Street and 5, 7, and 9 Millgate. The former were original single bay properties but with modern space standards they have been combined to provide larger units. The latter seem to have been built with double bay units.

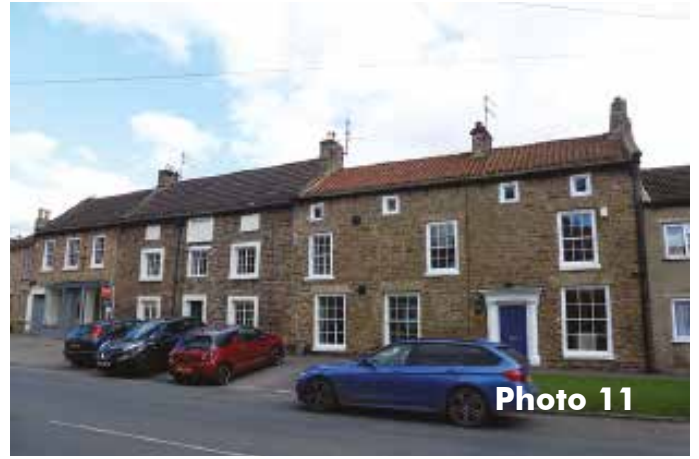
Photo 11

The majority of the rest of the properties in the village are two storeys with one, two or three bays. However, at the area centred around the junction with Millgate, a small number of the properties are either a full three storeys or two storeys with an attic level. This occurs sometimes under the same roof such as at The White Swan Inn and its neighbour 49 High Street. These two properties will have substantially different internal floor to ceiling heights (**photo 10**). A similar phenomenon occurs on the opposite site of the road between the former Post Office and 36 and 38 High Street (**photo 11**).

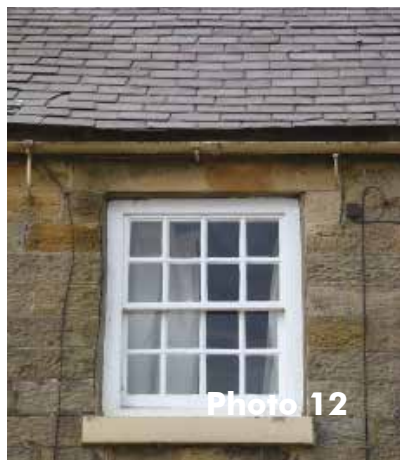
Photo 12

Traditionally windows generally have a vertical emphasis and are vertical sliding sashes with the majority having glazing bars - often either 8 over 8 (**photo 12**) or 6 over 6. On occasions, the upper floor windows are slightly smaller and the windows have been adapted to 4 over 8 or 3 over 6. Such as at 46 to 58 High Street. On a number of properties vertical sash windows have been 'updated' and the number of glazing bars reduced - often to 2 over 2 or 1 over 1.

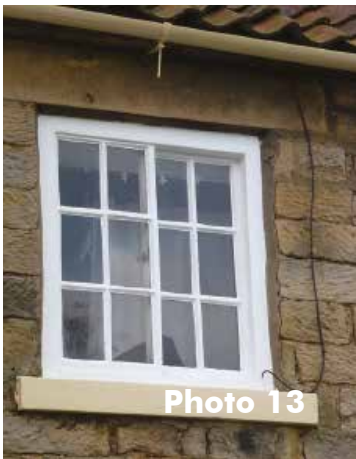
Photo 13

Less common in Gilling West are the Yorkshire sash windows which slide horizontally (**photo 13**). These are traditionally divided into two or three sections often with 6 or 8 panes in each section. They can be found on 36 High Street and are likely have been more prevalent but have been replaced with modern styles of windows as illustrated at 26 Millgate.

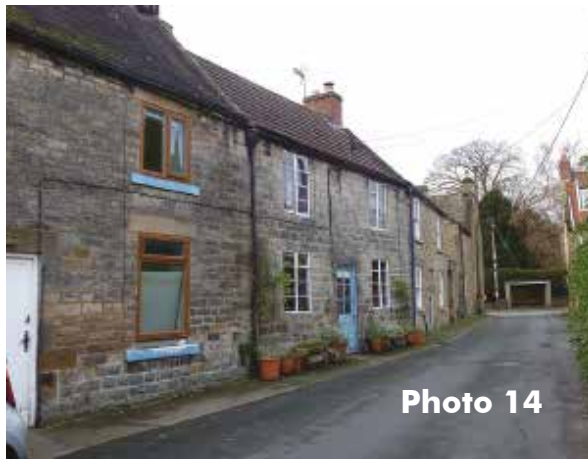
Photo 14

The use of modern forms of windows particularly on the properties that are not listed is unfortunate. This can be in terms of both the design and the materials and they can look incongruous in the street scene. An example can be seen on Millgate (**photo 14**).

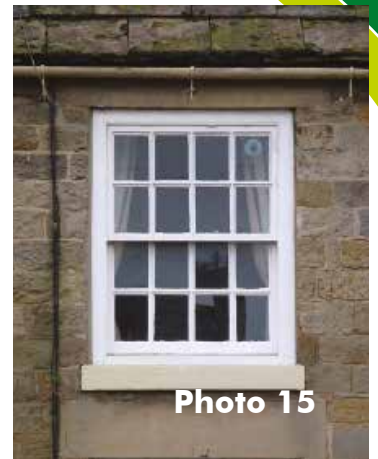
Photo 15

Windows generally have plain stone surrounds or plain stone heads and cills (**photo 15**). The notable exception to this is the gothic style architecture of 81 High Street (**photo 16**) where the surrounds are a single lancet window with a keystone.

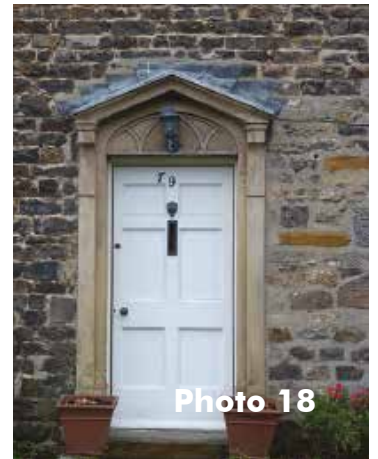
Photo 18

The design of doors varies but most are of a traditional form either vertically boarded or panelled. Some have plain stone surrounds (**photo 17**), others stone lintels, a few have canopies (**photo 18**), and the odd one has a dressed surround like the raised-quin surround of 88 High Street (**photo 19**).

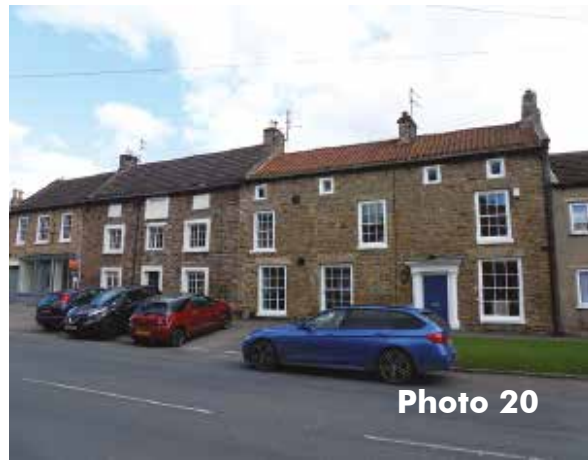
Photo 20

Roofs generally have the ridge parallel to the street and are uninterrupted spans, punctuated only by end chimney stacks indicating the extent of each property (**photo 20**). Dormers and rooflights are not traditionally found on elevations fronting on to the High Street. The lie of the land means that there is a fairly constant level to the roofs of properties with neighbouring properties often not being divided visually. Variation does occur where properties move between two storeys and three storeys and they are some occasions where the variation to the pitch of the roof creates a break to the span of the roofs. Many roofs have traditional features such as kneelers and copings (**photo 21**).

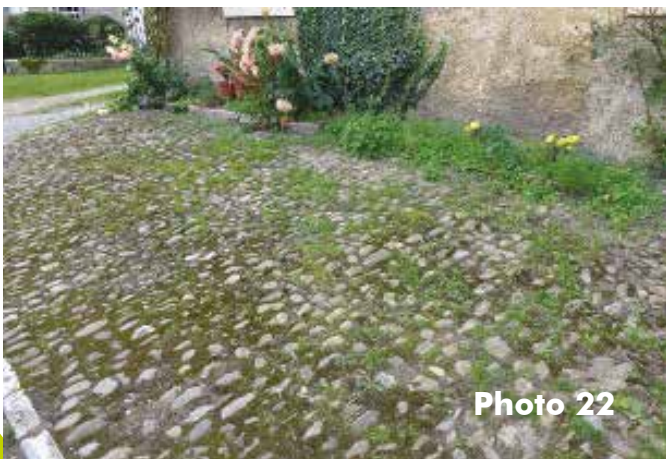
Photo 22

Although most properties front directly onto the street, in some cases there are small forecourt areas - often cobbled (**photo 22**). Porches are not traditional in the village and have only been introduced as a modern feature to properties, most notably at the northern and western side of the village (**photo 23**).

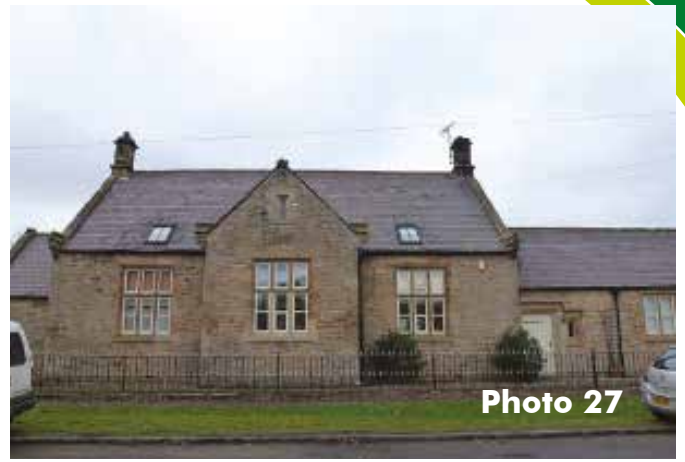
Photo 27

To the north of the village the former School and Masters House were built in 1847 (**photo 27**). They are built of coursed rubble stone with a welsh slate roof. The frontage School building is of a large single storey with the two storey Masters House behind. The architecture is unique to the village but is similar to schools in other villages built in this period. Most notable is the use of mullioned and transom windows.

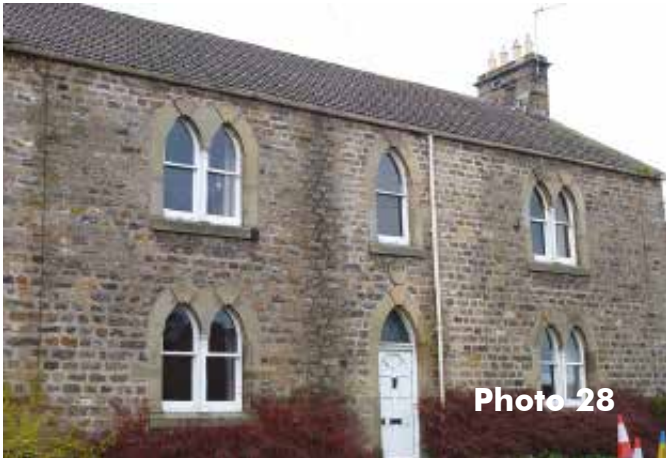
Photo 28

Town End Farmhouse (81 High Street) is a slightly later building from 1879 (**photo 28**) and is a fine and only example in the village of the Gothic revival so favoured by the Victorians. This property certainly stands out as different architecturally thanks to the series of pointed arch paired sash windows.

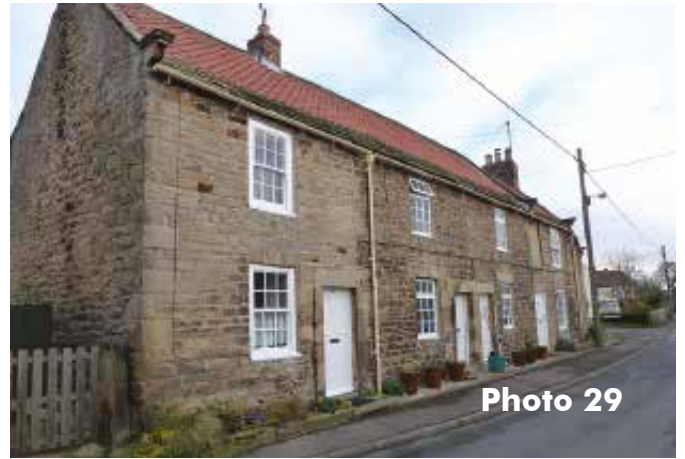
Photo 29

The mid to late 19th Century saw the infill of other small groups of properties in the village particularly along Millgate (**photo 29**). These are generally two storey of stone or render with slate roofs, in short terraces or added to existing groups of buildings.

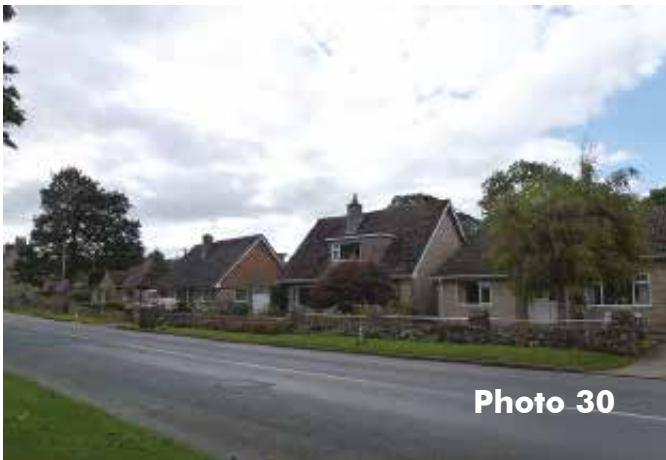
Photo 30

The first half of the 20th Century saw a change to the type of properties built, most are detached houses or bungalows sat within gardens, set back from the road (**photo 30**). These are found particularly to the west side of High Street close to the junction with Waters Lane. The development at Oswin Grove (**photo 31**) is typical Local Authority accommodation to meet a social need. Many of these 20th Century properties look out of context with the local vernacular architecture and instead they have a character of their own. Often the mature gardens act to partly screen the modern developments such as at the new vicarage, but others such as the properties on Oswin Grove are far more obvious.

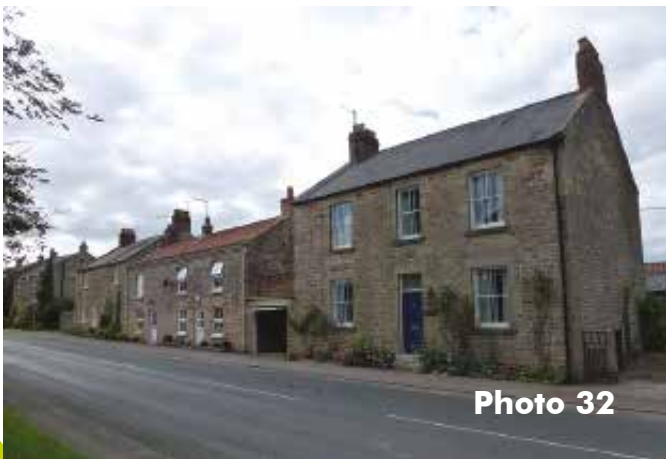
Photo 32

In more recent decades attempts have been made to integrate modern development into the street scene and many have been more successful, such as at 11-13 High Street (**photo 32**) and 89 High Street.

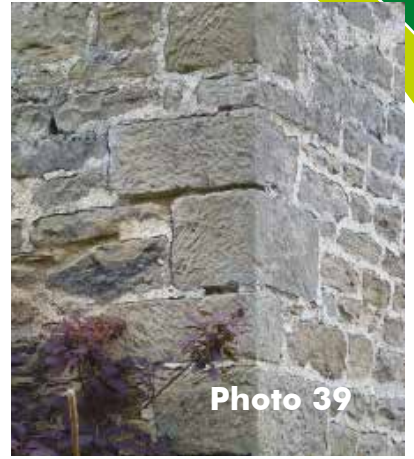
Photo 39

Until the mid 19th Century there were numerous local quarries with a reputation for producing high quality building stone. Transport problems and costs saw the decline and eventual closure of most of the quarries, however, the nearby Duns Bank Quarry survives and still provides stone for the local area. Given this historic reputation it is unsurprising that 80% of the buildings in the village are constructed of local stone. The majority of the cottages and houses use random rubble roughly brought to courses (**photo 33**) or coursed rubble (**photo 34**) construction for the walling. Dressed, often with a herringbone tooling pattern, and ashlar stone are generally used as details but not for whole elevations, although there are some exceptions (**photos 35 and 36**). Such details include door surrounds (**photos 37 and 38**), quoins and lintels as shown on the agricultural building off Waters Lane (**photo 39**) and on the Blacksmith's (**photo 40**).

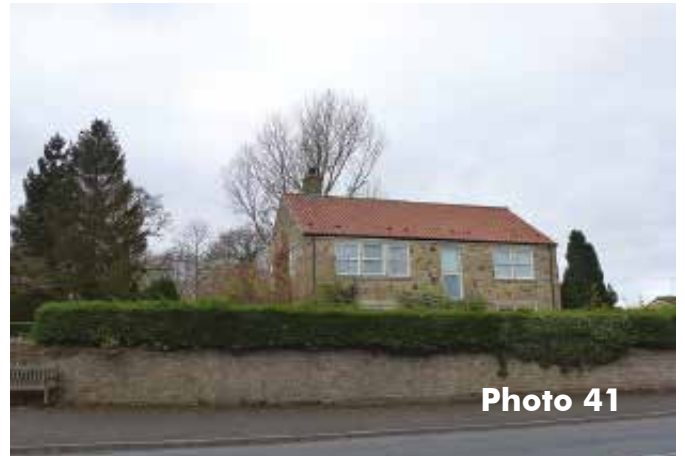
Photo 41

The use of stone has continued throughout the 20th Century and despite the form of construction changing from solid wall to modern cavity wall most recent properties continue the tradition of coursed rubble walling albeit not using stone from the quarries immediately next to the village (**photo 41**). Care must always be taken in new construction and repair to avoid leaving sawn faces exposed in rubble stone walls as the smooth surface left by disc cutters contrasts harshly with the surrounding masonry.

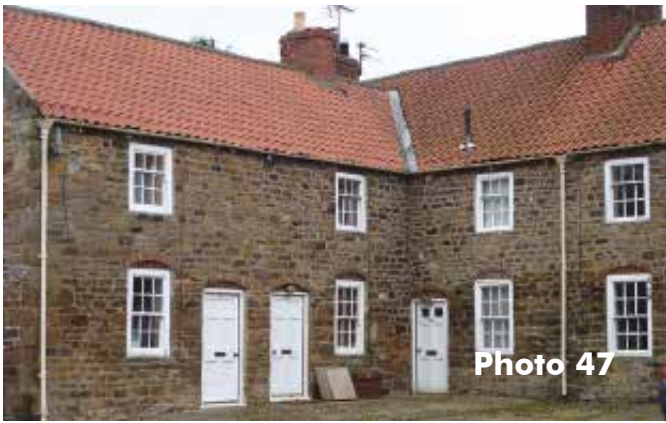
Photo 47

Pantiles are by far the most widely used roof covering in Gilling West and appear to have been the dominant roofing material for many years (**photo 45**). When combined with eaves courses of stone slate they make up 42% of the roofing materials. They vary greatly in age and character and their different ages and sources combine to produce a richly textured roovescape to the village. Such examples are at 122 High Street (**photo 46**) and 46 to 58 High Street (**photo 47**).

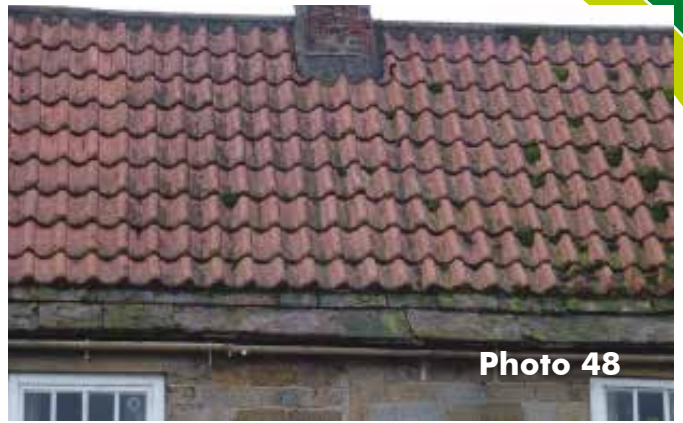
Photo 48

The biggest proportion of properties (29%) have eaves courses of stone slates, a traditional and interesting vernacular feature which can vary in width from a simple single course to three or four courses of stone. Pantiles and a stone eaves course can be seen at 87 High Street, 94 to 102 High Street (**photo 48**) and 8 to 14 High Street (**photo 49**).

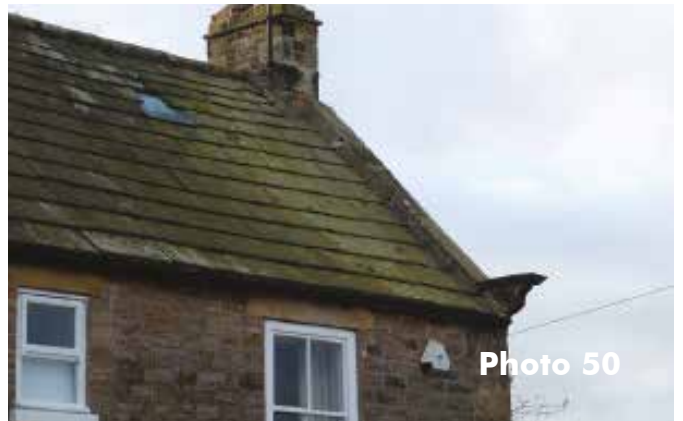
Photo 50

Stone slate (**photo 50**) has also been historically used on around 10% of the domestic roofing in the area, as shown on 39 to 45 High Street (**photo 51**). The stone slates will have been locally sourced. The sandstone slates are thick in comparison to other roofing materials and are laid in diminishing courses, narrowing from large slates at the eaves to small slates at the ridge, often finished with a dressed stone ridge piece. This produces a distinctive character to the roof very different from other natural slates as the covering is notably thicker and the roof has a textured finish arising from the thick slate edges. Although when first quarried the sandstone slates are a pale grey/buff colour they weather in time to a deeper grey/brown colour slightly darker than walling stone. Good examples of stone slate roofs can be found on many of the listed buildings. The stone slates are often combined with pantiles as an eaves course as referred to above.

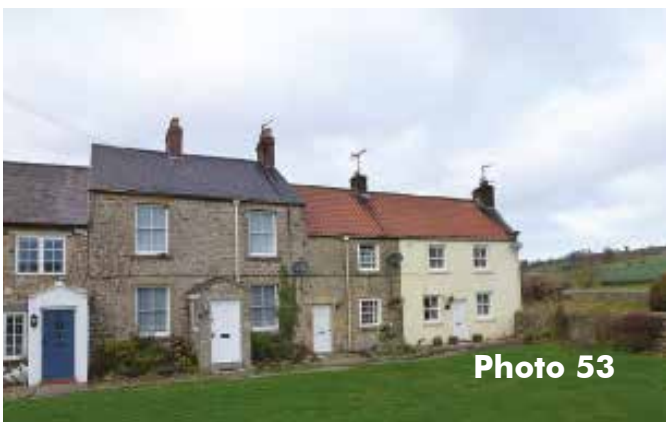
Photo 52

There are several types of slate used for roofing buildings but in Gilling West only Welsh blue/grey slates have been used (**photo 52**). 14% of the properties have this roofing material. The earliest use of slate will date from the latter half of the 19th Century when transport systems, particularly the railways, were sufficiently developed to allow slate to be imported to the area. The use of slate has continued alongside pantiles in both re-roofing of buildings (**photo 53**) and also as an alternative to pantiles and these are best seen at the Old School and its adjoining buildings (**photo 54**).

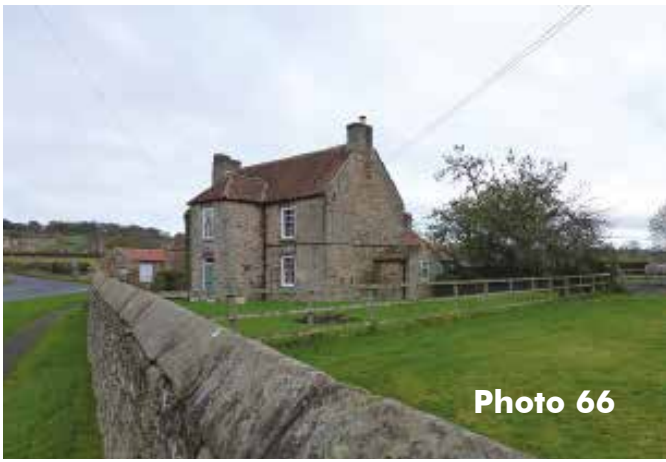
Photo 66

Stone walling, sometimes accompanied with railings and hedging, is found throughout the built part of the Conservation Area and this is either coursed rubble stone to the front of the more modest village properties or more formal dressed stone walls in front of some of the larger houses. This is sometimes coupled with the use of ashlar stone for the gate piers (**photos 64 and 65**). There are two main forms of copings in the village that are worth noting - the triangular dressed stone (**photo 66**) and the curved dressed stone (**photo 67**).

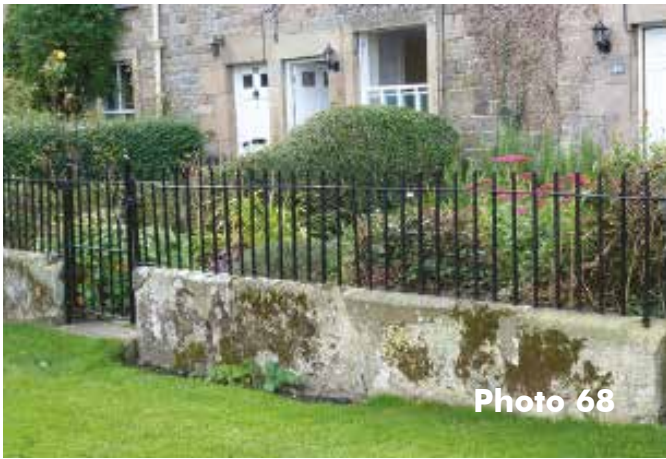
Photo 68

Railings are not common in the village and where found they range from the slim/simple railings in front of 39 to 45 High Street (**photo 68**) to the more ornate/robust 20th Century type as at the Village Hall and the former School (**photo 69**). To provide privacy to Gilling Hall a pillar and railing boundary was introduced picking up the detail of the original gate piers on High Street. There are a number of iron gates dispersed through the village those at the access to St Agatha's Church are listed and a good example. Others are of the more flimsy modern "off the peg" type and mostly to pedestrian accesses. The remaining gates tend to be of the 'farming' type either in metal or timber (**photo 70**).

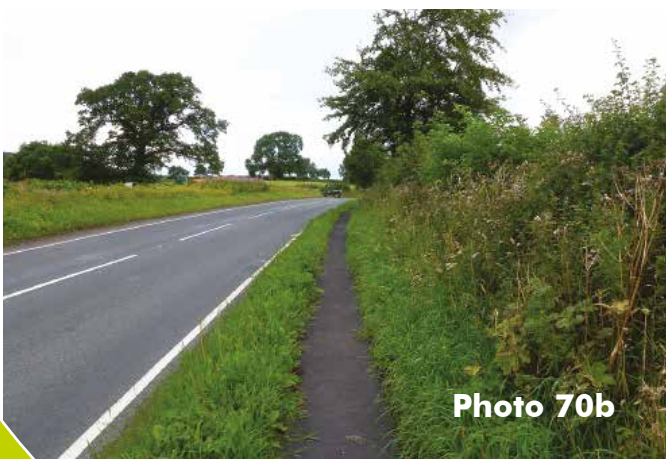
Photo 70a

Away from the main village core, some dry stone walling is used along the minor roads but mostly there is a transition to hedging in the surrounding countryside. Hedging is the other boundary treatment evident in Gilling West particularly along the roads approaching the village from the north (**photo 70a**), the east and the south (**photo 70b**) as well as bounding the agricultural fields. In all locations once in close proximity to the buildings, the boundary treatment changes to walls.

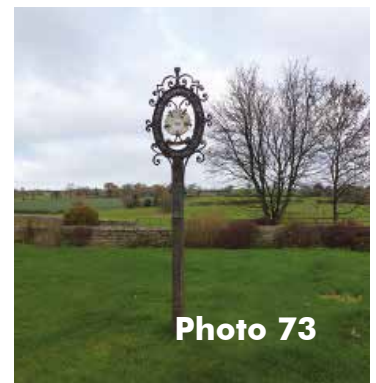
Photo 72

The most prominent monuments are the war memorial in the central part of the village (**photo 71**), the former water point (**photo 72**) and the iron memorial (**photo 73**) to the north of the High Street which has unfortunately decayed to a point that the wording is no longer readable. There is also a listed cast iron milepost from 1890 in the grass verge to the south east of the High Street near the telephone box. The box is of a K6 type (**photo 74**). Following the closure of the shop/post office the post box was removed so a new free-standing box has been installed to the side of the central bus shelter. There are two bus shelters, one at the northern end of the High Street and one centrally (**photo 75**). Both are of a simple single pitch open fronted structure of local stone and so are not incongruous in the street scene. There are a number of timber benches positioned along the length of the High Street (**photo 76**) and within the Millennium Green adjacent to the Beck are a few metal benches (**photo 77**). These are usually serviceable but could benefit from some periodic maintenance. There are regular bins often alongside features such as bus stops. Street lighting is provided throughout the village either as a series of modern brackets mounted on existing poles or on their own poles. These are quite sparse and their design is poor (**photo 78**) in a historic context but street lighting would not have been evident when many of the houses were built.

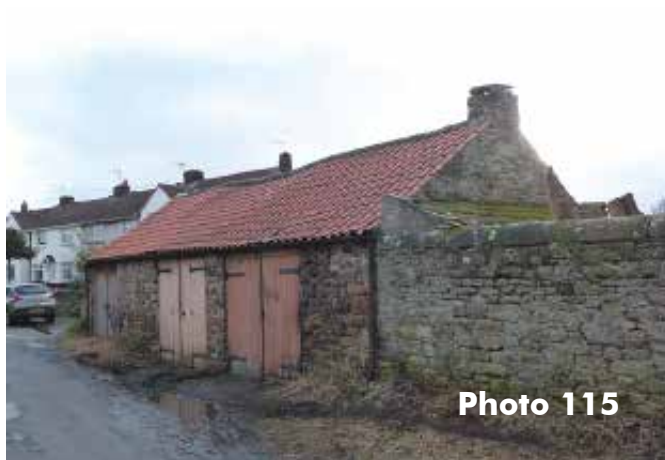
Photo 115

At the east end of Millgate at the boundary of the Conservation Area amongst the houses are a couple of groups of interesting single storey outbuildings (**photo 115**). This type of building is becoming increasingly rare as pressure for development increases and thus more important within the context of the Conservation Area.

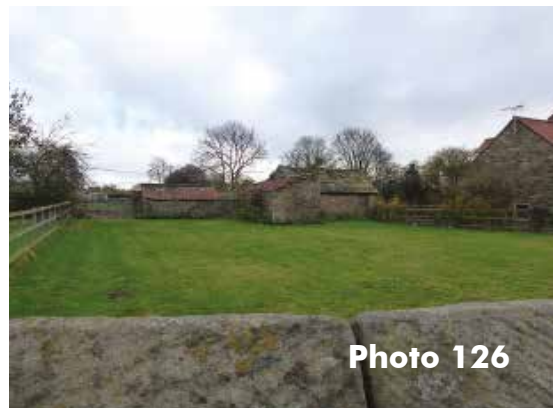
The buildings in Gilling West appear to be in good condition. The only buildings that might be considered to be at risk are those unlisted structures such as the Chapel on Millgate and the outbuildings (**photo 126**) and subsidiary elements such as walls which are generally to the rear of properties. Such buildings do contribute to the character of the Conservation Area and should be maintained in a decent state of repair.

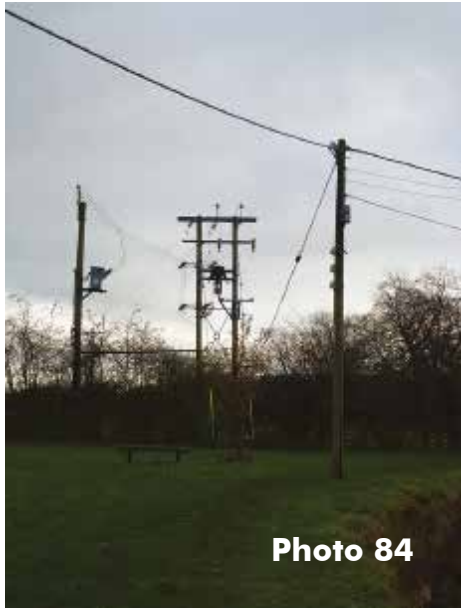
Photo 84

Overhead wires intrude along the length of the High Street (photos 84, 16 and 139). The village would benefit from the reduction in overhead cabling and poles, particularly around the central area at the junction with Millgate. These could benefit from the undergrounding of services and the removal of surplus poles. The disadvantage to their removal is that an alternative support will be required for street lighting.
