CATTERICK VILLAGE

CONSERVATION AREA APPRAISAL AND MANAGEMENT PLAN

Adopted as supplementary
planning guidance 17.07.08

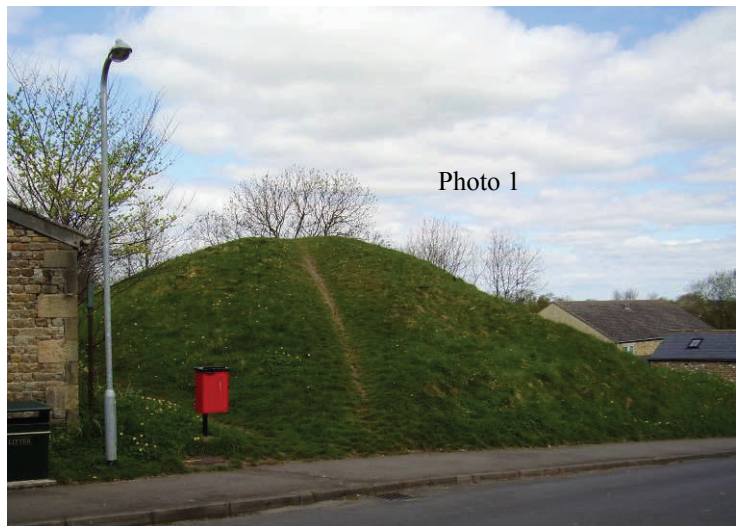
Photo 1

The Norman invasion of the country gave Catterick its oldest visible physical remains, the motte and bailey Castle to the north of the church (photo.1). This was founded by Count Alan but was dismantled by 1154 leaving the earthwork of the motte, sometimes incorrectly identified as a tumulus. The

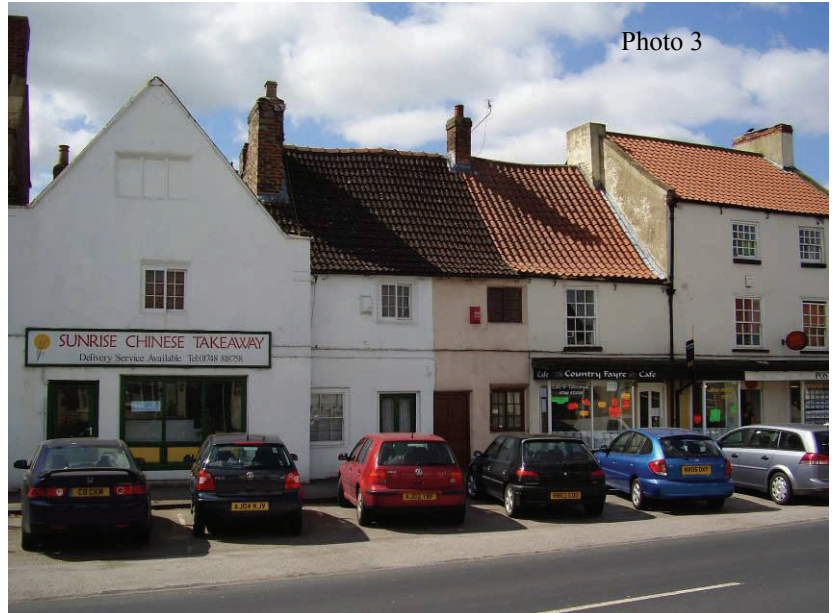
Photo 3

post medieval period and several of the buildings along High Street date from this period (photo.3). The roofscape of this area when viewed from the churchyard above clearly shows the historic form of development with narrow plots of three storey buildings fronting onto the main thoroughfare (photo.4). By the beginning of the 18th century substantial town houses were being built to the north end of the High Street however Edward Ellerton (1784-1870) noted a decline in the fortune of the settlement writing “the modern Catterick is only a village,

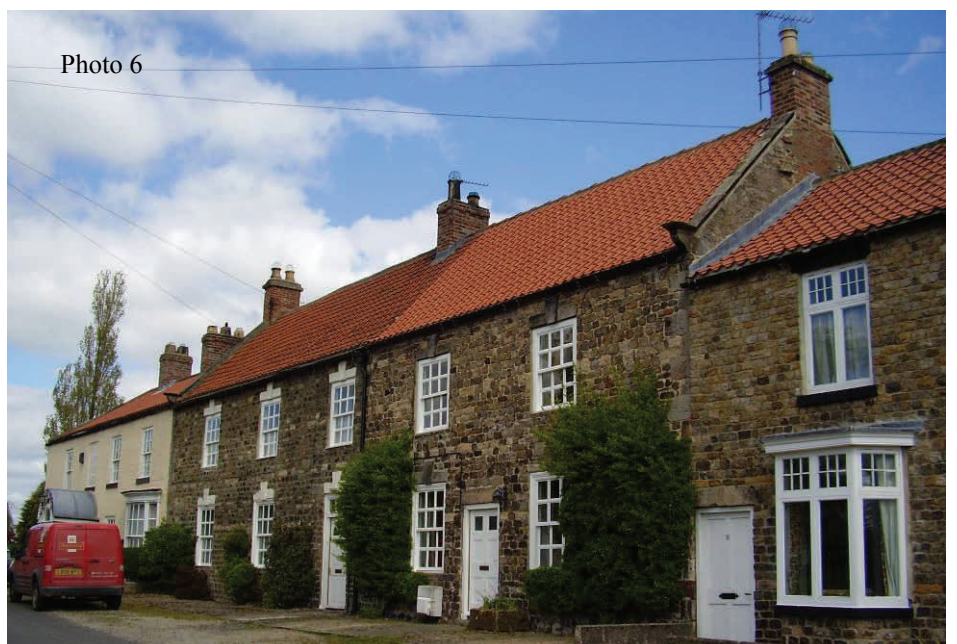
Photo 6

containing 561 inhabitants”. The historic core of the village remained centred close to the castle mound and church with later development throughout the 18th and 19th centuries flanking the existing greens. A number of substantial buildings were constructed including those at 41 and 43 High Street, dated 1709 (photo.5), and later, the houses that now line the north side of Low Green. Domestic buildings on The Bank also date from this period exhibiting a good range of typical Georgian features (photo.6).

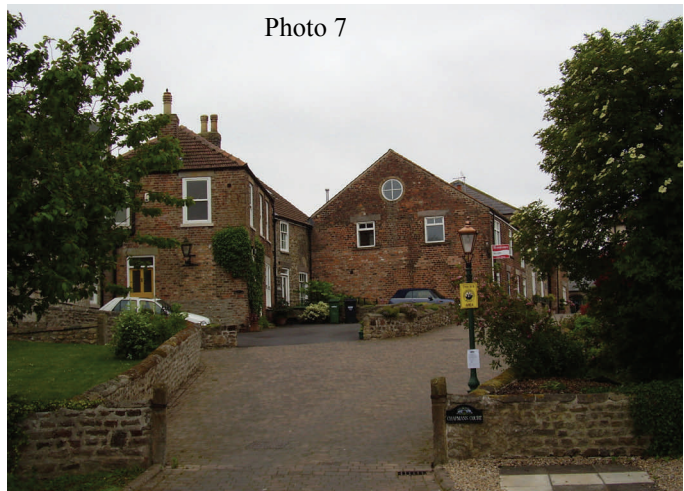
Photo 7

The village continued to grow through the Victorian period with the Manor House farm complex at the west of the village being typical of small planned industrial farmsteads (photo.7). Cottages throughout the village changed little in design in this period but continued to develop along the north side of High Green (photo.8). The Richmond branch of the Stockton and Darlington Railway opened to Catterick Bridge in 1846 linking Catterick village to

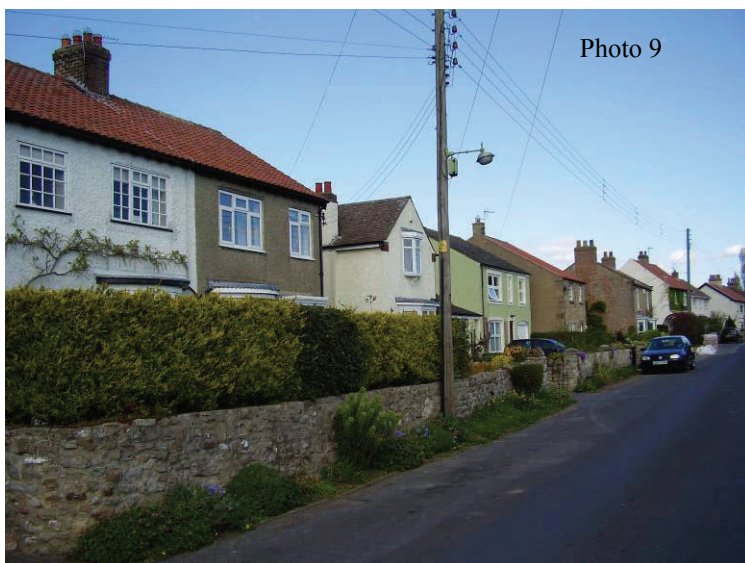
Photo 9

The 20th century has had little large-scale impact on the conservation area as a whole. A number of new houses have been constructed on gap sites and along the north side of High Green however these have not generally impacted adversely on the conservation area (photo.9). The two bungalows at the top of The Bank do not harmonise with the scale and character of other properties in this part of the conservation area

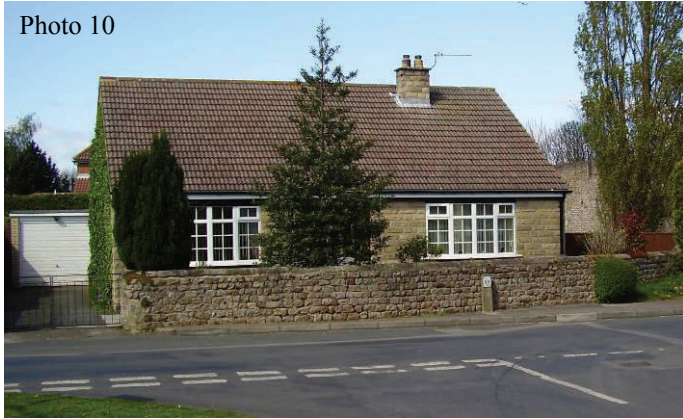
Photo 10

(photo.10). The Vicarage adjacent to the church is a very 1970's style building, but is much improved by the scale and landscaping of the plot on which it sits (photo.11). This site originally had a large vicarage and a range of domestic buildings towards the road with two entrances. The large size plot is unusual in the village but allows the new house to sit discreetly in its setting. On Low Green a pair of semi-

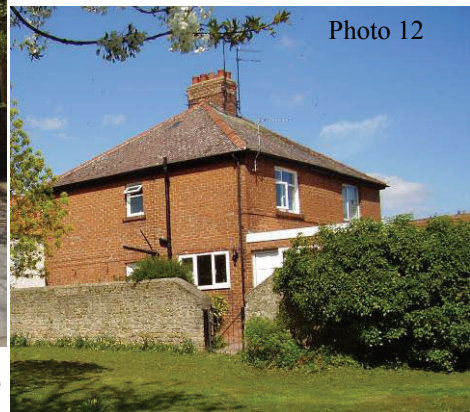
Photo 12

detached houses presents a very prominent brick flank to the green, which contrasts with the predominant stone of properties in the area (photo.12). Another pair of

Later, buildings of the 20th century used brickwork more widely in particular the semi-detached houses of the interwar period along the north side of High Green and at Low Green (photo.12). The use of red or red/orange brick here is discordant within the conservation area.

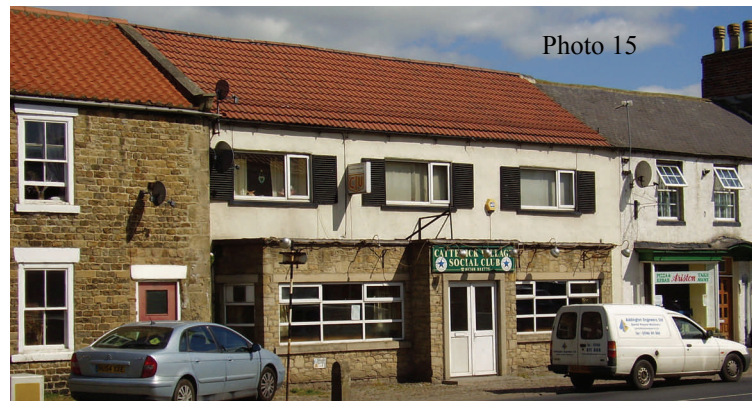
Photo 15

semi-detached houses further down Beckside are more successful in addressing the conservation area and show that 20th century development can make a positive contribution to an historic setting. The frontage of the Club on the High Street is a typical 1960's style and might present an opportunity for enhancement through a redesign. (photo.15).

There are some frontage properties that could benefit from sympathetic repairs and alterations to improve their contribution to the conservation area. Of particular note is the frontage of the social club on High Street that has been unsympathetically altered in the past (photo.15). A scheme to replace the frontage with a more in keeping design would be welcomed here. The group of old properties that include the Chinese take away and the café (photo.3) would benefit from further study to identify their historic features and significance and bring forward a scheme of conservation based repairs.

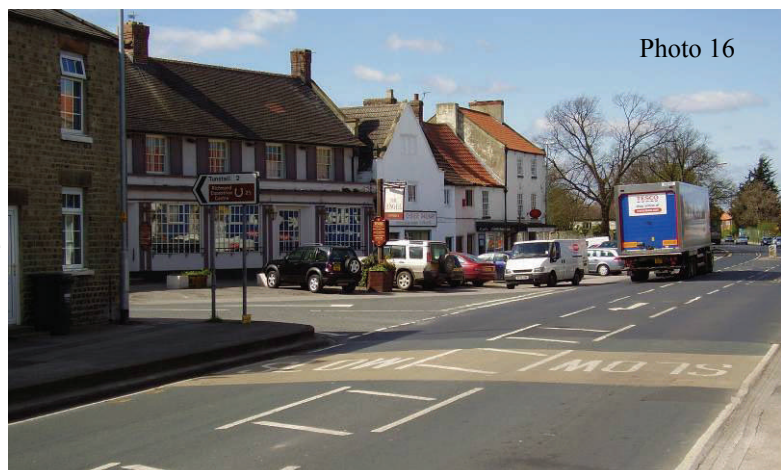
Photo 16

The growth of traffic in the 20th Century had a major impact on the character of the High Street with a need to accommodate ever-larger numbers of vehicles of ever increasing weights (photo.16). The roadway and its attendant parking areas have grown to cover the majority of the space between the building frontages. In addition the buildings themselves profited

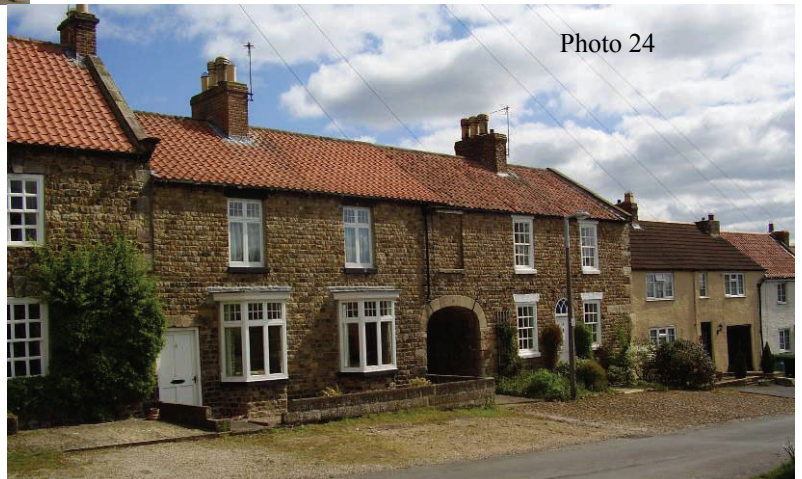
Photo 26

The Georgian period contributes many distinctive buildings to the village including 6 and 7 Academy Buildings (photo.23), 9-17 The

Bank (photos.24-26), 24 Low Green (photo.27) and 32 and 34 Low Green, Stepping Stones House (photo.28).

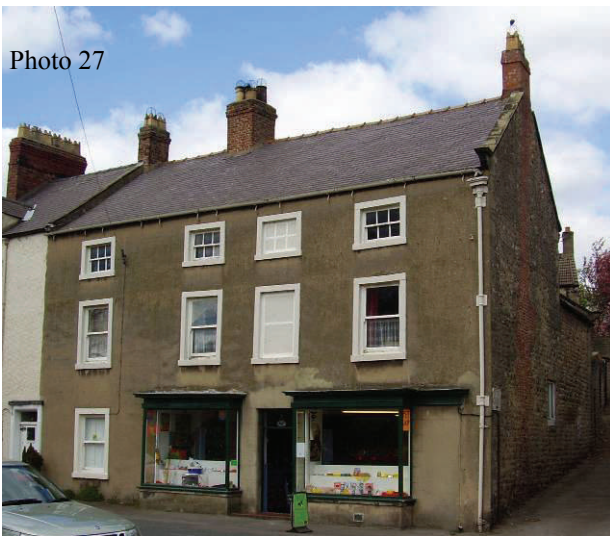
Photo 28

where the early glazing bars in the sliding sash windows are important survivors (photo.31). Stepping Stones House is a fine example of a good quality late Georgian provincial house with well-proportioned openings and classical details (photo.28). Other Georgian features in the village include a good fan light at 9 The Bank (photo.32), and the formal composition of the stable block to the south of the High Street (photo.34).

These slates appear as eaves courses on 12 High Street, a detail that is more common further west but never the less is an important local tradition (photo.49). Stepping Stones House at 32 Low Green is a sole domestic example of Westmorland green slate laid to diminished courses (photo.28). This is an example of an expensive, high status roof being used on a prestigious property in the village.

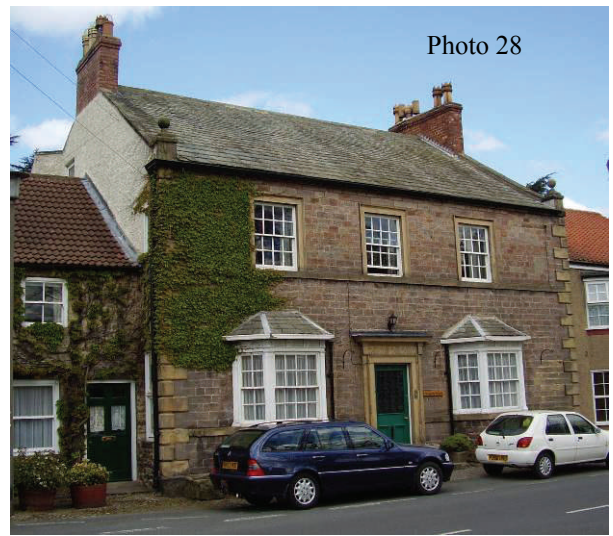
Typical features dating these buildings include the ashlar stone surrounds with keystone details (photo.29), the rusticated door surrounds of 41a (photo.21) (an early building) and Academy Buildings (photo.30), and the distinctive joinery particularly at 13 The Bank

The traditional roughcast render was formed of a lime-based mortar with a large gauge aggregate included for bulk. It created a distinctive rough texture and remains very successful at sheltering poor quality stonework from weathering. Photo 29 shows a patch of historic render still in place on Academy Buildings. Where a building was designed to have a rendered or plastered finish and this has been removed the revealed stonework often is of a poor quality. In other cases render has been applied to harmonise a group of buildings or to disguise alterations.

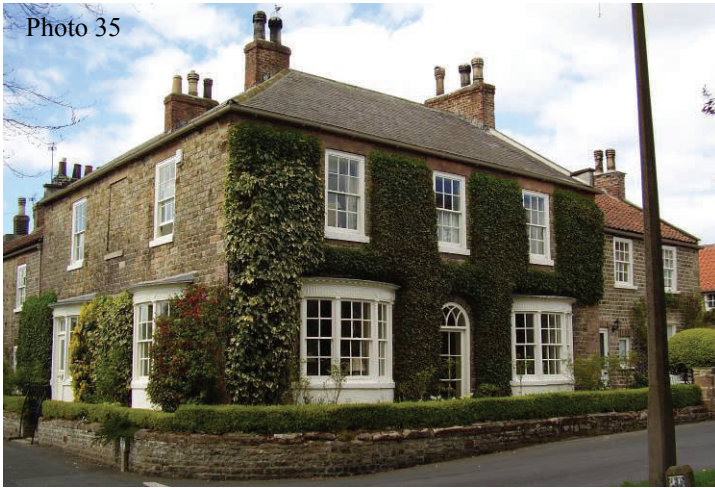
Photo 35

The 19th Century contributed a range of buildings to the village from several of the cottages on the north of High Green and the Corner House at 42 Low Green (photo.35) through to the Booth Memorial Institute building at the corner of High Street and Swale Lane (photo.36). The large farm complex to the western end of the conservation area, although dating from the 18th century has a significant amount of development typical of a Victorian planned farmstead.

There are several types of slate used on village buildings. Welsh slates are the most numerous traditional alternative to pan-tiles and these are best seen at The Corner House and the nearby buildings stretching eastwards from here along Low Green (photo.35).

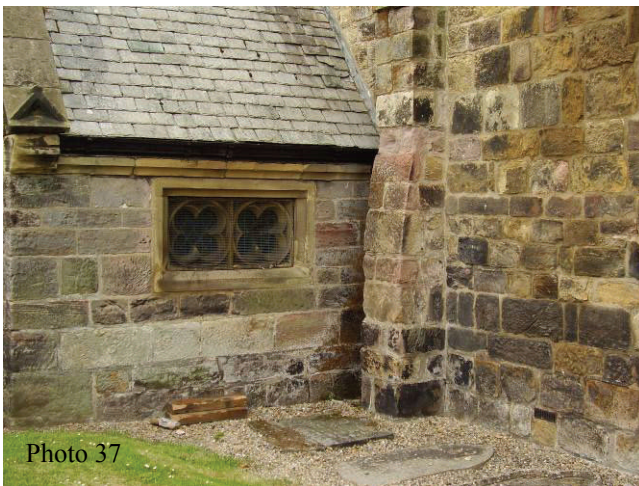
Photo 37

The church set the standard for the use of stone in the early 15th century. It re-used stone from an earlier church particularly in the north wall. It is constructed of well coursed local sandstone exhibiting a rich variety of colours from pale buffs through a range of greys and browns to a delicate pink tone (photo.37). This is likely to reflect the available stone from differing quarry beds rather than a conscious

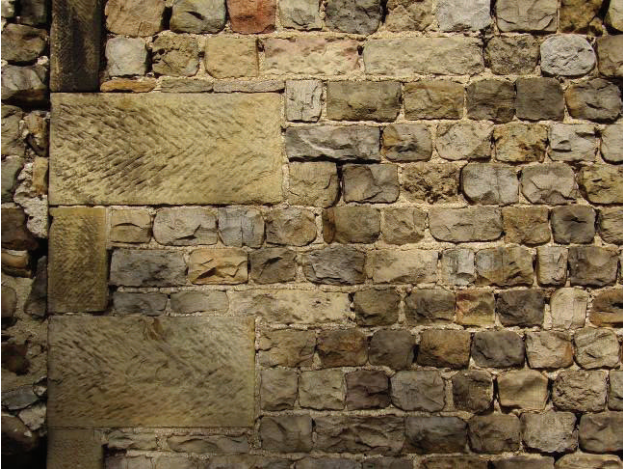
Photo 39

From the mid 18th to the mid 19th century the use of stone blossomed in the village. Much high quality walling was constructed using both coursed river cobbles and pitch faced blocks again brought to regular coursing (photo.39). Construction using river cobbles is difficult given the shapes of the blocks and to establish a well coursed wall is particularly noteworthy (photo.40). Ashlar sawn blockwork in local sandstone is used in many cases for detailed work such as archways, window surrounds and quoins (photo.41).

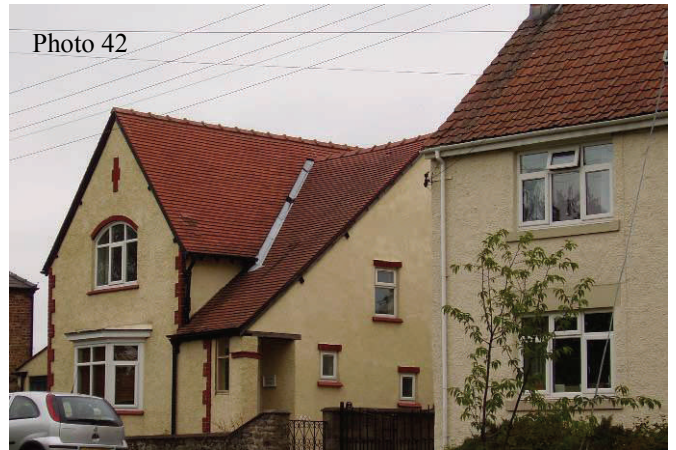
Photo 42

The 20th century significantly changes this approach. Edwardian houses are built to nationally adopted style with asymmetrical forms, tiled roofs and much render and decorative timber (photo.42). The local sandstone declines in use being replaced by brick, and it is only towards the end of the 20th century and the beginning of this century that stone makes a significant reappearance on the new development to the south of Low Green (photo.43). Notwithstanding the return to traditional materials the stone does not

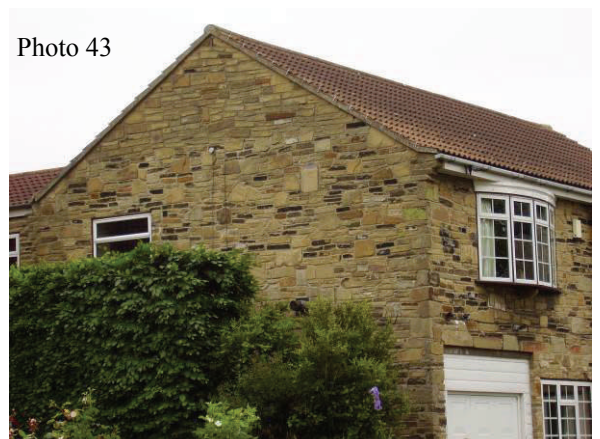
Photo 43

appear to be sourced as locally and the skill and quality of the modern builders does not match the high standard set by the masons who constructed the adjoining cottages in the 18th and 19th century.

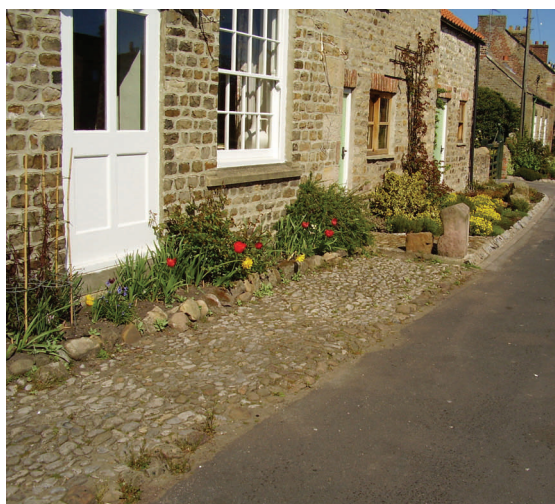
Photo 51

Although the floorscape of the village is dominated by modern tarmac there are still surviving areas of older traditional materials and forms of road surfacing. Cobbling is present in several areas and laid to various patterns. Notable areas are found on the east side of High Street (photo.50), at the top of The Bank (photo.41) and along sections of Low Green (photo.51). On High Green some areas of unmade road survive. Such finishes are traditional in rural locations and should be retained. (photo.52).

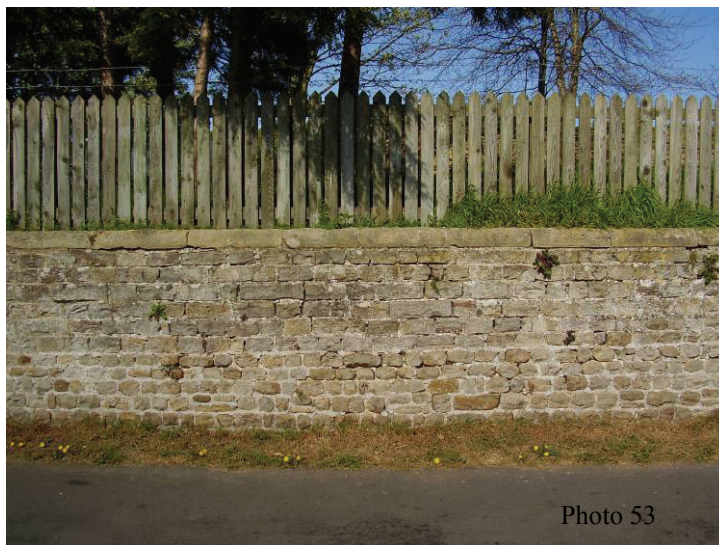
Photo 53

Many properties throughout the village front directly onto the edge of the footpaths or have open hard surfaced frontages running from the house to the roadside. The most prominent forms of enclosure are traditional stone walls with copings to various designs (photo.53). In many cases these have been supplemented with hedges planted behind and trained to different heights (photo.35).

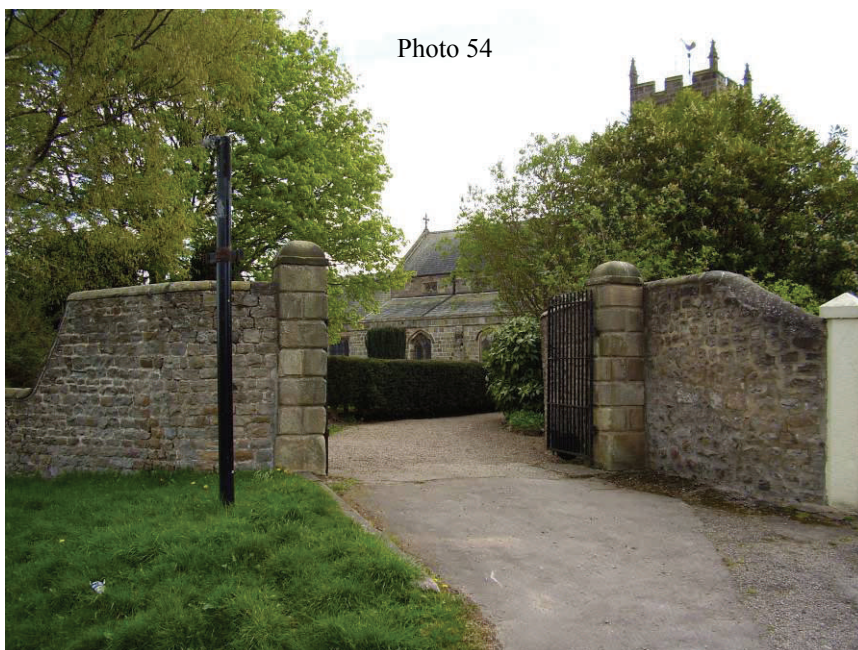
Photo 54

Some of these traditional enclosures and finishes are under threat from the creation of hard standing car parking spaces in place of small front gardens. Fencing and railings are rare in the conservation area as is the use of gates to private areas, the only notable example of gates being those listed items enclosing the churchyard (photo.54).

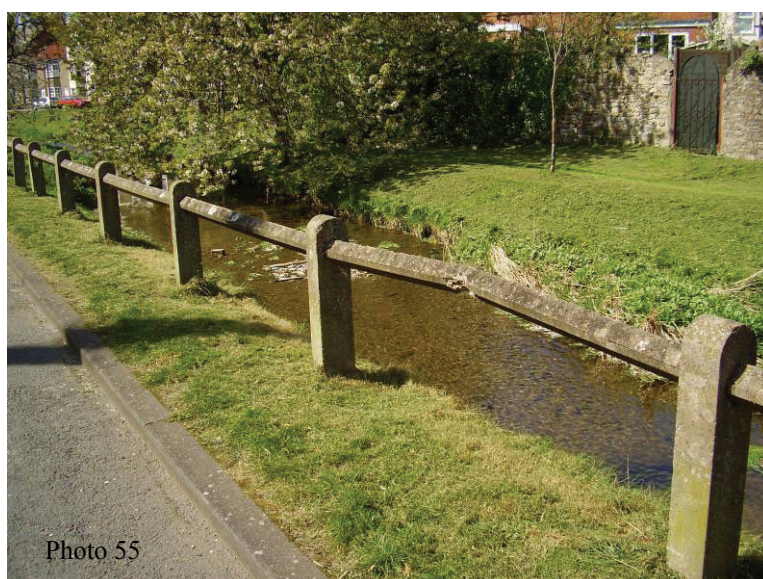
Photo 55

There are several forms of street furniture much of which is elderly and has deteriorated to a poor standard. There is no comprehensive scheme of street lighting, lamp-standards currently in use being mostly either concrete or standard modern steel items. Planters and litter bins throughout the village are generally in poor condition and safety railings on Becks side are damaged concrete items (photo.55). The footbridge over the beck

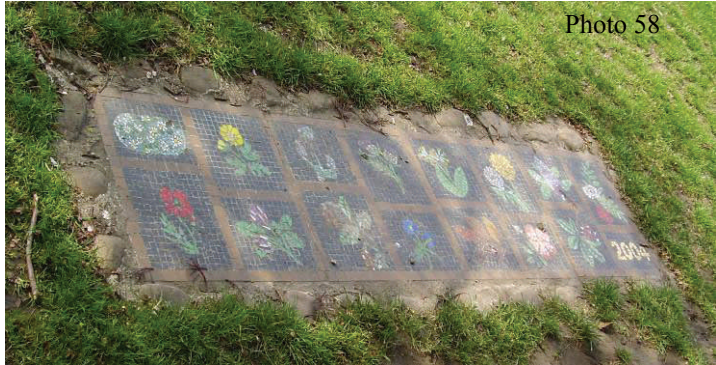
Photo 58

has been subject to repairs many times and this make-do-and-mend approach leaves the structure sound but not contributing to the quality of the conservation area (photo.56). There are some foundations of a former packhorse bridge adjacent to the existing structure. Seating is provided throughout the village and varies greatly in quality. Some is relatively new and in good condition whilst in other cases the seats are unusable (photo.57). Many of the seats benefit from attractive mosaics around them and this would be a feature well worth encouraging and maintaining (photo.58).

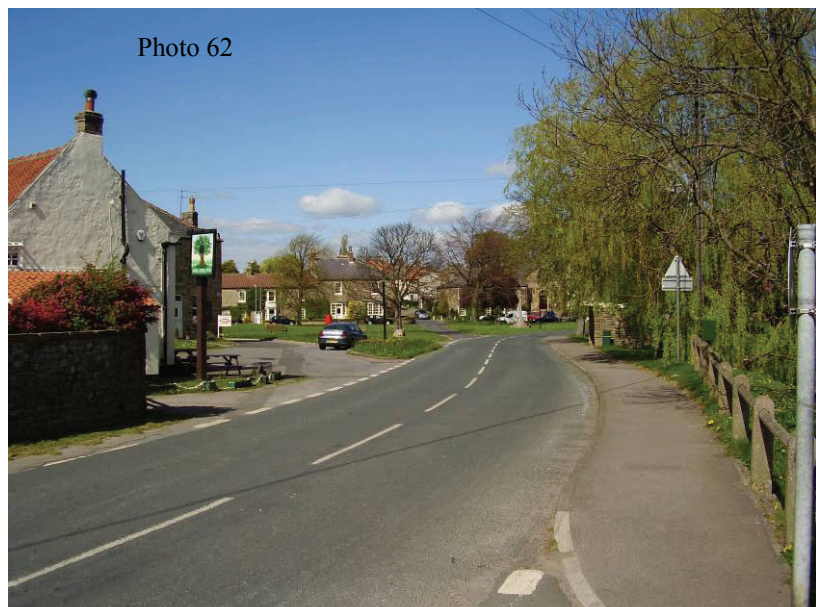
Photo 62

The remaining access to the village is from the Tunstall Road approaching from the southwest (photo.62). This minor road gives a much better view of the village as the approach is undulating and glimpses from high points, including the motorway bridge, reveal the pantile roofs of the settlement.

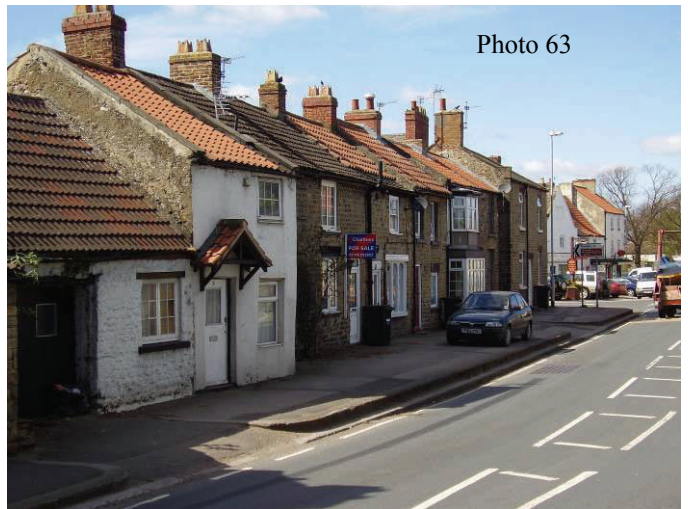
Photo 63

The approach from the south hints at a small, intimate settlement with low set domestic cottages lining the west of the road and the solidity of the coach house and its flanking walls to the east (photo.63). It is a visual surprise then to turn the corner and emerge into the broad expanse of High Street. The road, a wide expanse of tarmac car parking and cars and traffic dominate this area. The buildings enclosing the views are substantial structures of two and three storeys many of which have strong characters that impose on the view (photo.16). This is particularly the case on the west side of the street, less so to the east where buildings are restricted to two storeys. There is a bustle and liveliness in this central portion of High Street which is derived from the commercial uses and the passing traffic.

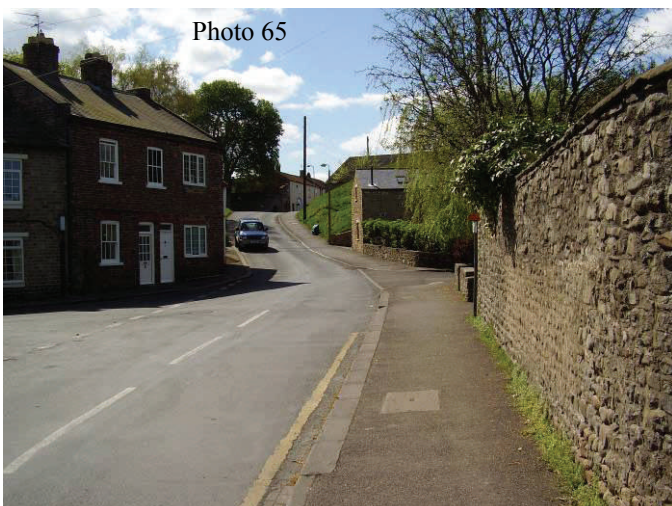
Photo 65

The High Street also benefits from glimpsed views along streets leading both to other parts of the village and out to the countryside. The view along Swale Lane makes an indifferent contribution to the townscape but the views up High Green (photo.65) and along Low Green and Beckside hint at a more extensive and interesting village (photo.66).

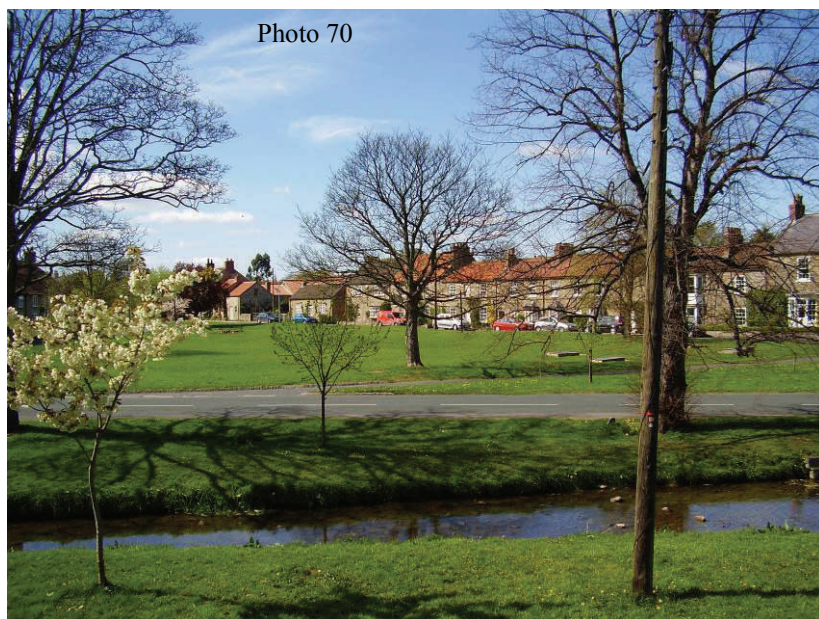
Photo 70

This extensive part of the village is strictly contained to the north by the two and three storey buildings flanking the street at the pavements edge. This gives a strong identity to the Green and provides an interesting backdrop to the wider scene (photos.69&70). The area opens out from east to west, being rather closely set with buildings where Low Green meets the High Street (photo.67) but spreading out to an expansive green with specimen trees, seating and quoits pitches further west. The beck creates a strong linear feature

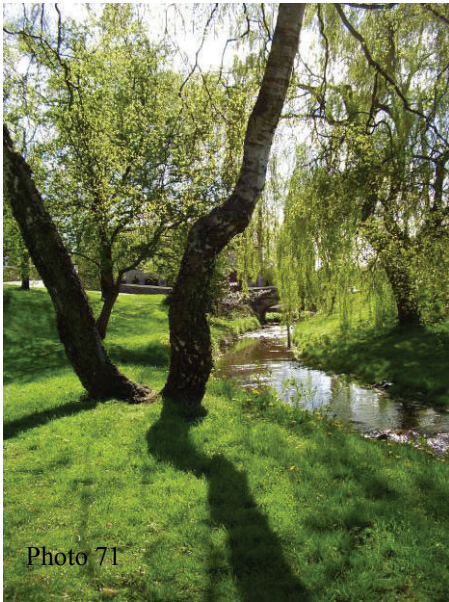
Photo 71

defining the southern and eastern boundary, and brings some topographical relief to the open space. Trees are extremely important in views through this area and are of a variety of species giving a range of leaf tones and blossoms (photos.68&71). The banks of the beck are suffering from erosion caused particularly during times of flooding.

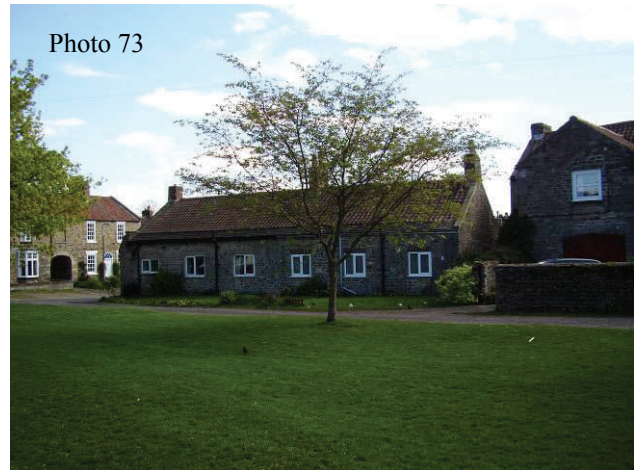
Photo 73

Historically the buildings in this area are of great importance as they include the castle mound, the church and several of the older buildings on The Bank (photos.72&73). Visually however this area does not have such a strong character. Although High Green itself is well defined and attractive, particularly at the eastern end where it is bounded by The Bank, many of its boundaries are less well defined relying on indistinct or back garden boundaries and a variety of blank stone walls.

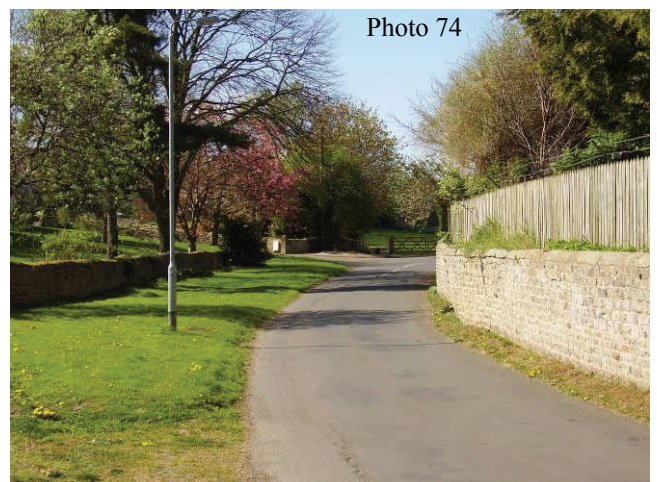
Photo 74

The west of the village has no single clearly defined character to unify it. At the far western end the large predominantly Victorian farmstead has been converted into housing but still retains the appearance of a farm. This building group provides a useful visual stop to the village and to views along the approach roads. The stone walls flanking the road from Low Green are important to the linear character of this part of the conservation area and reveal the open fields to the south (photo.74). This is a very attractive part of the village which survives substantially

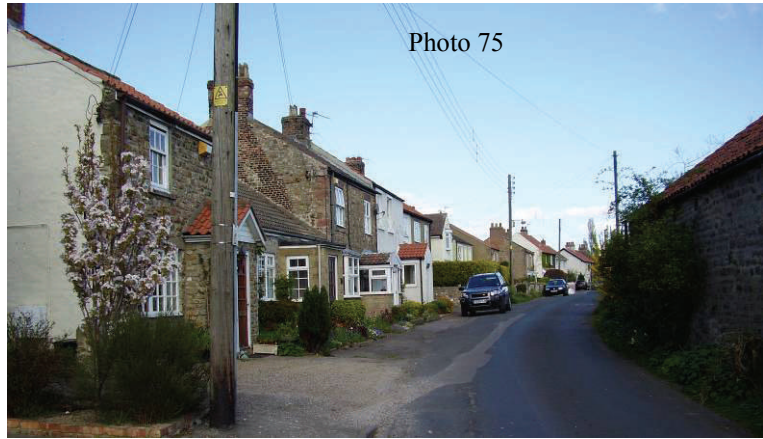
Photo 75

Heading west from High Green the road is flanked to the south by a high stone wall and to the north by small houses of varying ages (photo.75). The range of sizes, designs and ages give a rich grain to the boundary. Glimpses through the houses reveal buildings and gardens in the back-land but screening is adequate to prevent the visual intrusion of the new development to the north. On the south side of High Green the main facades of the houses face south away from the public façade.

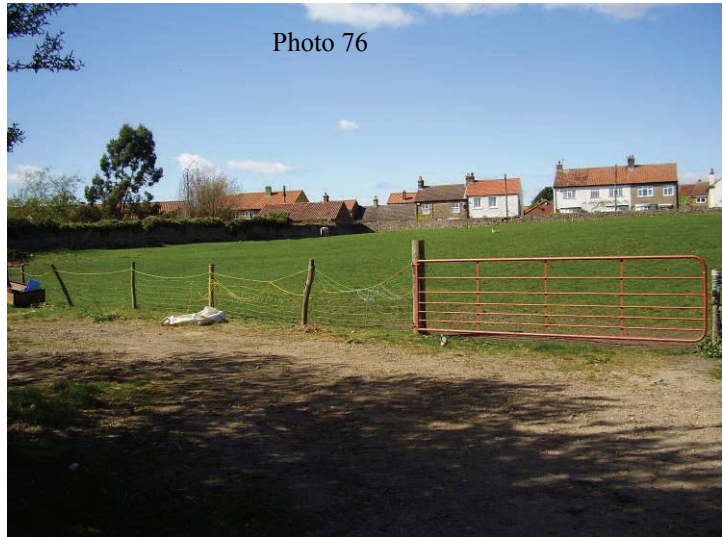
Photo 76

Set within the western part of the village is a large open field currently being grazed (photo.76). This is an important feature in the village as it maintains the open character of the urban area. It is flanked on all sides by stone walls that enclose it most thoroughly and from the majority of locations hide it from view. Although not a visually prominent feature its scale and location are important in defining the character of this large part of the village.

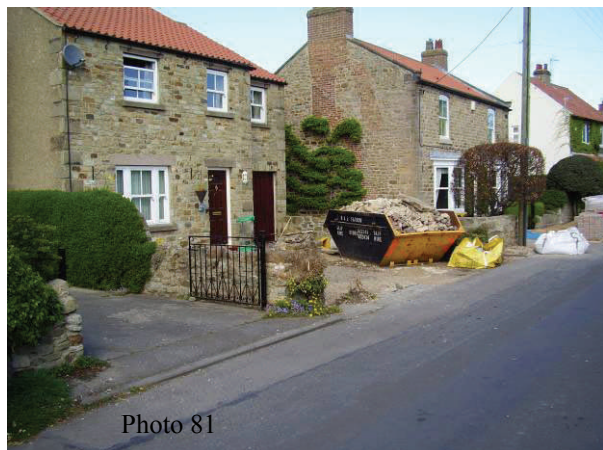
Photo 81

In certain parts of the conservation area low domestic boundary walls make a significant contribution to the character of the area. These are under threat to allow the provision of front yard car parking (photo.81), but the loss of these boundary features should be resisted because of their importance in the streetscape.

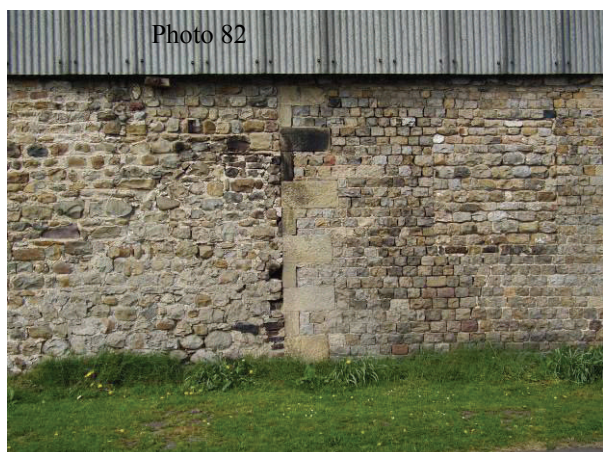
Photo 82

In general buildings in Catterick are in good condition, however there are some sites and buildings in a poor state of repair. Generally these are ancillary buildings, barns etc to the rear of the main frontages but as these are an important part of the character of the village their decay and ultimately their loss would be to the detriment of the character of the conservation area. Of particular note is the large agricultural building adjacent to the castle mound (photo.82). Although now in agricultural use

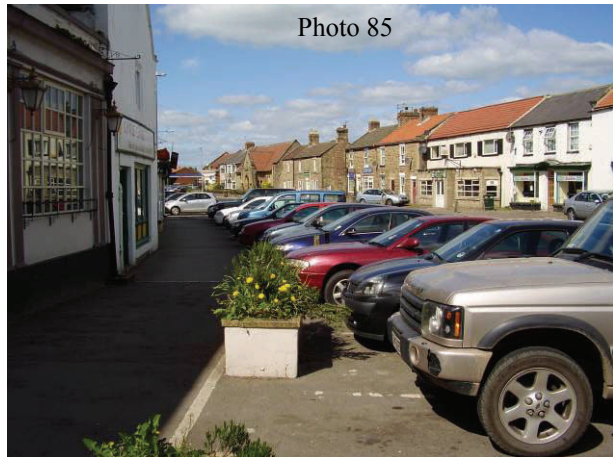
Photo 85

expanse of carriageway far larger than required by the level of traffic using it (photo.85). This is obviously a legacy of the Great North Road. The attendant parking areas to the frontages of the commercial buildings should be better organised and maintained. In several cases historic and high quality surfacing remains and this should be exploited and repaired, replicating it in more locations where appropriate. A comprehensive assessment of the parking and traffic requirements here would inform a landscaping scheme that could have a very significant impact on the quality of this historic core.

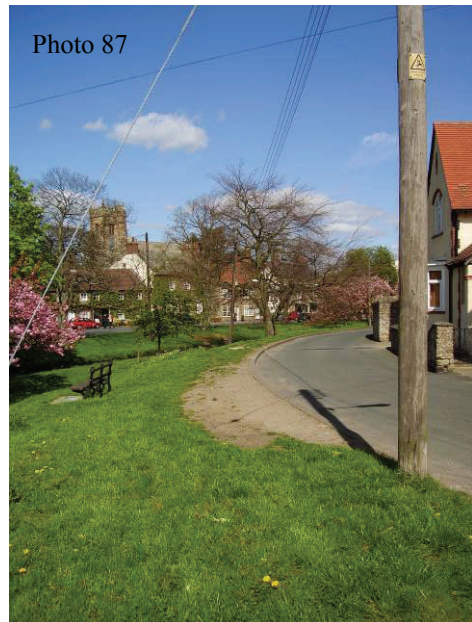
Photo 87

Overhead wires in the conservation area are a sporadic problem with some areas not suffering unduly but locations being significantly marred by the poles and lines. Along High Street it is not considered too much of an issue as the area has a busy commercial character and the wires tend to be lost in the general scenery. Along Becksides however the poles and wires are particularly prominent and a significant improvement could be made by either the undergrounding of these wires or their omission all together (photo.87). The extent of this area is show on the plan in the appendices.
