GAYLES

CONSERVATION AREA APPRAISAL AND MANAGEMENT PLAN

Adopted as supplementary
guidance 23 February 2010

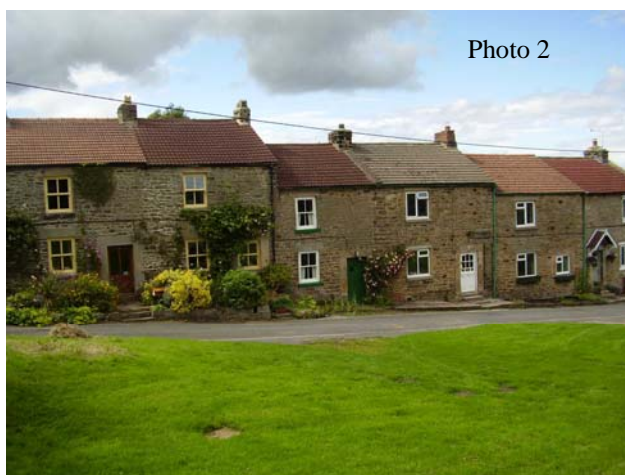
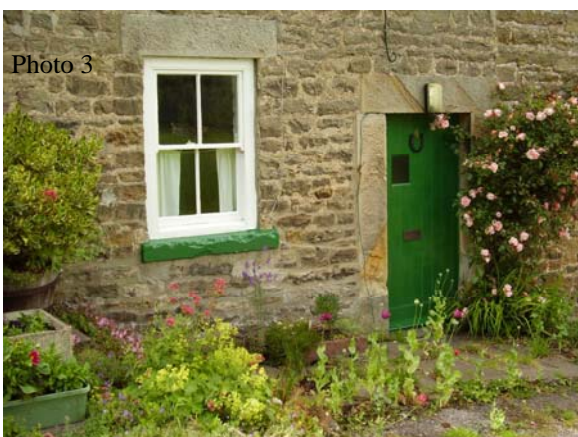
At the smallest end of the scale the terrace of buildings at the west end of West Street represent typical workers cottages (photo 2). They are simple single bay buildings with a single window to each floor on the front elevation. It is likely that they were one-up-one-down houses when constructed. No 4 appears to be largely unaltered. Others are now much altered with extensions to the rear and in some cases combining two small cottages to make a more substantial property. They appear to be Victorian in date and constructed of coursed rubble with well-cut and dressed window and door surrounds (photo 3). Although the terrace appears at first sight to be a

single development changes in masonry style, variations in detail and straight joints between properties demonstrate that these houses were built in batches, not necessarily at the same time. Alterations to these properties, carried out with the best of intentions, have not

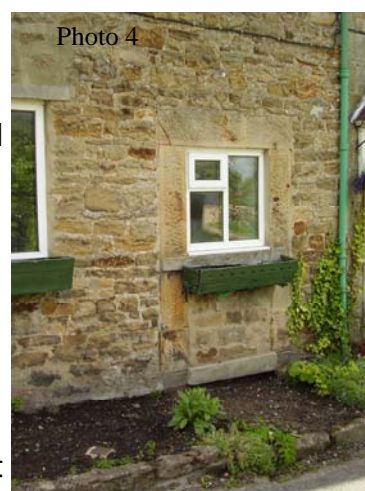
always been in keeping with the character of the Conservation Area (photo 4). It is possible that many of the lost, demolished properties of the village took this form, as they would tend to be the first to be abandoned as the population contracted.

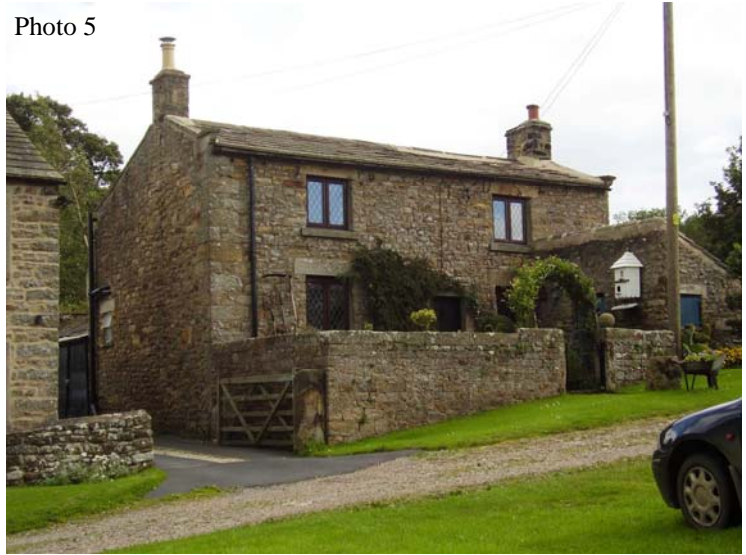
Photo 5

The largest number of buildings in the village are the smaller individual cottages such as Pleasant View (photo 5) and West View (photo 6) on West Street and Appletree Cottage (photo 7) and Sundial Cottage (photo 8) on Middle Street. These properties span a range of dates from at least 1686 as proclaimed above the door of West View (photo 9) through to the mid Victorian period. Typical features include the dominance of solid wall over the small windows

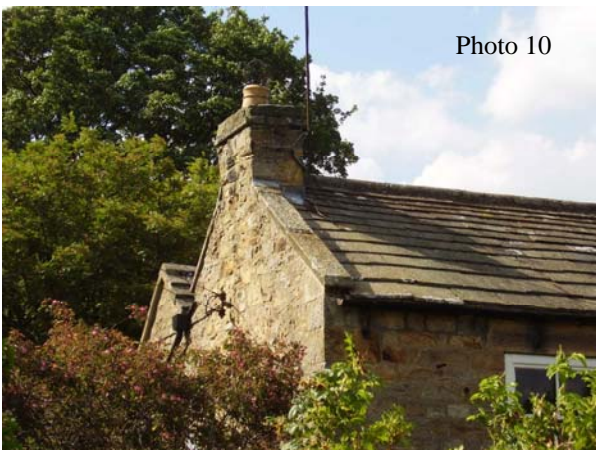
Photo 10

seen well at Pleasant View, the shallow pitch of the roofs as at Appletree Cottage (photo 10) and the roughly symmetrical arrangement of windows to the property. Styles of roof vary, though most have raised eaves with sandstone copings weathering the wall head as found at Appletree Cottage. The arrangement of chimneys to the properties can indicate the number of heated rooms to the house;

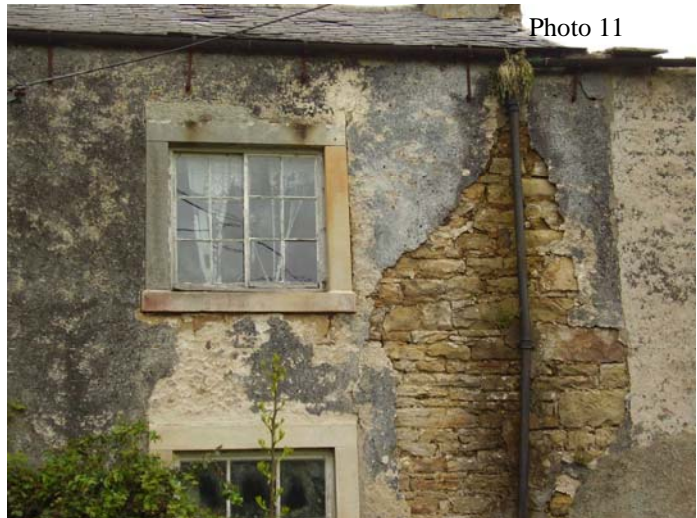
Photo 11

example of an early horizontal sliding sash window (photo 11).

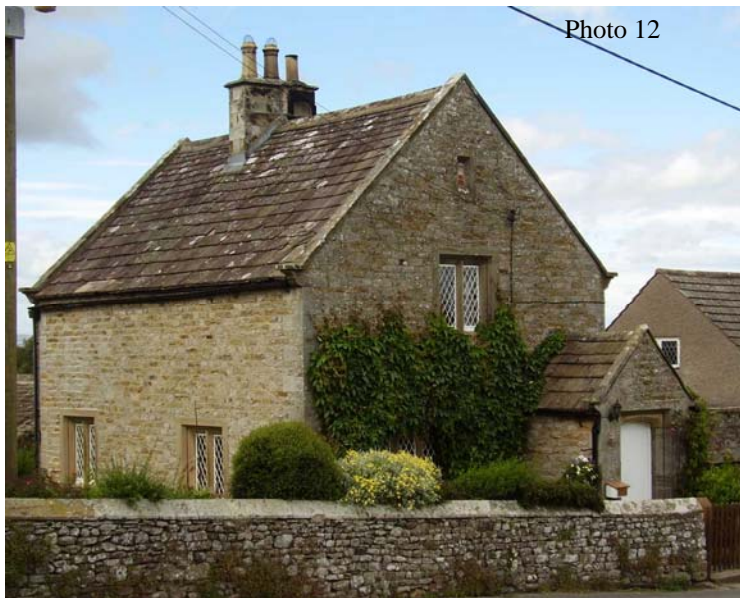
Photo 12

The exceptional property of this size in the village is Rose Cottage (photo 12). This is a well-proportioned and beautifully designed example of Victorian Gothic architecture in a village setting constructed using the good quality local stone. The steeply pitched roof, single central chimney (photo 13) and gable end to the village green define it as different from other properties in the village. Gothic detail extends from the front

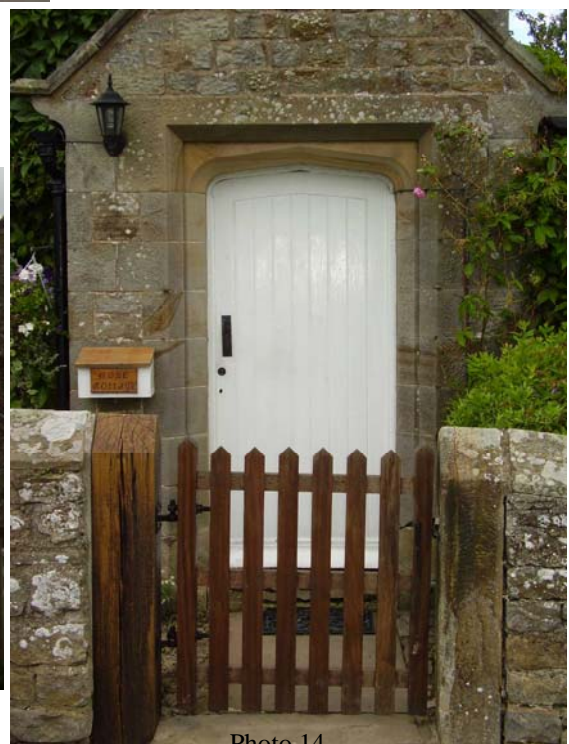
Photo 14

door and small porch (photo 14), through the mullioned window surrounds and the unique diamond paned steel framed casement windows

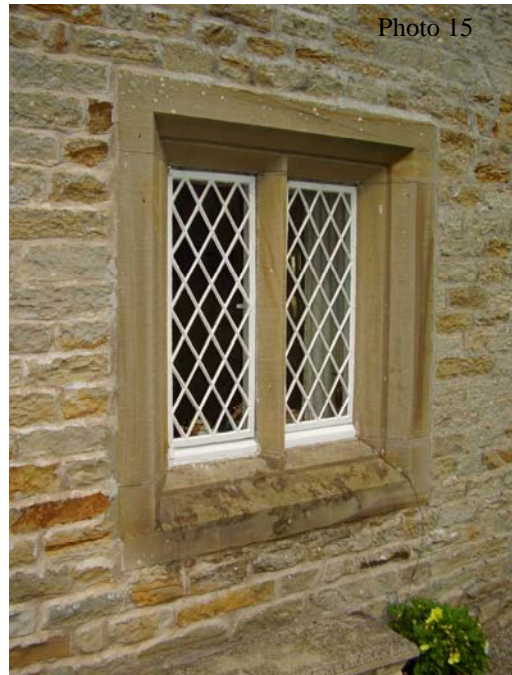
Photo 15

(photo 15), to the copings to the front wall (photo 16). This is a thoroughly Victorian building where a contemporary popular style has been

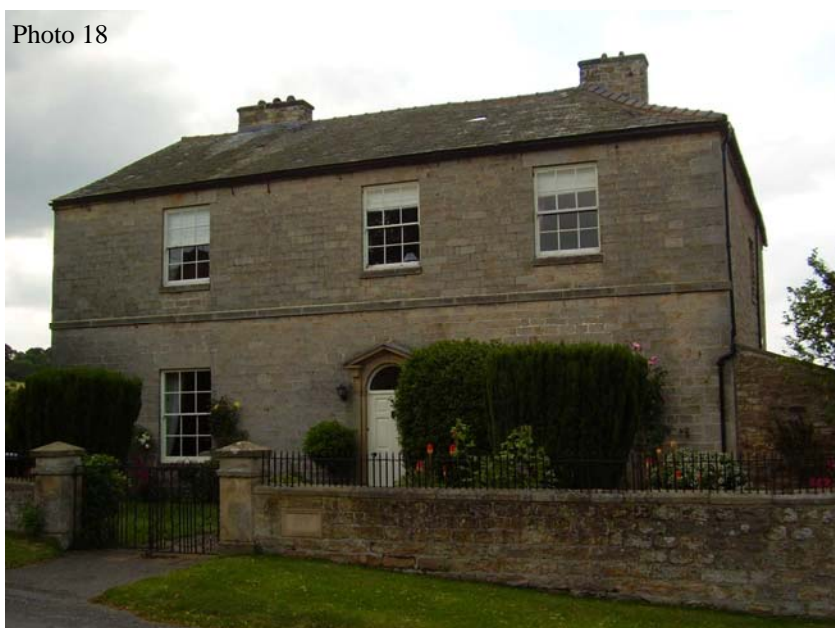
Photo 18

There are several larger individual houses in the village, which contribute differently to the Conservation Area, often being positioned in larger gardens and with more substantial frontages. They are usually set back from the road behind formal walls with manicured gardens to the front. The four best examples of these houses are Gayles House (photo 18), Belmont House (photo

19), Town Farm (photo 20) and The Grange (photo 21). Gayles House is a substantial late Georgian property, unusual in the village for having a hipped roof, partly covered in Westmoreland green slate to the front elevation. The style is very formal with well-dressed stone, well-proportioned windows (photo 22) and an attractive stone door surround (photo 23) to the front elevation. A stringcourse divides ground and first floor and the buildings wide proportions give it a low-set appearance. Although the

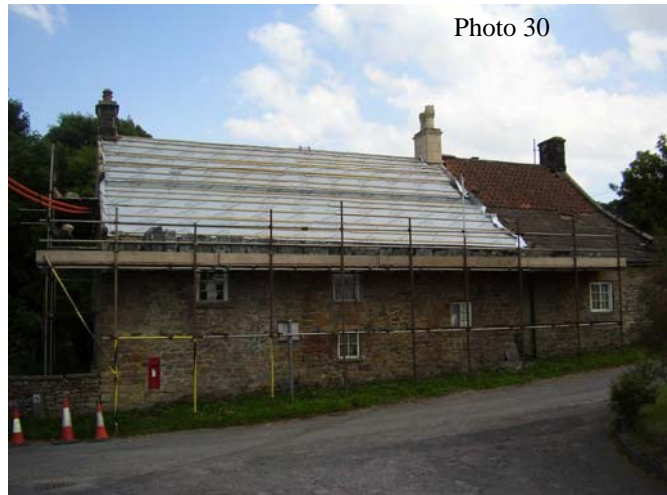
Photo 30

the house was constructed later as the masonry takes a very different form from the front wall. This part of the house certainly was not as smart as the front as the windows to the rear elevation are not as evenly laid out (photo 30). The Grange on East Street (photo 21) is a similar scale substantial farmhouse of a slightly later date. Its presence is less noted as it is surrounded by overgrown trees and shrubs and sits back from the little used East Street (photo 31).

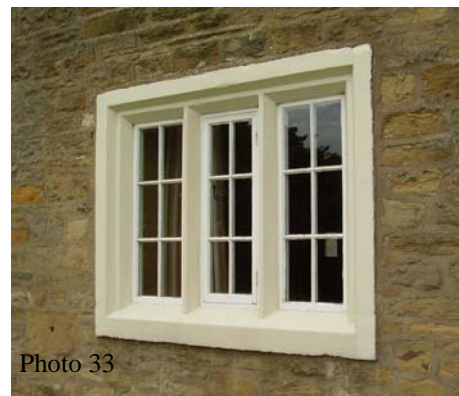
Photo 33

houses in the village but its historic use as a pub distinguishes it from the others. Occupying a prominent location it appears to have been rebuilt several times throughout its history and now sports good quality mullioned windows throughout its elevations (photo 33) and a matching front door surround (photo 34).

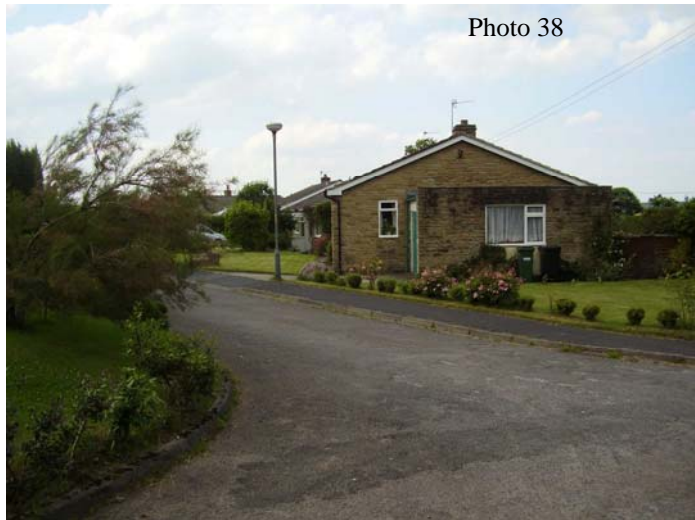
Photo 38

The 20th century has added several properties to the village not all as successful as they could have been. The development at Watling Close (photo 38) and other properties constructed in the 1960's and 70's introduced single storey bungalows to a settlement that appears not to have had cottages of this scale in the past. The proportions and detailing of these houses have no relevance to the established pattern of properties in the village but the use

of stone and flat tile roofs has helped assimilate the new buildings to some degree. The more recent properties adjacent to Bay House bear more resemblance to established village buildings and their use of materials is again appropriate (photo 39). Smaller scale details could have improved these buildings, such as the use of a weathered eaves detail to the gables and shallower roof pitches to pick up on the prevailing style of the village. The conversion of the

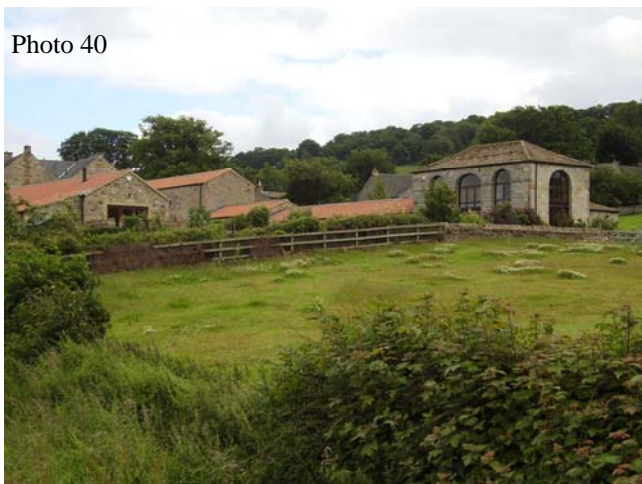
Photo 40

barn complex to the rear of Gayles House (photo 40) has been carried out well in many respects as it has retained and consolidated many of the older farm buildings including the large Hay House (photo 41) that is prominent in views from the northwest.

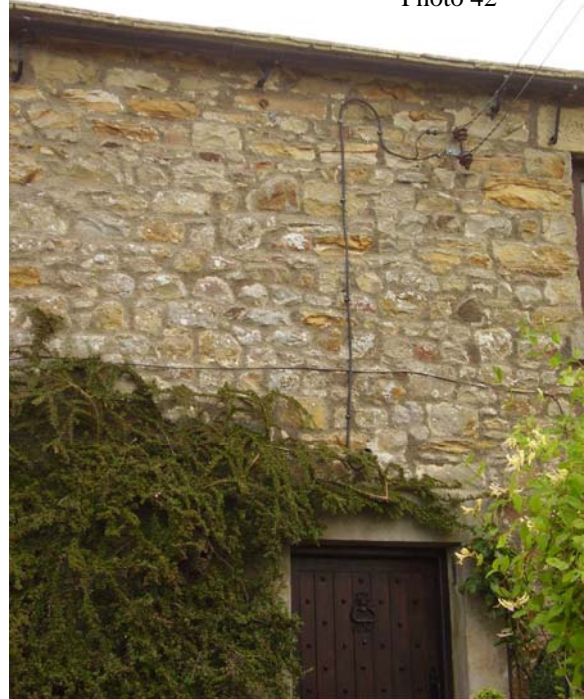
Photo 42

The majority of smaller cottages and houses use random rubble construction for the walling mostly employing angular

rubble as found at West View and Pleasant View on West Street (photo 42). The extension to Town Farm is constructed in this manner but incorporates rounded river cobbles into the wall (photo 43). At White Lion Cottages, West Street the stone is roughly squared and brought to course in the wall (photo 44) whilst the neighbouring property at number 1 is more formally dressed and coursed and incorporates quoins to its corners (photo 45). A formal

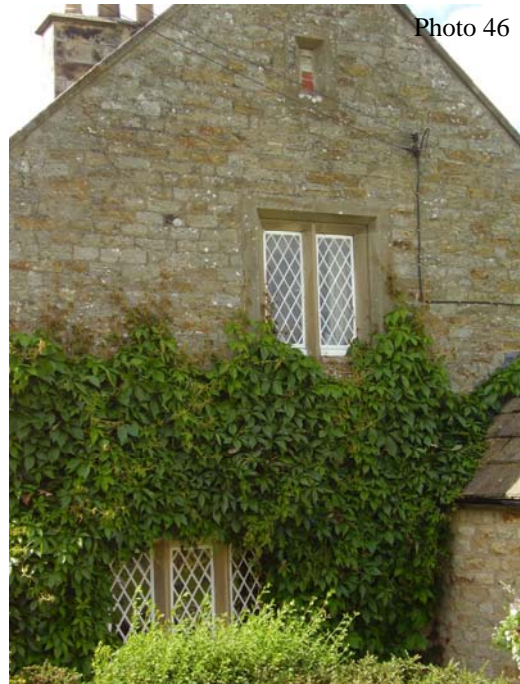
Photo 46

regular coursing has been used nearby at Rose Cottage (photo 46) where the quality of stonework extends through to the back of the house and includes the surviving outbuildings. At The Grange the coursed dressed stone is finished with raised quoins and window surrounds to highlight the detail of the building (photo 47). The Manor House, Belmont House

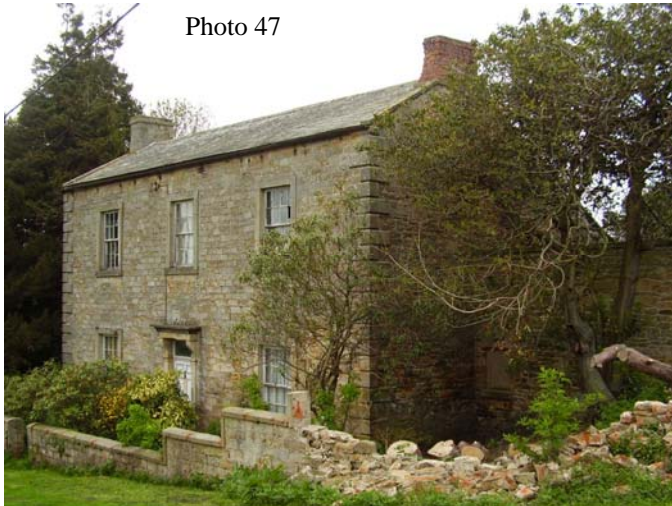
Photo 48

(photo 48) and Gayles House all employ sawn stone blocks to create a high quality formal finish to the walling whilst at Town Farm similar

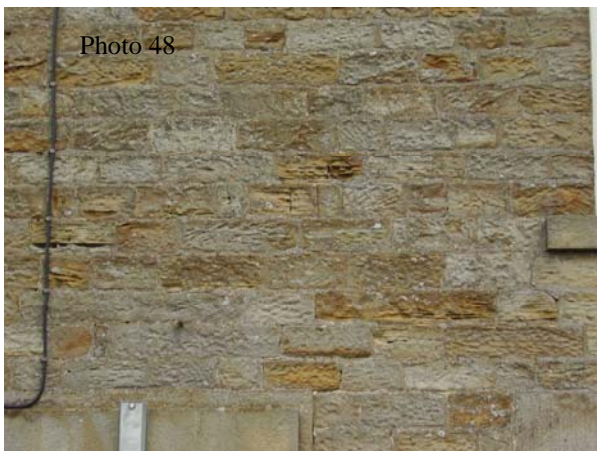
Photo 49

blockwork has been used but dressed with a herringbone finish (photo 49).

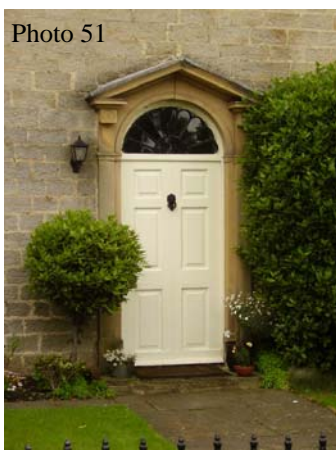
Photo 51

cases in particular at The Grange and Gayles House (photo 51) and several styles

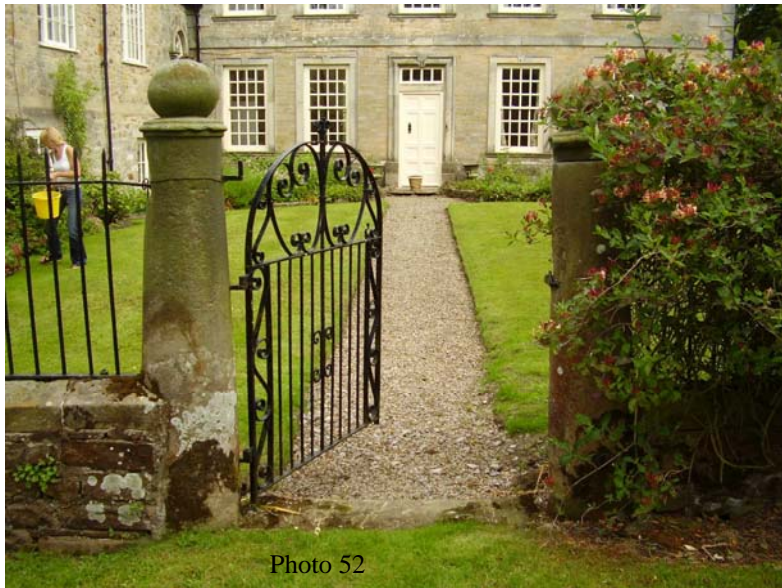
Photo 52

of dressed lintels and surrounds to windows and doors throughout the village. The decorative gateposts to the Manor House are also worthy of note as good local examples of late 18th century craftsmanship (photo 52).

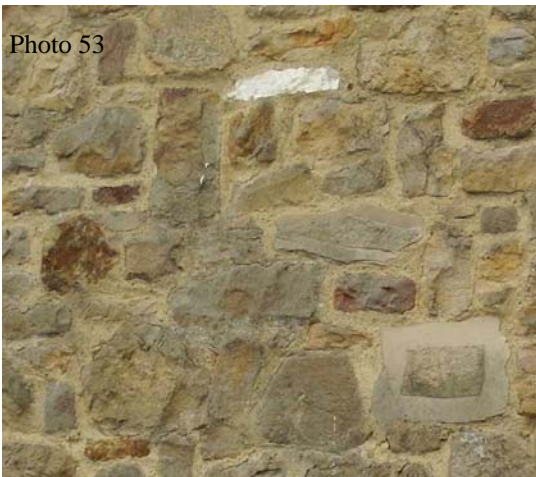
Photo 53

recent properties continue the tradition of coursed rubble walling albeit not using stone from the quarries immediately next to the village. Care must always be taken in new construction and repair to avoid leaving sawn faces exposed in rubble stone walls as the smooth surface left by disc cutters contrasts harshly with the surrounding masonry (photo 53).

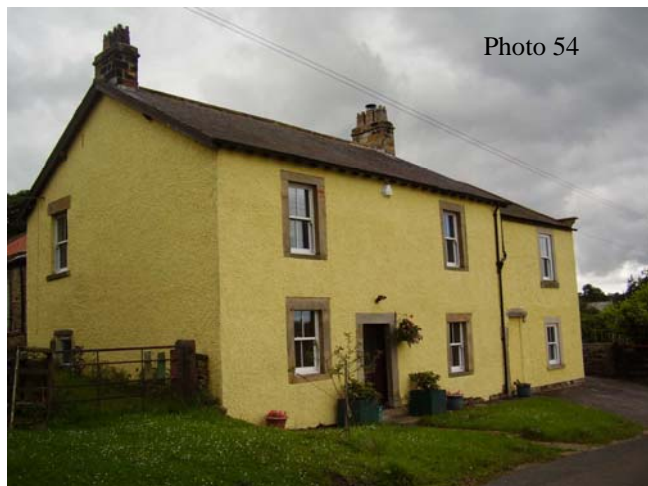
Photo 54

rendered in a traditional roughcast render and painted appropriately (photo 54). Also outside the Conservation Area but seen in views through and out of the village is Woodlea, a rendered late 20th century bungalow set high and prominent above the village on Middle Street as it approaches Gayles Hall (photo 55). This white painted rendered property is completely at odds with the character of the village. The small extension to Bay House on the right

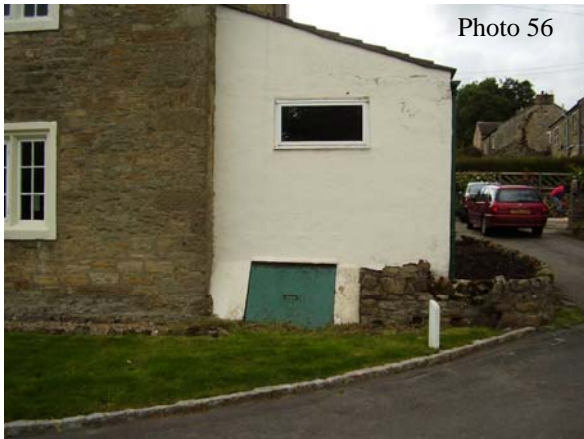
Photo 56

hand side is a prominent example of render within the Conservation Area (photo 56). This is a small addition to the former public house, The Bay Horse, which functioned in past as a shop above the cellar access. It is prominent in views and out of character with the main façade of the building. A further single property in the village has a historic render finish and this is the derelict cottage on East Street (photo 57). This historic render is important and care should be taken in repairing or replicating this material if the cottage is restored.

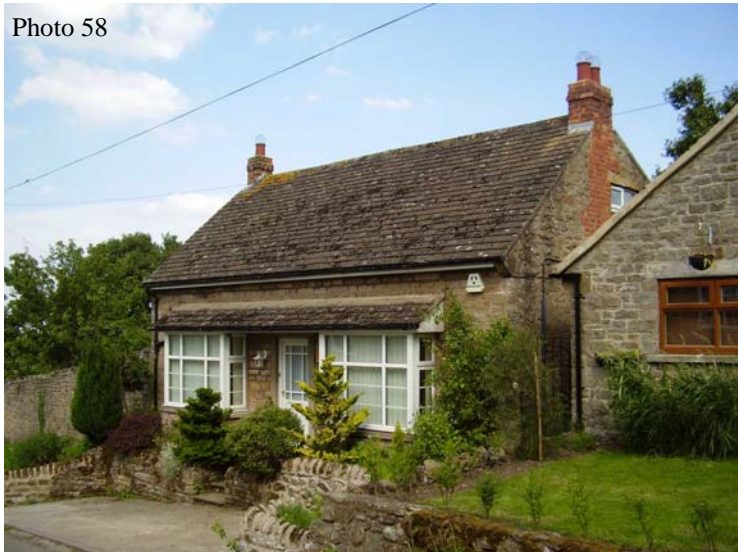
Photo 58

Brick only appears notably in the chimney of a single property on Middle Street in Gayles (photo 58). It has been used to construct a very few small ancillary buildings such as the garage to Woodlea but these are less prominent in the Conservation Area. Brick has not been used for any significant external work on buildings in the village and, in a similar manner to render, brick should be

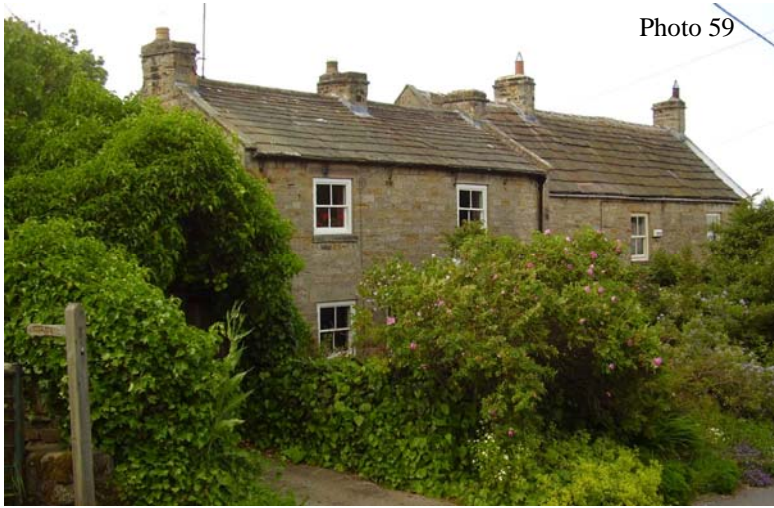
Photo 59

This has been historically the dominant material for domestic roofing in the area and has been used almost exclusively on buildings throughout the village. The stone slates will have been locally sourced, possibly from either the village's own quarry or from nearby workings such as Duns House quarry. These sandstone slates are thick in comparison to other roofing materials and are laid in diminishing courses,

narrowing from large slates at the eaves to small slates at the ridge, often finished with a dressed stone ridge piece. This produces a distinctive character to the roof very different from other natural slates as the covering is notably thicker and the roof has a textured finish arising from the thick slate edges. Although when first quarried the sandstone slates are a pale grey/buff colour they

weather in time to a deeper grey/brown colour slightly darker than walling stone. Good examples of stone slate roofs can be found at Appletree Cottage and l'Anson House (photo 59) on Middle

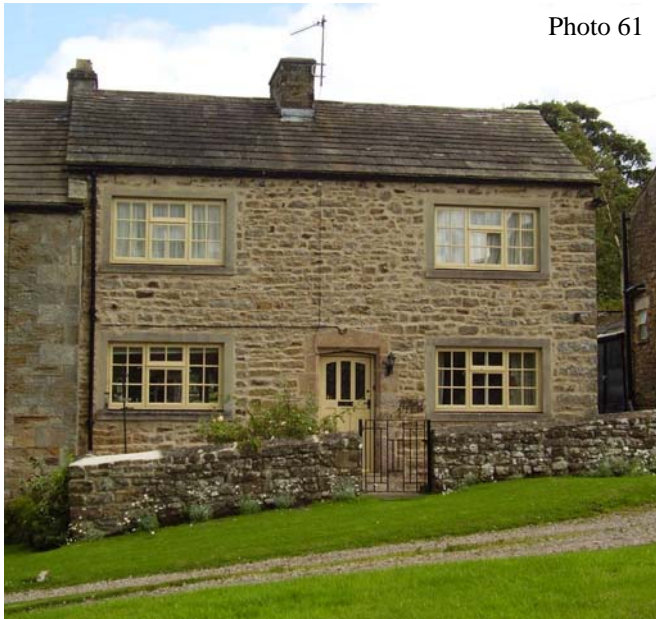
Photo 61

Street and at Rose Cottage (photo 60), West View (photo 61) and Pleasant View on West Street. At Lilac Cottage at the top of East Street half the roof is in stone slate whilst half is grey slate showing an interesting contrast (photo 62).

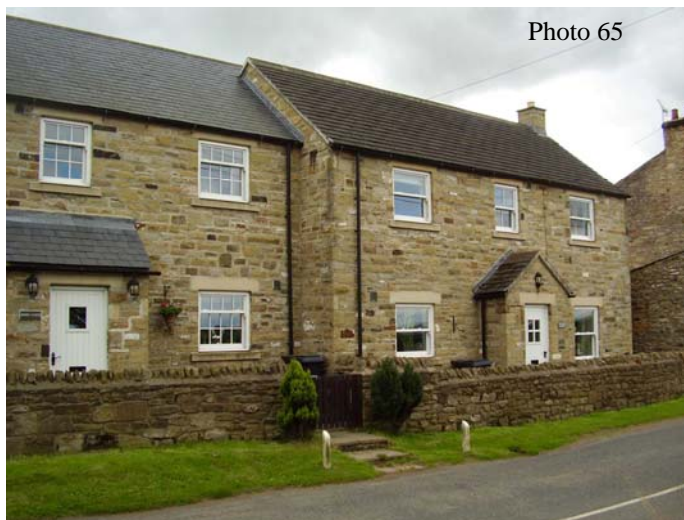
Photo 65

Throughout Gayles the traditional stone slate roofing materials have been supplemented with more readily available, cheaper alternatives including grey slate, imported stone slate and modern concrete tiles. Grey slates have been used on some of the more recent developments (photo 65) and re-roofing projects (photos 62 and 66) in the Conservation Area and are a reasonably successful alternative to the local stone slate for less prominent buildings. These slates weather well and quickly assimilate into the village scene helped by their neutral dark grey colour. The front slope of the roof to Gayles House Farmhouse does not appear to be covered in stone slate and may be a singular example of

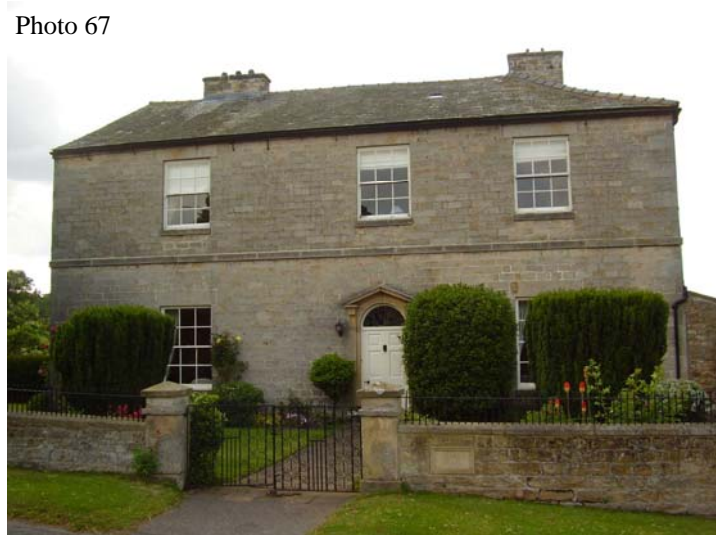
Photo 67

Westmoreland Green slate (photo 67). This is an unusual material to find in a location so well provided with good quality stone roofing slate and may be an indication of the high status that this prominent village house enjoyed. In a limited number of cases imported stone slate has been used to roof ancillary buildings (photo 68). Whilst a good attempt to fit into the village vernacular care must be taken in the selection of stone to achieve an appropriate colour match to the local material. Weathering of the roof will help soften the contrast between these materials and the traditional locally sourced stone. Concrete tiles have been used extensively on village properties through the later

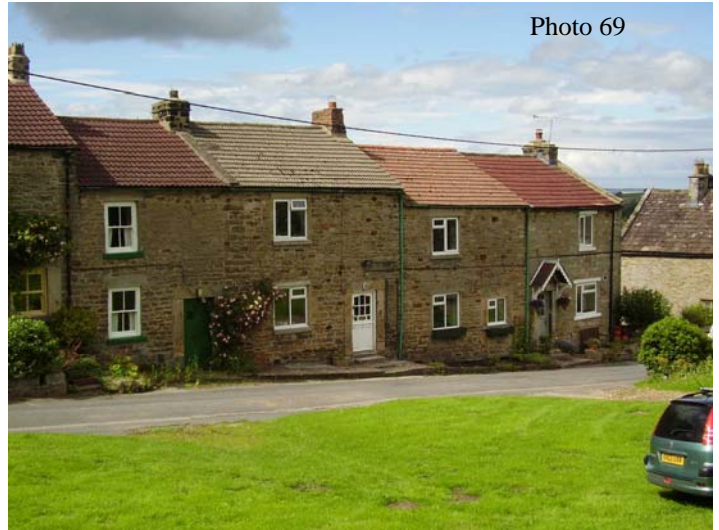
Photo 69

part of the 20th century to replace older traditional stone slate roof coverings (photo 69). Although not ideal for the building due to the characteristics of the material itself and the regular mechanical appearance of the finished roof, which differs from the traditional slates, these tiles have usually mellowed with weathering to blend into the street scene. Ideally these will be replaced with more traditional alternatives as they become life expired.

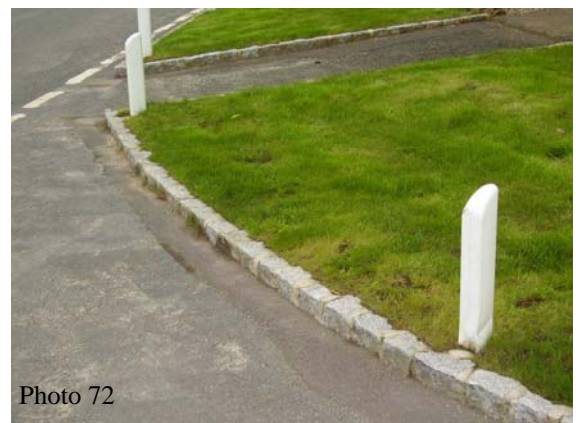
Photo 72

granite sets around the front of Bay House (photo 72). This informality is very important to the character of the village and should be maintained to protect the quality of the Conservation Area. All areas of public road are finished in black tarmac although on West Street some of the tracks across the green remain un-metalled (photo 73). Private drives feature a range of surfacing from informal

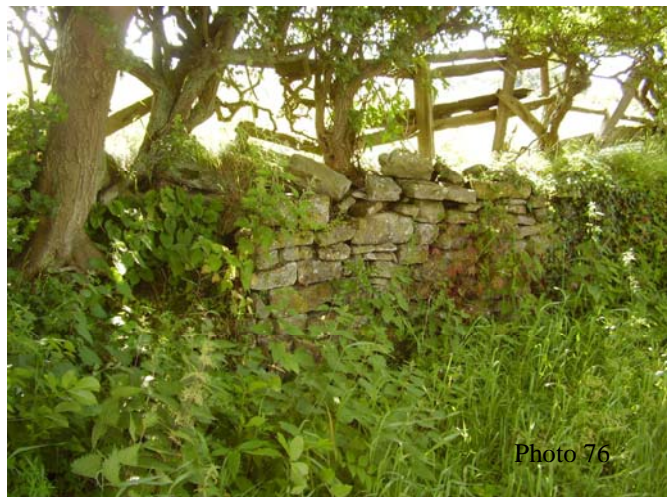
Photo 76

There is a wide range of walling through the Conservation Area from the weathered, overgrown and decayed dry stone walls present along the main road (photo 76), through the coursed rubble stone walls to the front of most village properties (photo 77) to the formal dressed stone walls in front of the larger houses such as Gayles House (photo 78) and the Manor House. The dry stone walls vary discretely in style mostly

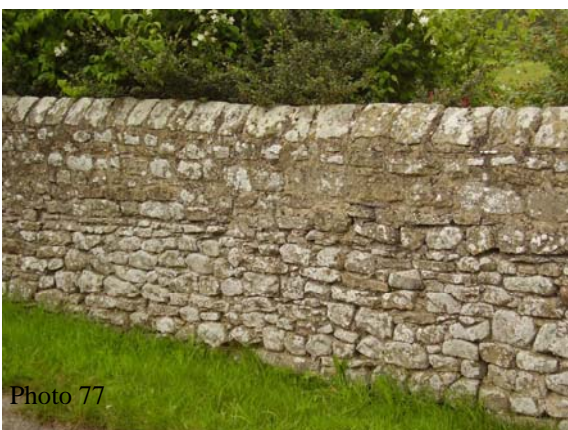
Photo 77

finished with a simple boulder coping (photo 79). A similar boulder wall exists at the south end of West Street (photo 80). The new walling to the south of the Manor House (photo 81) is more clearly coursed and demonstrates that the skills required for this type of work are still to be found. To the front of Sundial Cottage the low wall uses thinner stone to establish courses and has roughly shaped copings whilst the wall around Greenacres on West Street uses saddleback copings on a mortared coursed wall (photo 77). On East Street a section of wall to the derelict property

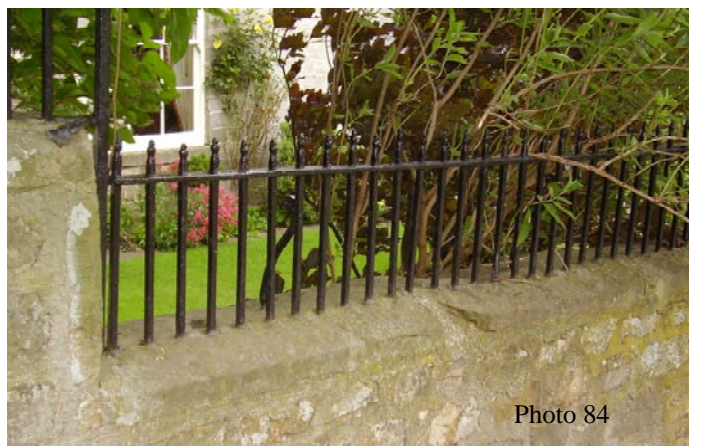
Photo 84

becomes more formal, with a curved, dressed coping, regular coursing and railings along the principle front section (photo 84). Other examples of railings are to be found at The Manor House (photo 85) and the property opposite The

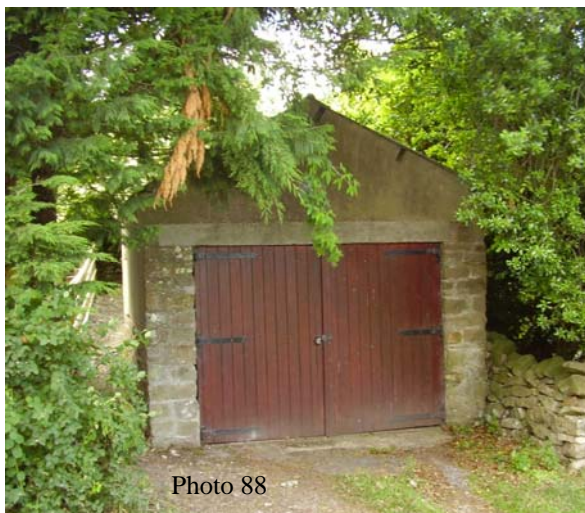
Photo 88

The creation of garage door openings in the village has been handled with varying degrees of success. In some cases the impact of the opening has been reduced through the use of a dark colour (photo 88) whilst pale timber finishes can create prominent and often discordant features in the streetscape (photo 89).

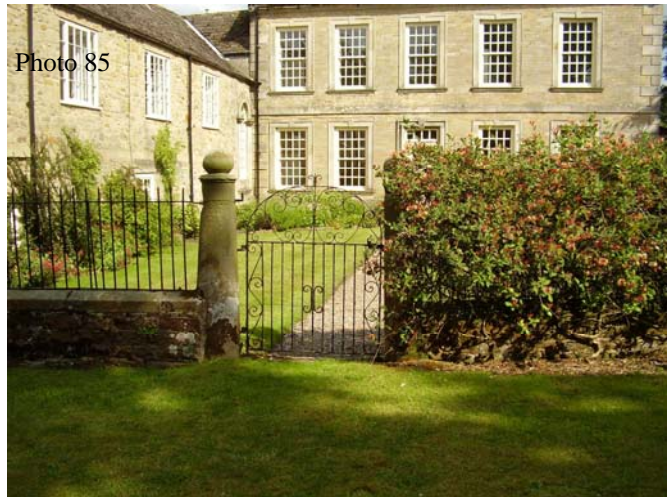
Photo 85

Grange (photos 86 and 87). It is important to note that these railings all differ and are handmade examples of local blacksmithing rather than modern commercial items.

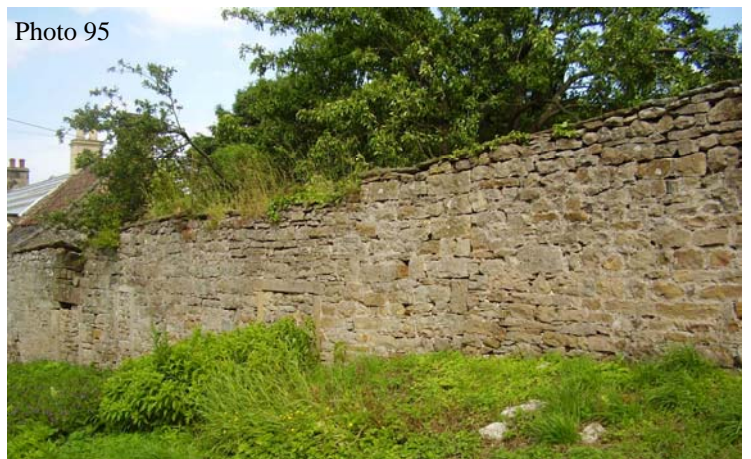
Photo 95

On Middle Street the boundary walls to the south of Town Farm (photo 95) are worthy of note as they are the former front walls of some of the lost

houses of Gayles. The presence of door jambs (photo 96 and 97) and window openings give an indication of the scale of the buildings and these surviving walls document the historic change in population of the village and the subsequent abandonment of houses.

in views both along the main road and in the northern part of Middle Street (photo 27). Adjacent to the farmhouse the boundary wall is both prominent and of interest as it comprises a front wall of long lost houses with blocked door and window openings (photo 95). The Manor House at the top of the street contrasts with Town Farm in that its main frontage is almost completely hidden in views along the street and the ancillary buildings and yard do not hint at the importance of this building

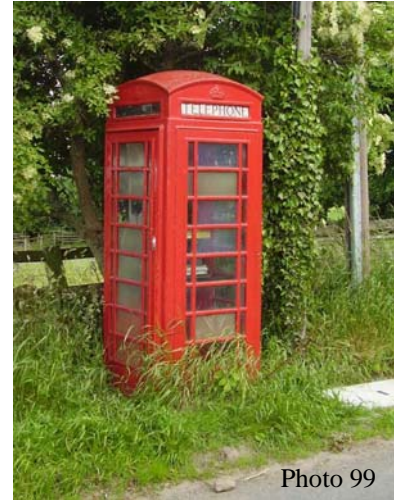
Photo 99

There is a limited amount of street furniture in Gayles but the range that exists includes several important items, which make a valuable contribution to the character of the Conservation Area. The most prominent item is probably the telephone call box on the main street (photo 99).

Although this is a standard national design it has an important place in the community and appears well cared for. It is an important landmark on the road despite its relatively small size. Slightly smaller but similarly important is the post box set in the wall on Middle Street (photo 100).

There are several prominent features in the public domain that contribute to the character of the area notably the telephone box, post box and the bus shelter. Generally these are in good condition and make an interesting and worthwhile addition to the village. It is important to respect these in future works within the village and also to exercise restraint in trying to add further features and commemorations which could result in unnecessary clutter and jeopardise the character of the village.

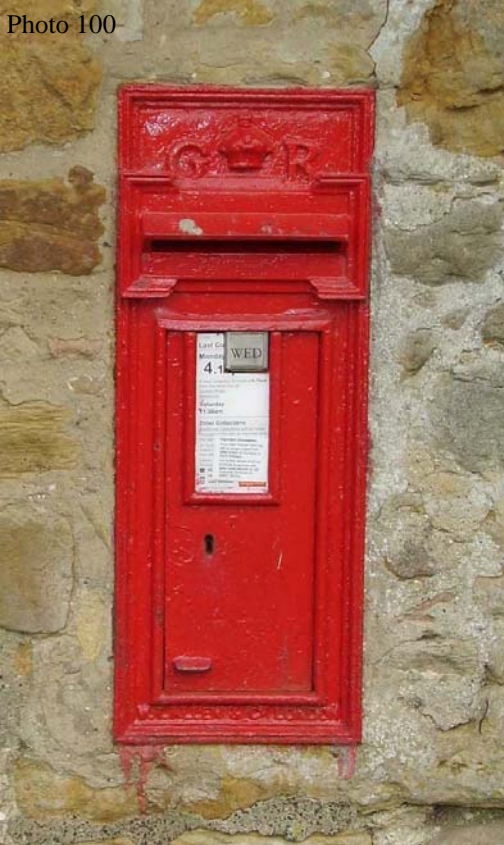
Photo 100

This George V example is still in regular use and provides an important service in the village as well

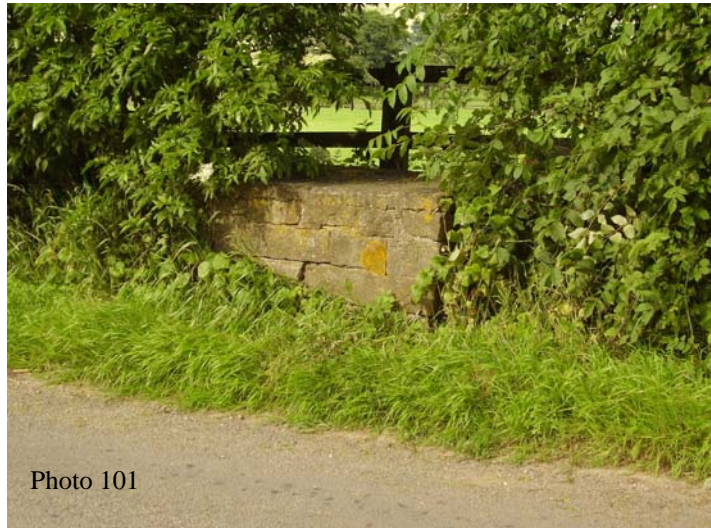
Photo 101

as being a landmark in the Conservation Area. Less visible but historically equally important are the two milk churn stands built into the field walls along the main road (photos 101 and 102). These are both situated on the far side of the road from the village and would have played an important part in village life up to the middle of the 20th century and perhaps later. A few bench seats are positioned at strategic points around the village often to take advantage of particular views. These are usually serviceable but could benefit from some periodic maintenance. The provision of a concrete hard standing and goal posts on the common land (photo 103) is rather at odds with the

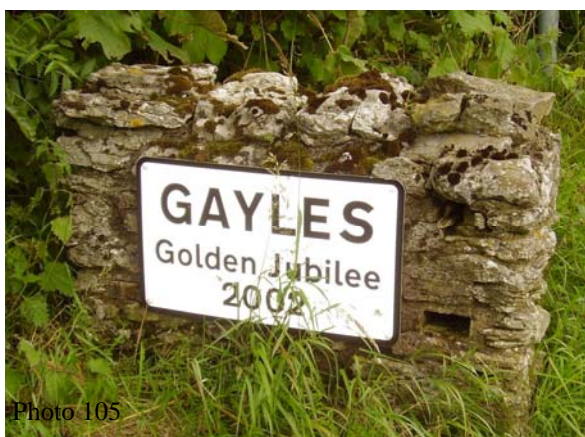
Photo 105

It is appropriate that the village name is set on a local stone plinth at the side of the main road (photo 105) however this is somewhat lost in the vegetation of the roadside. The bus shelter (photo 106)

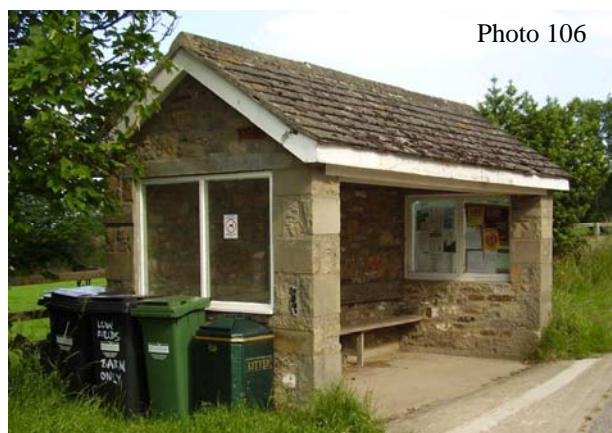
Photo 106

is functional and serviceable and the positioning of the village notice board in one window serves an important role, however aesthetically this structure could be improved, perhaps with some screening to the wheeled bins that are stored against it and some appropriate surface treatment. The plastic bollards outside Bay House are effective in demarking the edge of the kerb but could be made from a more sensitive material for their location (photo 107). Street lighting is provided throughout the village on a series of brackets mounted on existing poles. There is little to commend the current provision and a considered programme of replacement could achieve an enhancement. Modern light fittings are more effective at lighting but create less light pollution and would be of benefit to the village.

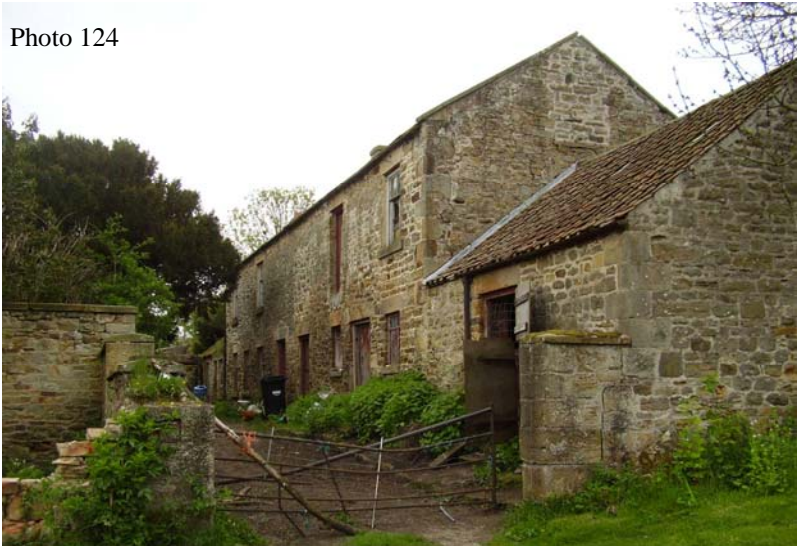
Photo 124

repair extend from the road back into the open countryside behind the house (photo 124). These buildings have an important presence on the street frontage and can be seen in views looking east over the field boundary where they define the edge of the farmyard with blank stone walls (photo 125). Glimpses of these buildings are also possible from the road approaching the village from the east (photo 126).

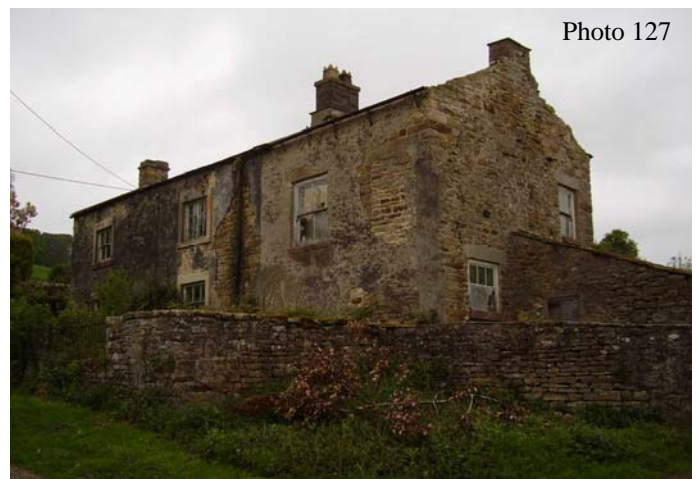
Photo 127

The final element of note in East Street is the derelict cottage opposite The Grange (photo 127). This building and its ancillary barns (photo 128) are in an advanced state of decay but retain several interesting and important features. The handmade iron railings (photo 87), the horizontal Yorkshire sliding sash window (photo 57) and the rendered finish to the house are all

worthy of note. In terms of its contribution to the streetscape this building forms a large mass softened by decay and by the encroaching shrubbery. It contrasts completely with the adjacent Kirkwall and presents a mid-way point between the abandoned appearance of The Grange and the overgrown ruinous state of the cottage beyond Kirkwall. Time will tell whether the fate of this house mirrors Kirkwall or its less fortunate neighbour beyond.

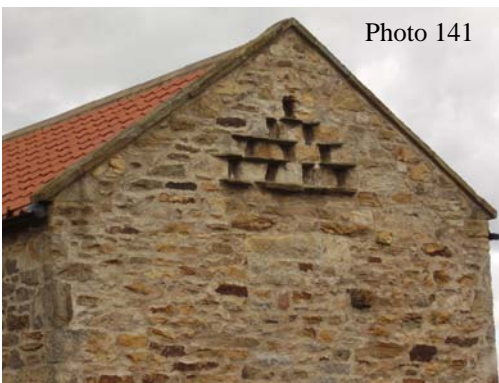
Photo 141

built into the barn gable (photo 141) and the railings to the front of Gayles House (photo 84). The street curves slightly at this point and when combined with the rising ground level and the encroaching buildings and walls, views into the main part of West Street and the lower Common are restricted.

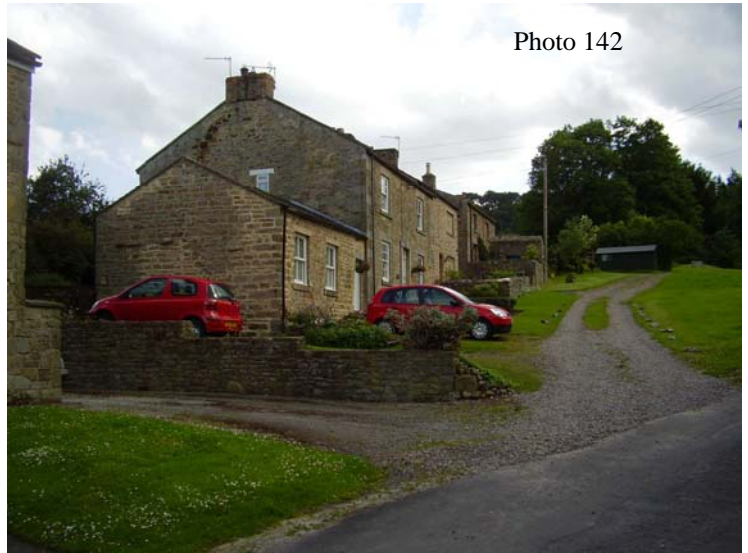
Photo 142

frontages of the important group of Listed Buildings Belmont House, West View and Pleasant View which define the left hand side of the lower Common (photo 142). Beyond this the scenery comprises a dense range of trees and shrubs with only a single timber garage structure set incongruously on the lower Common to interrupt it. The right hand side of the street is defined by trees and, further in the distance, by the gable and frontage of the cottages at 1 to 6 West Street. The properties of Greenacres and Rose Cottage do not intrude on this view as they are set back from the street edge and obscured by the trees. The road itself provides a strong element in this view, sticking close to the right hand boundary it directs the view up the hill into the middle distance before disappearing behind the cottages. From this point there is no immediately obvious exit to the south.

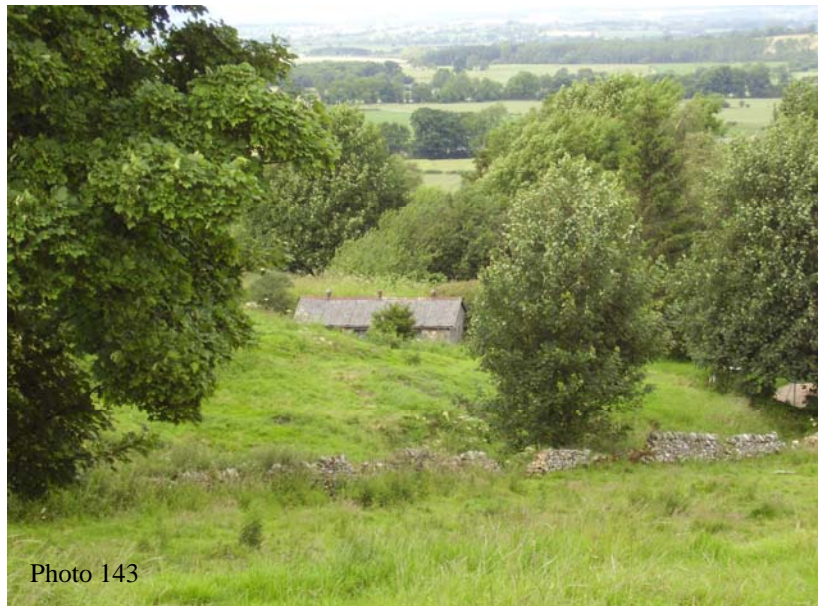
Photo 143

Area 5 – Quarry Hill Common
This is a distinctive open space characterised by the trees that surround much of the area and the rough undulating form of the ground (photo 143). It is important in views along West Street as the trees form a backdrop to the street and close

Smaller incidental groups of trees within Gayles include the green finger that follows the footpath south of Appletree Cottage (photo 150) and those in the garden between Gayles House and Greenacres (photo 151). There are also other fine single specimens in the surrounding fields between Middle Street and West Street and within the Quarry Hill Common area (photos 143, 151).

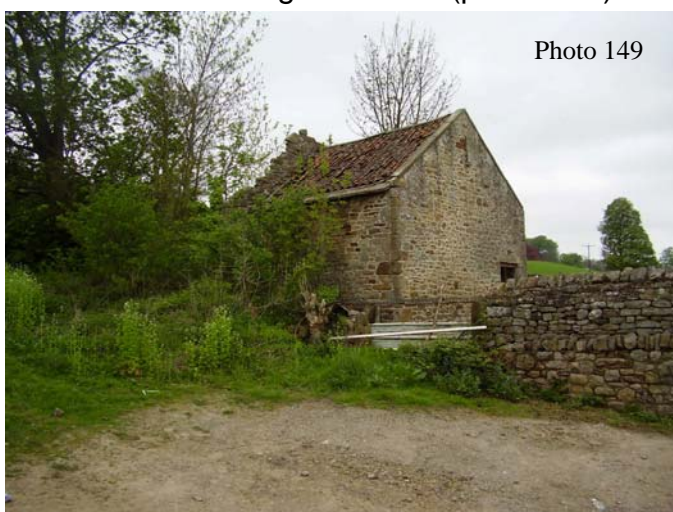
Photo 149

(photos 116 and 119) where the scale and prominence of trees also has a significant impact on the wider Conservation Area. To the south of the village, trees provide a backdrop to the street scene, effectively closing the view at the head of the lower Common on West Street (photo 71), forming an important feature around the barn at the south end of Middle Street (photo 148) and extending into the open countryside and finally, at the end of East Street, stretching out to engulf the ruined cottage creating an impression that the village is slowly disappearing into the surrounding woodland (photo 149).

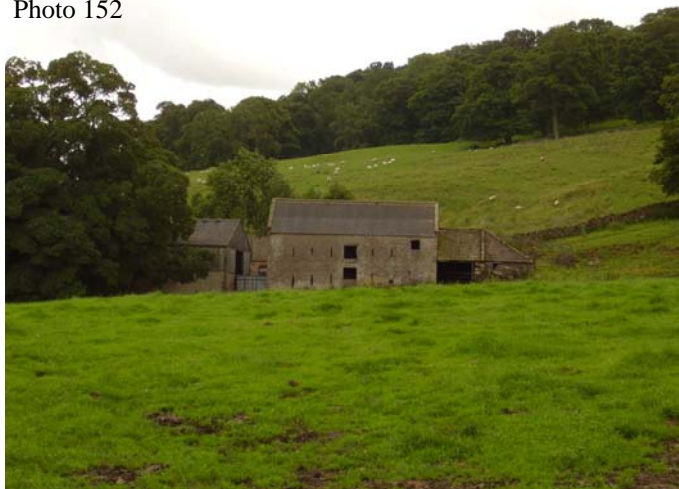
Photo 152

core is one of the oldest structures in Gayles probably dating from the 16th century, and its form and site as a fortified manor house are unique to the village. In views to the south from the Conservation Area it is seen from Quarry Hill Common and the surrounding fields (photo 152) and has a distinct presence at the top of Middle Street, which terminates at the farm complex (photo 37). Gayles Hall adjoins the current Conservation Area boundary to the northwest and an extension to cover the
