# MELSONBY

## CONSERVATION AREA APPRAISAL AND MANAGEMENT PLAN

Adopted as supplementary planning  
guidance on 24<sup>th</sup> April 2012

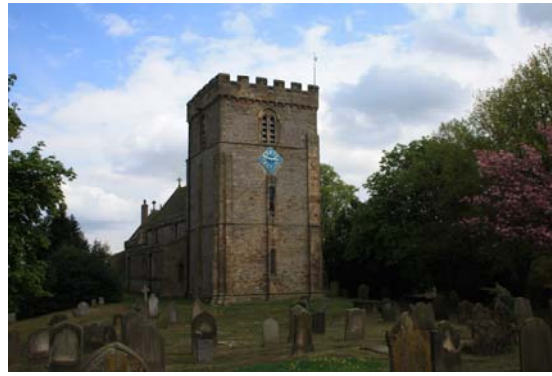
Photo 3

- 3.3 The church was rebuilt in the mid 12<sup>th</sup> century, finished about 100 years later and has remained the principle building within the village throughout the centuries. Successive rebuilding has significantly altered its appearance and size and although some Anglo-Saxon style features remain these are limited to the south door (photo 2), a few minor openings and some of the internal arcades. Following centuries of minor alterations the church was 'restored' during the Victorian period, first in around 1850 when the vestry was relocated, the south porch added and new windows were inserted, then again more thoroughly in 1871/72 by Paley and Austin of Lancaster who rebuilt much of the nave, leaving the village with the building it enjoys today (photo 3). The church records date back to 1574 and are now held at the county record office.

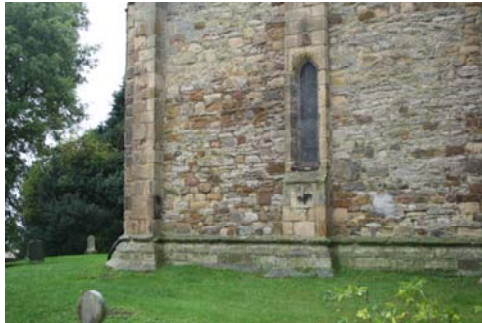
Photo 4

- 4.1.1 As is often the case in villages that the church remains the earliest building in the settlement and the church of St James the Great at Melsonby dates from the 12<sup>th</sup> and 13<sup>th</sup> centuries. The different phases of building can be discerned through the variation in style of stonework as well as the changing style of decoration. Some of the earliest stonework dates from the late 12<sup>th</sup> and early 13<sup>th</sup> century and can be recognised by its random use of field stone and cobbles as found in the

base of the tower (photo 4) or by its very square block form as found in the lower sections of the eastern wall (photo 5).

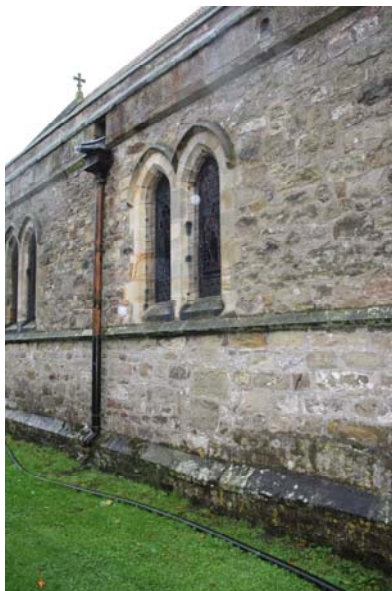
Photo 6

4.1.2 The style of the windows dates to this Early English period of church architecture and is recognised by their tall slender lancet form, although many of them here at Melsonby have been heavily restored or replaced particularly in the Victorian period (photo 6). Some very early stonework and decoration survives within the church, notably around the south door (photo 7) and some internal sections, particularly the large circular column of the north arcade. Whilst much of the church was restored through the 19<sup>th</sup> century the porch itself (photo 8) appears to be completely new with a very different, clean-cut form of masonry comprising well dressed stones with sharp edged clear detail, surviving much better than the older work by virtue of being merely 150 years old rather than having weathered through several hundreds of years.

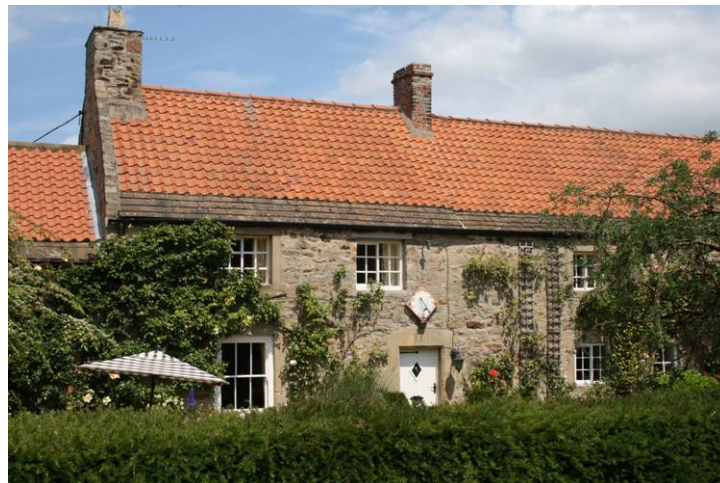
Photo 10

4.1.3 The first domestic buildings are the larger farmhouses - a good example being Layton Farm house at the west end of the village (photo 10). Dated 1698 the large chimney stack at the west end, the small square windows with casement details and the low storey heights with a steeper roof slope are all typical of these earlier buildings. The detail of the stone slate eaves to the roof is an attractive vernacular feature.

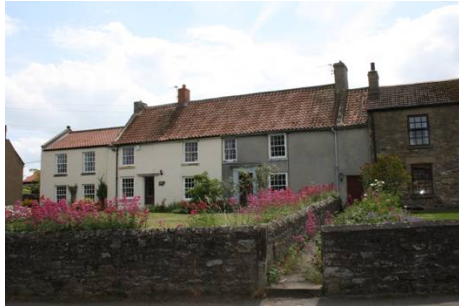
Photo 11

4.1.4 Some of the smaller cottages on East Road may also date from this period, the best example being number 12, Fern House (photo 11). The steep pitched roof, substantial chimneys and raised brickwork to the gables are typical features of this period however the window openings have been altered during the early 19<sup>th</sup> century to provide typical Georgian sliding sash windows. It is likely that prior to this the earlier windows would have been a casement style similar in form to those at Layton Farm House. Much of the Rectory also dates from this

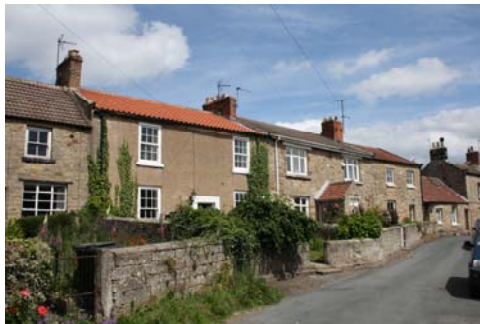
Photo 13

4.1.5 The cottages and houses from 32 to 50 High Row are also typical of the last half of the 18<sup>th</sup> century (photos 13 and 14). The best preserved of these is number 38 (photo 15) which retains two different styles of multi-paned sliding sash windows, those on the first floor being set deep into the wall within dressed ashlar surrounds whilst the ground floor window is close to the face of the building and has exposed sash boxes. Also of note is the boarded side passage door to the right of the front door (photo 16) and the kneelers and dressed copings at the gables to the roof (photo 17).

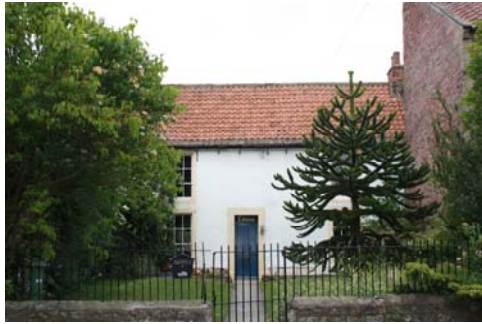
Photo 20

4.1.7 The late 18<sup>th</sup> and 19<sup>th</sup> centuries saw significant construction throughout the village in a variety of styles. Typical small cottages continued to be built in a vernacular form and The Lilacs at 19 Church Row (photo 20) is a typical example of this period. Important characteristics are the multi-paned vertically proportioned sliding sash windows and the taller room heights when compared to earlier cottages. The painted surrounds against the roughcast render (photo 21) reflect the local style of moulded stone surrounds where the building is finished with exposed masonry for example 31 Church Row (photo 22).

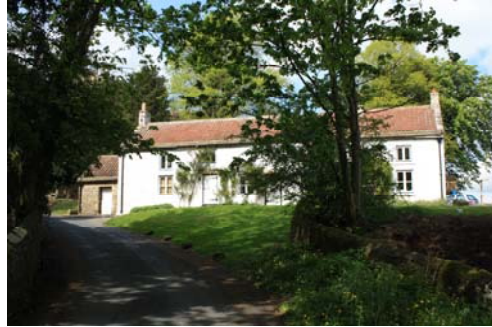
Photo 23

4.1.8 At the eastern end of Church Row Glebe Farmhouse (photo 23) dating from 1800 retains the smaller windows and lower proportions of the earlier period and is finished in a roughcast render to the front elevation, the side gable exhibiting roughly coursed rubble stonework (photo 24). It is a particularly lengthy property and may have at its origins as part domestic and part livestock building with the functions separated by a cross passage, the limited number of chimneys suggesting that the house was at the east end and a later chimney was added on the west gable when the whole building became residential. The bridge over the beck (photo 25) is dated on a date-stone as 1800 and is contemporary with many of the buildings in this area.

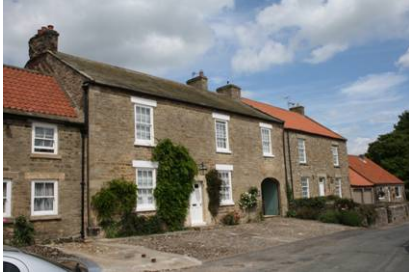
Photo 26

4.1.9 The 19<sup>th</sup> century continued to see construction around the central core of the village and this brought new emerging styles to the village. Early examples of the period include numbers 4 and 6 High Row (photo 26) which are of a notably greater size than neighbouring cottages and retain their Georgian pattern windows. The well dressed ashlar stone of number 6 (photo 27) contrasts with the random rubble of its neighbour (photo 28) but both houses share a similar confidence of design and generous proportions to their principle elevations.

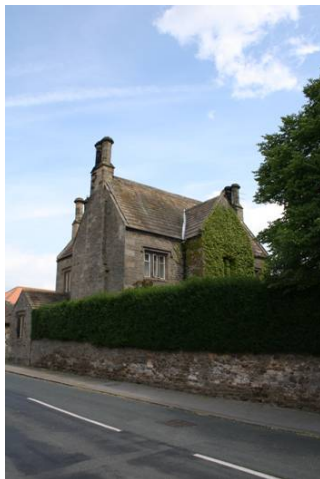
Photo 29

4.1.10 By the mid 19<sup>th</sup> century the fashion for Gothic style had reached the rural north east of England and Wharton Farm house (photo 29) has elements of this exhibited in the tall Elizabethan influenced chimneys (photo 30), the mullioned windows and the Tudor style drip moulds over the windows and doors (photo 31). The steep roof slope also reflects this style. Central Villa (photo 32) is of a similar date and also draws on historic architectural references being more typical of a domestic Tudor style but still featuring large decorated chimneys, mullioned windows and detailed drip moulds.

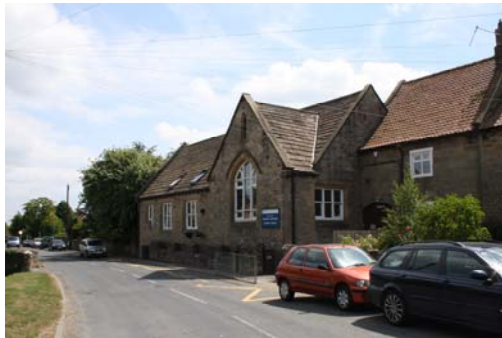
Photo 33

4.1.11 Several of the larger village institutions date from this period and include the school (photo 33), the Methodist chapel (photo 34) and the Church Hall (photo 35). These buildings are typical Victorian institutional buildings, well detailed, using local materials where they are suitable and reflecting a confidence of design in establishing new styles. The steep roof of the Church Hall with its prominent gable window facing the green and the Early English style lancets of the Methodist Chapel are good examples of the period whilst the simple robust detailing of the school predates the memorial window of 1899 but gives a strong identity to this important village institution.

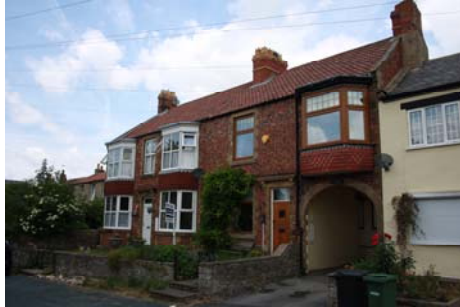
Photo 36

4.1.12 By the end of the 19<sup>th</sup> century alternative materials had started to filter into the village and the best example of this is found at 21 and 23 Church Row (photo 36) with the two most prominent brick houses in the village. The design of these houses is typical of the turn of the century using as it does hanging tile and contrasting feature materials for corners and details, here relying on imported sandstone to create

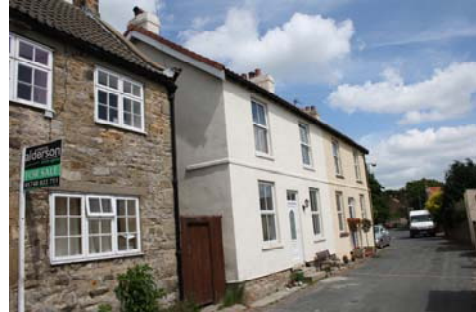
Photo 37

variety in the elevations. The pair of houses at 12 and 14 High Row (photo 37) may also have been brick set on a stone plinth in a similar style however the unfortunate rendering of this building has obscured the original finish.

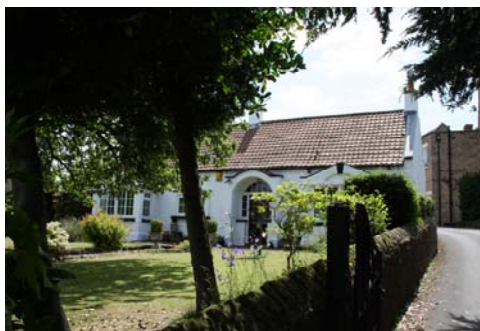
Photo 38

4.1.13 The 20<sup>th</sup> century has also made a contribution to Melsonby with the low set bungalow of 1930's/40's date at number 33 West Road (photo 38) and later single storey houses at 12 West Road (photo 39) and to the rear of Central Villa (photo 40). These buildings are very much at odds with the established style and form of residential properties in Melsonby and should not be seen as a form to encourage within the Conservation Area. The majority of later 20<sup>th</sup> century construction lies outside the Conservation Area to the south and takes the form of Local Authority housing and bungalows of differing styles and periods.

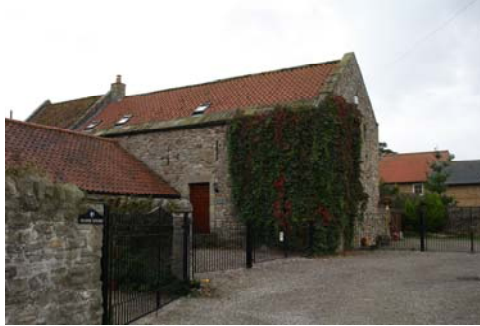
Photo 41

scheme into the established rural setting. Melsonby has several examples of this type of development including the conversion of the tithe barn and associated buildings at the Old Rectory (photo 41), the barn conversions and new build developments at Orchard House (photo 42) and the residential development of the farmyard at Wharton's Farm (photo 43), much of which lies outside of the Conservation Area. To the extreme west of the village and set in the land to the south of Melsonby Farm an isolated barn complete with gingang feature has also been converted (photo 44).

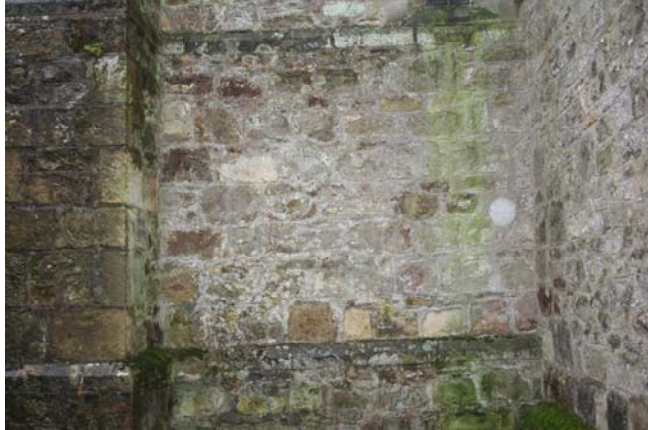
Photo 45

4.2.2 The earliest stone building in the village is the church and this exhibits a few styles of stonework, the earliest dating from the 12<sup>th</sup> century. This can be distinguished generally by the large squared blocks typical of early stonework (photo 45). Later stonework used smaller blocks of stone for the walls and this dominates the later Early English phase of construction and completion of the original church during the 13<sup>th</sup> century (photo 46). Pevsner notes an amount of surviving early stone features around the tower area however many of the windows and

other features belong to the Victorian period of restoration and can be distinguished by more regularly cut stonework which has not had the same degree of weathering.

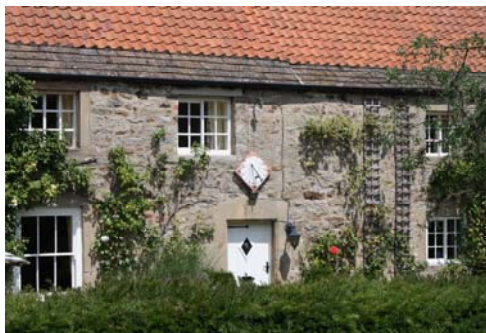
Photo 47

- 4.2.3 Nothing else of medieval date survives to materially contribute to the Conservation Area and the earliest domestic structures are of coursed random rubble, usually with sawn heads and sills and sometimes complete framing to the windows or door openings (photo 47). Buildings are finished with well dressed quoins to the corners and chamfers decorated higher status openings in some cases but in general stonework is simple, solid and with robust detailing (photo 48).

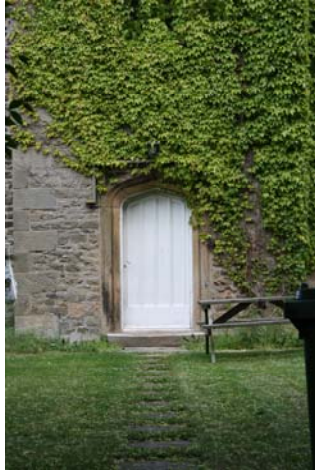
Photo 49

- 4.2.4 The Victorian period saw the flourishing of stonework details with finely dressed stone appearing on wealthy farm houses such as Wharton's Farm (photo 49) with intricate detailing being employed to good effect in window surrounds (photo 50) and chimney stacks (photo 51). The larger public buildings also reflected this style of stonework and this defines much of the character of buildings such as the School on West Road (photo 52), the Wesleyan Chapel on Moor Road (photo 53) and the former Church Hall on Church Row.

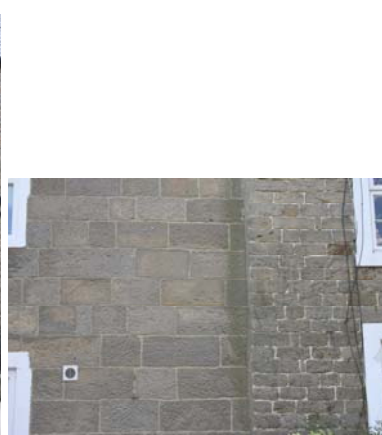
Photo 54

4.2.5 Although many of these principle buildings have distinctive features an important but subtle element of a building's character is the difference in walling stone used for the main construction. This is most notable on the houses adjacent to the school on West Road (photo 54) where the property most closely associated with the school itself has larger, more expensive stone blocks forming the walls, finished with a well dressed herringbone pattern. Adjacent cottages of a similar age and style have a more vernacular, less machined appearance and form to the stone with a pitched face leaving a rugged finish. The scale of the stones varies significantly and the jointing further exaggerates the differences in construction, creating an attractive variety to a single terrace of properties.

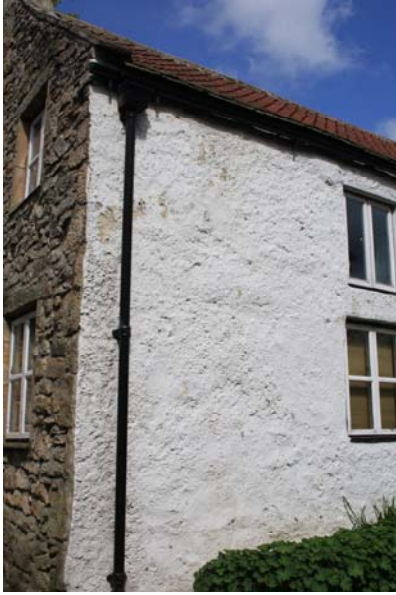
Photo 55

4.2.8 Examples of rendered buildings in Melsonby are numerous and include Grange Farmhouse at the eastern end of Church Row (photo 55). This property has a traditional roughcast render to the south facing front elevation which makes an important visual contribution to the area around the church. Further west along Church Row, The Lilacs (photo 56) presents a very traditional appearance with a smooth finish to the historic render and a considered use of paint colours to emphasise the windows. The Old Rectory on East Road has an important example of a smooth finished lime-washed render to the front elevation which is used to emphasise the architectural quality of the façade, however its discrete and heavily screened position make this a difficult elevation to fully appreciate (photo 57).

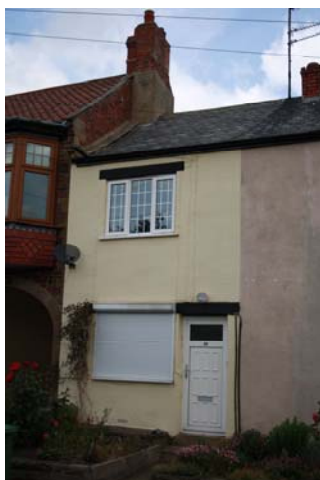
Photo 58

4.2.9 A more modern hard render has been used at 25 (photo 58) and 29 Church Row and the differing paint colours here do little to unify the pair of much altered older cottages. A similar lack of uniformity occurs at Fern Cottage and the adjacent property on East Road facing onto the green (photo 59). Here however the modern extension to Fern Cottage has been rendered to match the main house unifying the single property if not the group. Certain of the older cottages to the rear of the Black Bull retain the traditional render finish and this highlights the buildings in glimpsed views through the streetscape and into back-land areas (photo 60). The modern hard render applied at 27 West Road (photo 61) creates a very flat and visually dead finish to the building when compared to the traditional renders used elsewhere in the village, for example at Grange Farmhouse. A hard cement render has been used to provide shelter to the gable end of 28 High Row (photo 62) however the principle frontages of this group of buildings remain in stone.

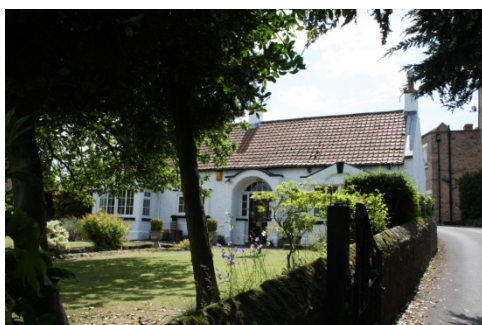
Photo 63

4.2.10 The bungalows at 29 West Road (photo 63) and 12 West Road show different forms of modern render, the first producing a textured finish appropriate to the inter war style of the building. The weathered grey render at 46 High Row (photo 64) blends well with the neighbouring stonework, however further along the street at 12 and 14 High Row a pair of traditional houses have been thoroughly modernised and the two forms of contrasting render used clash both with each other and with the setting of the building (photo 65). Finally mention must be made of the much extended property at the corner of Glebe Court and East Road (photo 66) where render has been used to disguise the modern extension, most probably constructed in block-work, and visually attempt to unify it with the original house, probably constructed of stone.

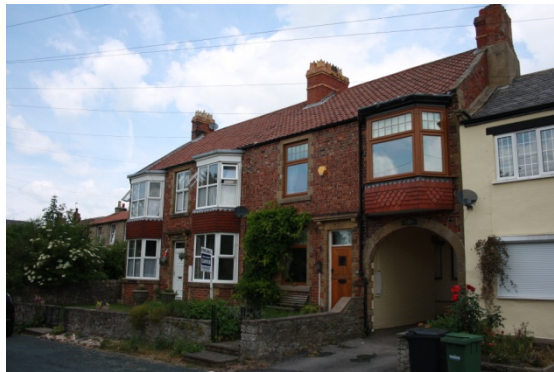
Photo 67

4.2.11 Brickwork is unusual in Melsonby, probably due to the abundant supply of good building stone in the immediate area. Only one building is constructed in facing brick, the pair of houses at 21 and 23 Church Row (photo 67). The properties are typical late Victorian or Edwardian houses and use a locally sourced common stock brick with sandstone dressings to the windows and quoins.

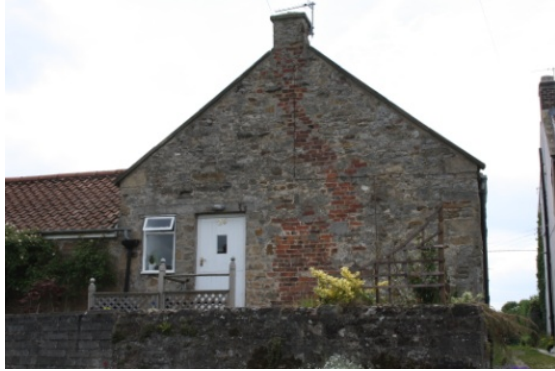
Photo 68

4.2.12 Elsewhere brickwork is used for a few incidental buildings such as the small single storey store to the rear of the Black Bull pub, but mostly it appears as detailed elements such as chimney flues and stacks as noted on the prominent gable of 26 East Row (photo 68), or on secondary gables as found at 33 Church Row (photo 69). Many of the bricks used in details are older handmade bricks typically irregular in colour and with slight distortions to their shape.

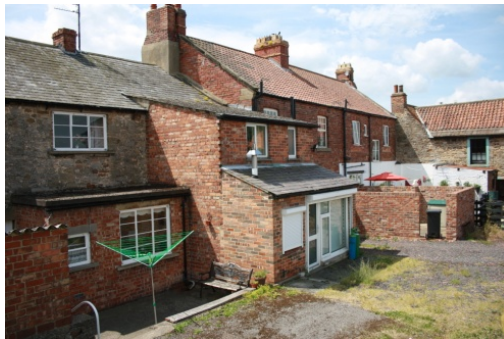
Photo 70

4.2.13 To the rear of Church Row several of the properties were extended some time ago using modern common stock bricks which do not complement the quality of these historic buildings (photo 70).

4.2.14 Given the scarcity of brick buildings in the village it would be out of keeping to allow new buildings to be built entirely of facing brick and this material should be restricted to details and highlights only.

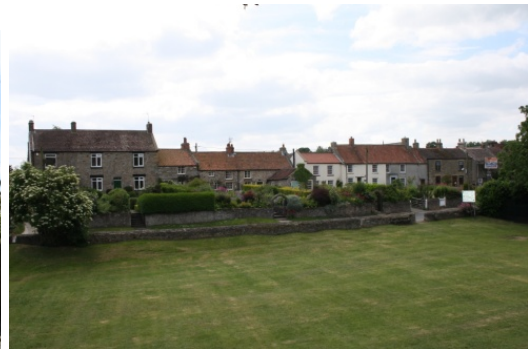
Photo 74

important to maintain sound roof coverings to buildings and to accept that the use of modern natural clay pantiles is acceptable in the Conservation Area it is also important to recognise older pantile coverings and to record and preserve them where they exist. Pantiles were often local products that could vary in shape and size from one producer to another and so surviving historic roofs could provide examples of tiles from long vanished local companies. Good examples of older pantile roofs include several of the properties between 8 and 24 East Road (photo 74) which are particularly prominent, and 34 High Row.

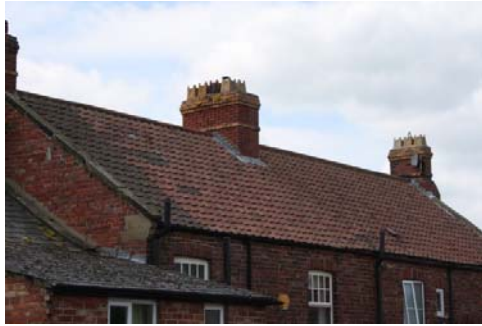
Photo 75

4.2.16 The use of alternative forms of natural clay tiles differing from pantiles has been relatively widespread in Melsonby. A number of properties have used single Roman rolled tiles possibly as replacements for either slates or old pantiles and examples include 17, 21 and 23 Church Row (photo 75), and 15 East Road. The other form of tiling, not commonly found in this area uses small plain tiles, sometimes referred to as 'Rosemary' tiles and these have been used to re-cover the Church (photo 76) and Post Office roofs (photo 77) in the past. Whilst not strictly a local form of roofing these alternatives have a similar colour to pantiles and blend well into the wider setting of the Conservation Area. As a natural material they are also more appropriately employed on historic buildings than more modern roofing alternatives.

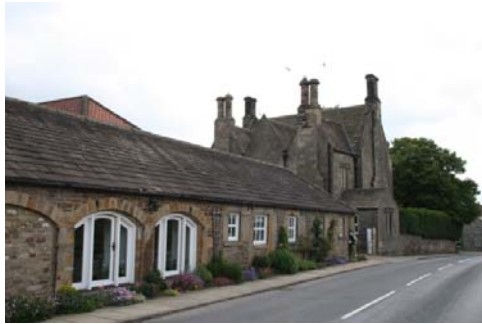
Photo 78

4.2.18 Locally sourced Dales stone slates are also found in the Conservation Area both as the eaves course to pantile roofs and as a complete roof covering. This material is increasingly uncommon and its scarcity makes it important to record and preserve such roofs where they exist. The slates are heavy in comparison to other forms of covering and so the internal roof structure is usually found to be of larger more substantial timbers. The roofs have an attractive appearance with the slates being laid in diminishing courses and exposing a thick stone edge to give a distinctive pattern to the courses. Different quarries and different beds of rock would produce slates of different thickness and there is a great deal of skill in selecting slates and laying them evenly across the slope of a roof to give an even finish. The village has several examples of this type of roof most notably at the prestigious

properties of Wharton's Farm House (photo 78) and Central Villa (photo 79) and these should be preserved.

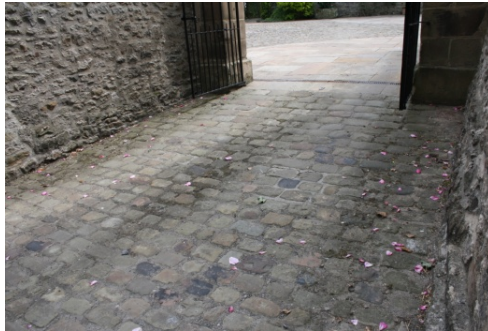
Photo 84

4.3.1 Throughout Melsonby tarmac dominates the floorscape and little remains of the traditional historic forms of surfacing. Historically roadways are likely to have been unbound rolled earth tracks covered with crushed rock until the late 19<sup>th</sup> or early 20<sup>th</sup> century with footpaths, where they existed, comprising cobbles or perhaps stone flags. Kerbs would have been formed of sandstone edging. Within the village a single small area of this type of surface remains outside 38 High Row (photo 82). It is important to note the pattern of cobbles and their density as more modern attempts at cobbling nearby fail to replicate this and in some cases resort to a few cobbles in a bed of smooth concrete, a finish which does not complement the character of the Conservation Area. Further along High Row at number 6 good quality cobbles have been used along with stone flags to create an attractive forecourt to the property, allowing parking space if required (photo 83). At the entrance to The Old Rectory on East Road squared sets have been employed to create a high quality approach to the property (photo

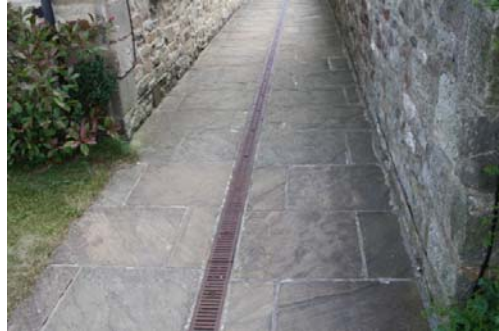
Photo 85

84). Other forms of surfacing include crushed and rolled stone to some rear yards, flag stones to the footpaths at the side of Wharton's Farm House (photo 85) and modern concrete blocks and sets to provide driveways in a few locations including Wharton's Farm and off East Road. In some cases concrete drives remain however these are not usually of appropriate quality in the Conservation Area and should be resisted and replaced where possible.

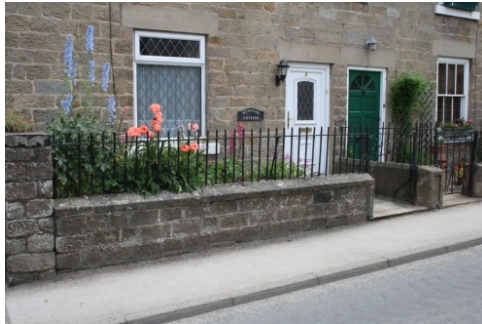
Photo 86

4.4.1 Stone walls are an important component of the character of Melsonby, defining routes through the village, boundaries to property and protecting against hazards. Most of the village properties have front gardens of varying sizes and these are almost exclusively defined at least in part by stone walls. In many cases the walls are supplemented by substantial hedges and shrubs which grow above and over the walls to create the lush and verdant views through the village. None of the principle walls in the village are of brick or other material and only in a very limited number of cases are railings used, notably at 1 to 7 Moor Road (photo 86) and at 13 to 19 Church Row (photo 87).

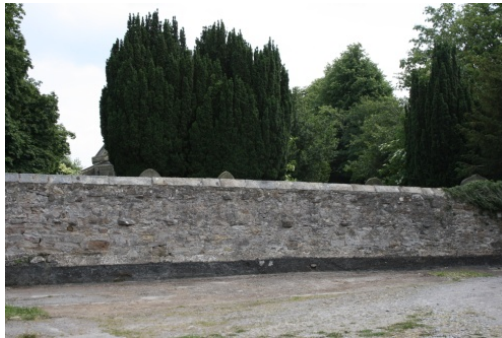
Photo 88

4.4.2 The copings to the stone walls vary with distinctive pyramidal copings to the churchyard wall (photo 88), deeply tooled copings on the approach to the village at Melsonby Farm (photo 89) and more widely found half round copings elsewhere in the village. Many sections of wall use traditional random thickness top stones set on edge as a coping, a practise widely used in local dry stone walling (Photo 90).

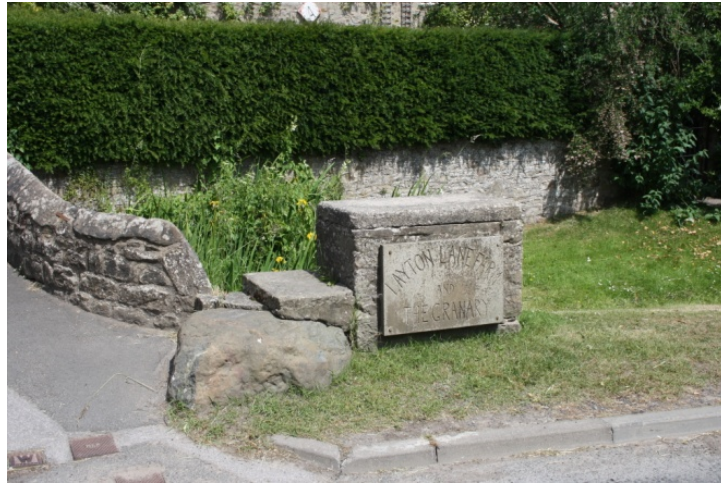
Photo 94

- 4.5.2 At Layton Lane Farm the former mounting block and churn stand has been adapted to support the property name and this is perhaps one of the last reminders in the village of the important role of the horse and agriculture in the development of rural settlements (photo 94).

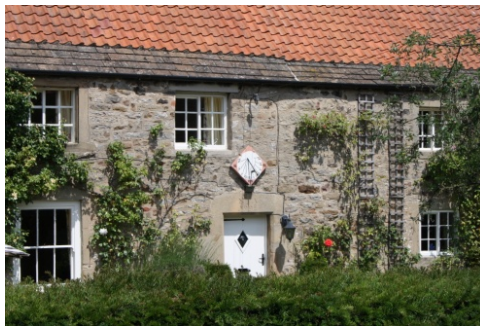
Photo 95

4.5.3 More individual features include a range of sundials including the one on Layton Lane Farmhouse dated 1646 above the lintel to the door dated 1698 (photo 95). Others worth noting are found on the rear of 51 West Road (photo 96), and at 20 High Row (photo 97).

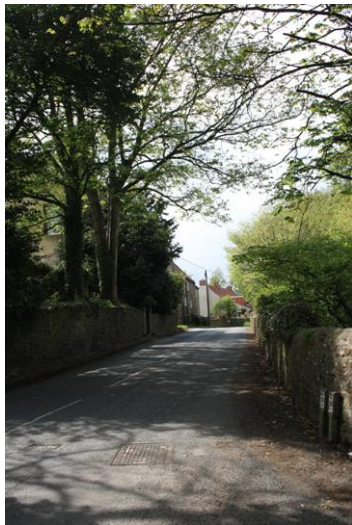
Photo 133

5.4.20 This is a diverse part of the village encompassing as it does the wooded dell which contains Waterfall Beck, the properties around Orchard House, the approach to the village from the east and the range of buildings which include the Old Rectory. The overall impression of this area is one of dense tree cover and the approach to the village from the east is dark and secluded within the sunken lane beneath the overhanging greenery (photo 133). The Old Rectory does

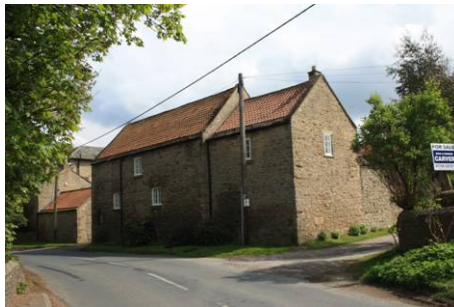
Photo 134

not have an important role in the streetscape as it presents a large looming blank gable to the road side and the rest of the property is discretely hidden behind the high hedges and trees. The subsidiary buildings to the Rectory are similarly forbidding from the roadside, presenting a very solid face to the public realm with a few small windows set high in the wall (photo 134). The solidity of these large stone walls is important to the character of this area and is mirrored to some degree by the lower walls enclosing the woodland and leading to the bridge. The properties at 38 and 40 East Road (photo 135) have been much altered over many years and, although they probably originally took the form of a pair of vernacular stone cottages they are now very much out of keeping with the character of the surrounding Conservation Area.

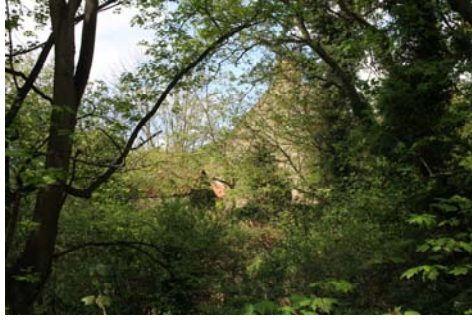
Photo 136

5.4.21 Orchard House and the other domestic properties to the north are at best glimpsed through the trees (photo 136) but their presence provides a backdrop to the wood, hinting at the domestic setting within the village. Within the deeper reaches of the glade lies a small pantile roofed shed (photo 137) which provides a human element in the greenery and this complements the historic bridge spanning the beck and allowing views into the woodland. This area is a tranquil secluded spot, well positioned to provide a worthwhile asset to the village and make a significant contribution to the whole character of Melsonby, particularly the eastern parts of the village.
