RAVENSWORTH

Conservation Area Appraisal and Management Plan

Adopted September 2, 2015

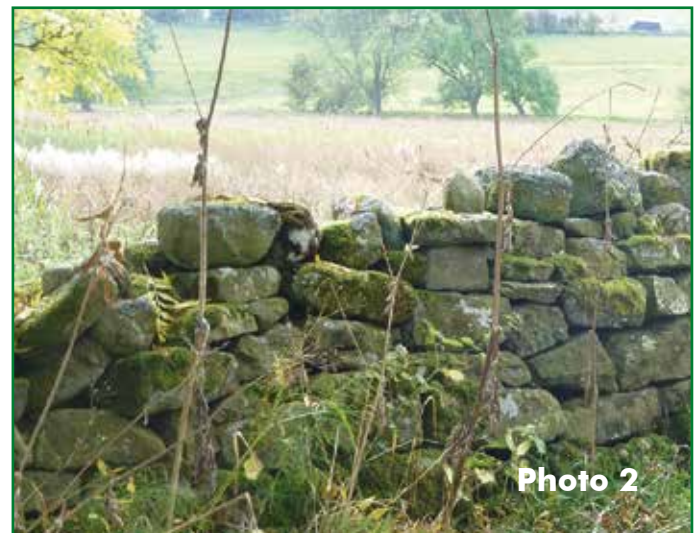
The Lord of the Manor in 1066 was Thorfin, and the village is documented in the Domesday Book (1086). At that time it was recorded as having 21 households, a church and a priest and quite a large settlement. This is presumed to be in the wider landscape which included Kirby Hill.

The Manor passed through various hands and in the reign of Henry I the Fitzhugh family built a fortress which would have offered protection against Scottish raids. Henry Fitzhugh built the current Ravensworth Castle in 1391 (photo 1) on the site of the previous 11th century fortress and received a licence to enclose 200 acres of land around the castle to make a park. The park pale

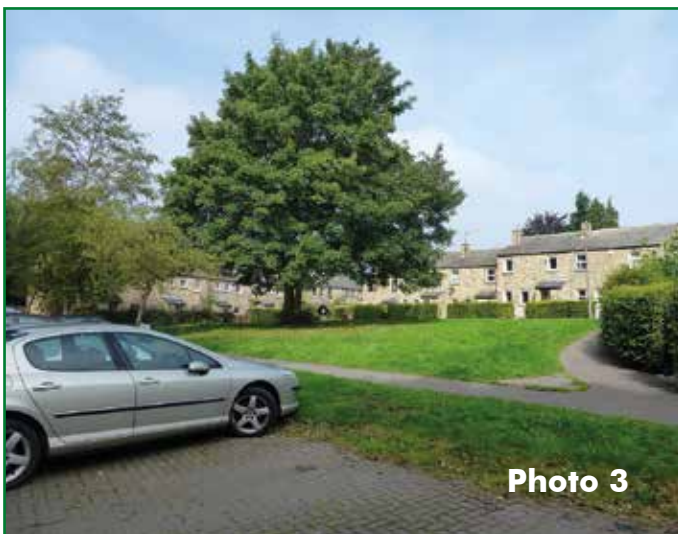
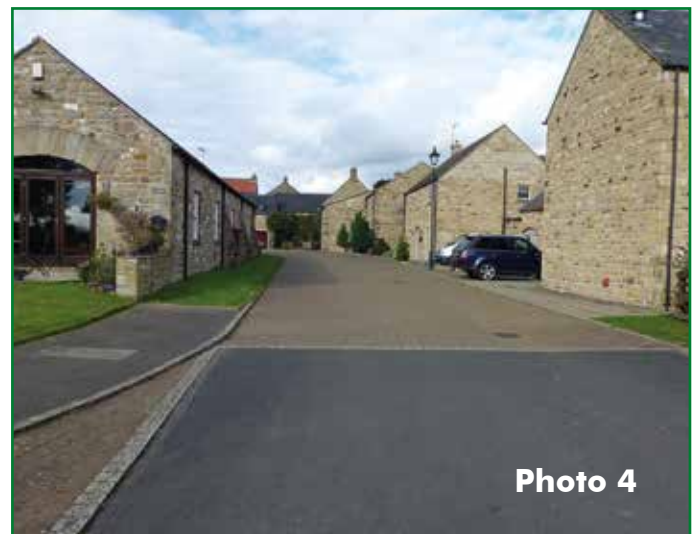
Much of the housing stock dates from the mid to late 17th century when the basic form of the current village was established. Over the years Ravensworth has been described by many, most notably by 16th century antiquarian, John Leland, as a 'pretty' village and later as 'exceedingly neat'. The artist M W Turner made several sketches of the castle and Walter Scott referenced the village in 'Rokeby' 1813, an epic poem set in the area.

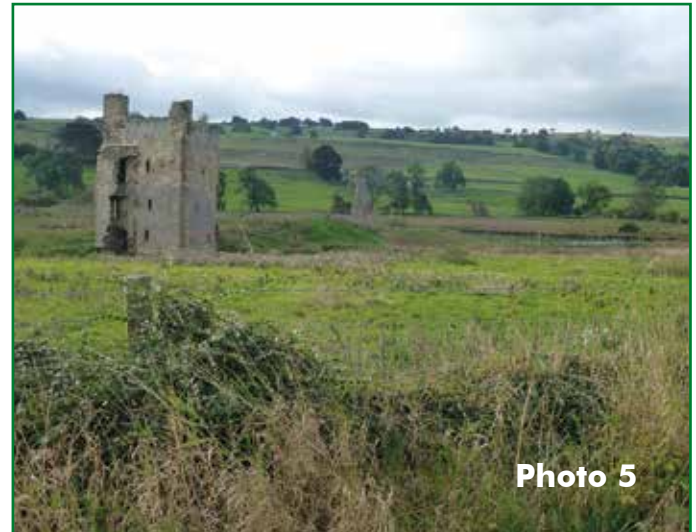
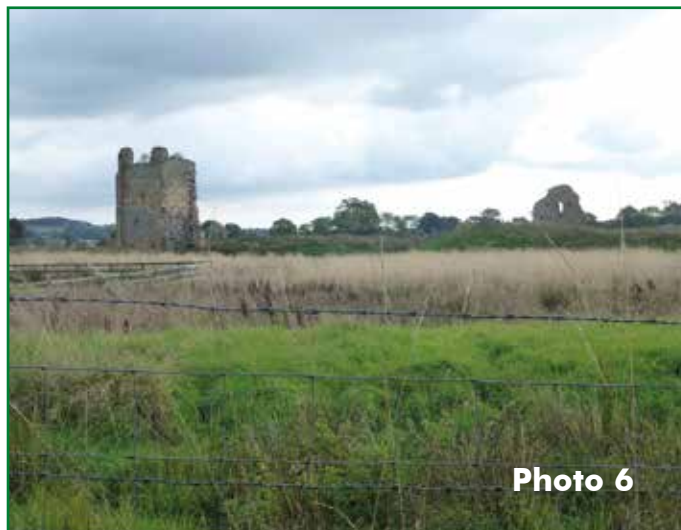
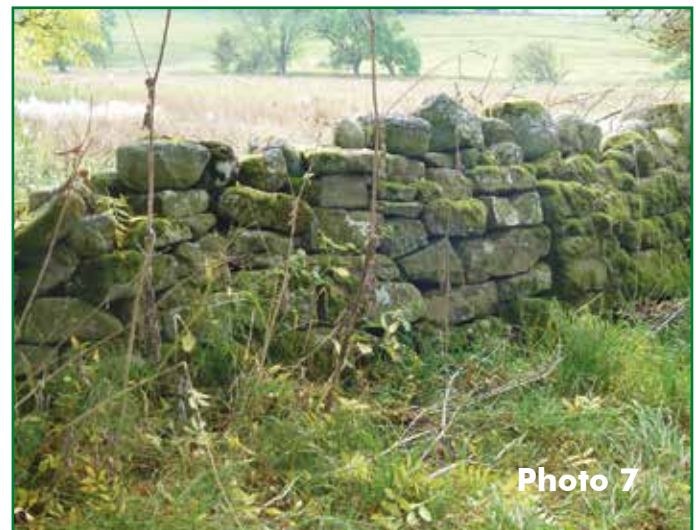
The importance of Ravensworth Castle has been recognised in its designation as both a Scheduled Ancient Monument and a Grade I Listed Building.

Although in a ruined state, significant parts of the Castle have survived, and the original plan and layout is preserved. The standing fabric - particularly the gatehouse and the belfry tower - survive reasonably well and other remains of medieval structures are preserved below ground. Unusually the main defensive feature of the castle was the waterlogged area surrounding the castle, which was managed by a system of embankments and channels, which still survive as standing earthworks (photo 6). There are also earthworks relating to the deer park attached to the castle and long sections of the wall - which was originally three miles long - survive (photo 7), and Remnants of the medieval village settlement adjacent to the castle are also still in existence.

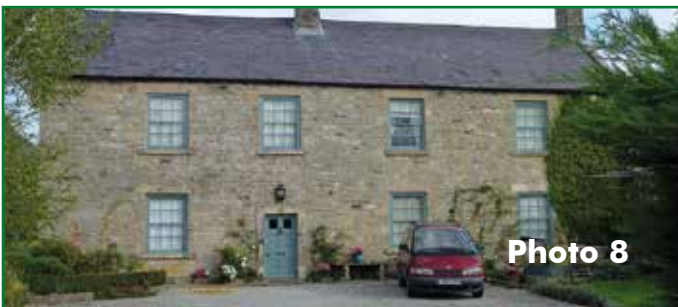
The biggest portion of the buildings within Ravensworth are of C18th and C19th date, constructed mainly in local stone, which is generally of good quality and typically incorporating vertically sliding or Yorkshire sash windows and solid doors. The few painted and rendered buildings provide an important and interesting contrast. Traditionally roof coverings are generally stone slate and clay pantiles but Welsh slate is also apparent. In more recent times a number of properties have replaced these traditional roof coverings with varying forms of concrete tiles. The architectural qualities of the buildings lie generally in their grouping and simple vernacular style.

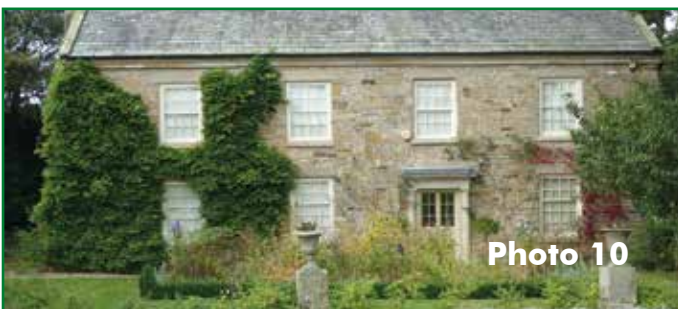
Photo 10

Of a slightly later date is Park House (photo 10), listed Grade II - built in the mid to late 17th and late 18th to early 19th century. It has an irregular U-shaped plan with the early house now forming the left rear wing, possibly with early extension forming two bays left of the main façade and with later 19th century service buildings to the rear right. The front façade is two storey with four bays and unusually for the village it has a Westmorland slate roof. The door-case has fluted Tuscan engaged columns supporting a decorative frieze. The main facade has 16-pane sash windows but the older section to the rear retains a chamfered mullioned window. Behind the main buildings are range of outbuildings including a cowhouse, coach-house and disused livestock enclosure which are all listed Grade II. They are all thought to date from the mid to late 18th century. All are constructed of rubble sandstone with dressed quoins, some ashlar copings and the livestock enclosure has two small vaulted chambers.

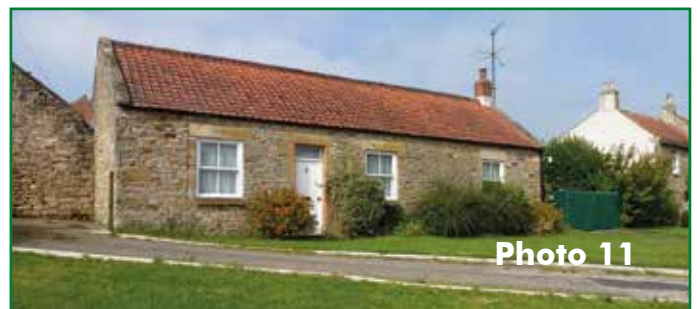
Photo 11

Mill Farmhouse Cottage (photo 11) is dated 1699 and is of a far more humble design than the two earlier houses. It is single storey of rubble sandstone with quoins and a modern clay interlocking tile roof. The property has three bays and four-pane sash windows with projecting cills and deep herringbone tooling. This window surround detail with the tooling feature is common on many of the older properties.

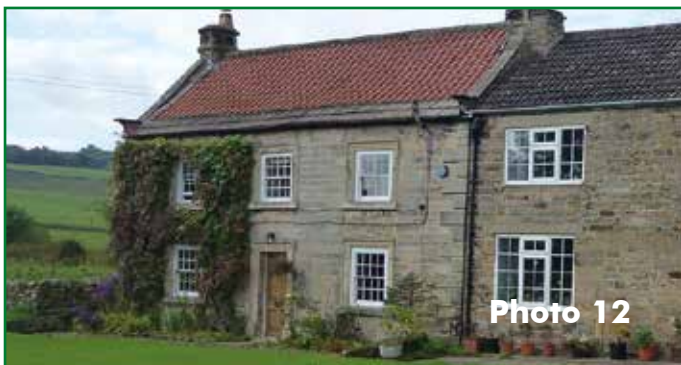
Photo 12

39 The Green (photo 12) dates from around 1700 with later alterations. The main façade of this house is ashlar, which is rare in the village, with coursed rubble to the rear and side. The roof is of modern pantiles with stone slate eaves course and shaped kneelers, ashlar copings and end chimney stacks. The house is two storey with three bays. It has rusticated quoins and architraves to openings with a six panel door and 16-pane sash windows.

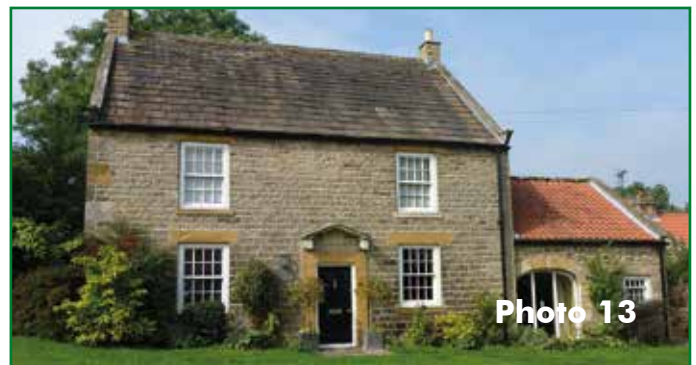
Photo 13

15 The Green (photo 13) dates from 1786 with an early to mid 19th century outbuilding. The house is of coursed dressed sandstone with quoins and has a stone slate and pantile roof with shaped kneelers. The house is two storeys and two bays with a central door with ashlar surround, incorporating a medieval inscription protected by a pediment. The windows are 16-pane sashes with projecting cills and deep lintels incorporating the inscription 'IE 1786'. A single storey building to the right incorporates an arched opening of dressed stone, presumably for a cart.

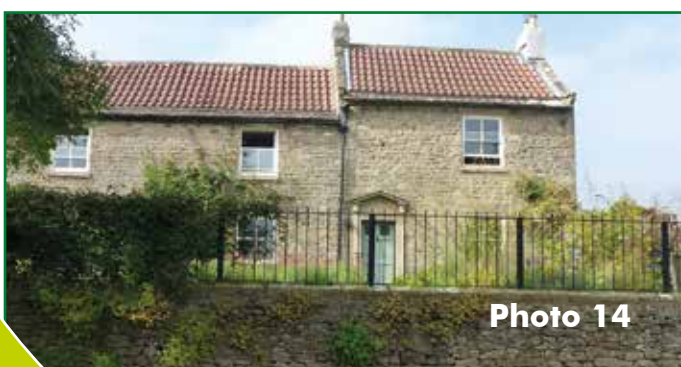
Photo 14

In the late 18th to early 19th century Mill Farmhouse (photo 14) was built and has had 20th century alterations. It is constructed of coursed watershot, rubble which is rare for the village, and has a modern pantile roof that has a slate course at eaves with shaped kneelers, ashlar copings and brick end stacks. It is two storey and of two parts, the older part being to the left with two bays. The later range to the right is slightly taller and has one bay with a door to the left in an ashlar surround with pediment. The windows are four-pane modern sashes with cills and deep lintels. At the front of the house is a cobbled garden wall with ashlar copings swept up at the sides to a lower front wall and a modern iron railing.

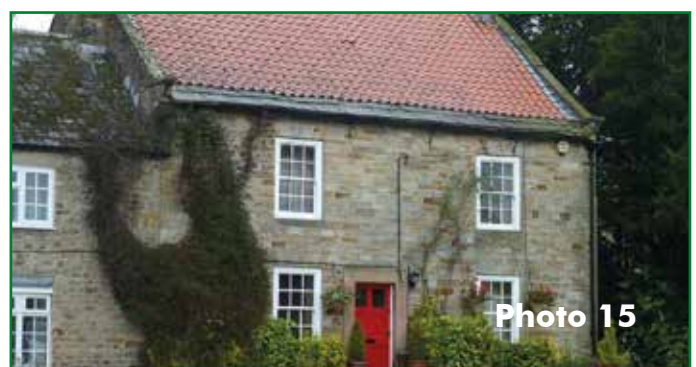
Photo 15

Park Farmhouse (31 The Green) dates from the late 18th to early 19th century (photo 15). This property is built of coursed rubble with quoins and has a modern pantile roof with a stone eaves course, shaped kneelers and ashlar copings with brick end stacks. It is two storey and has two bays with a central door in ashlar surrounds.

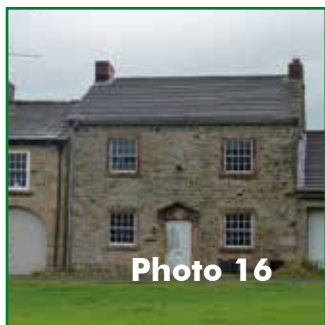
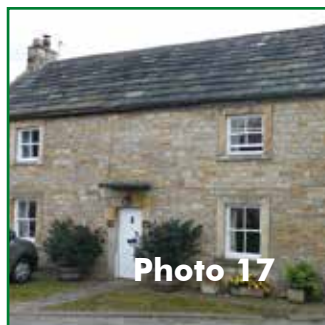
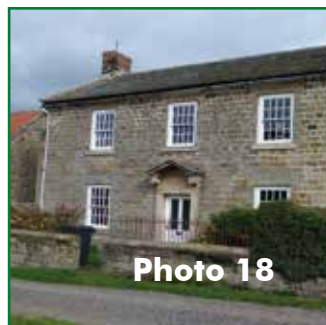
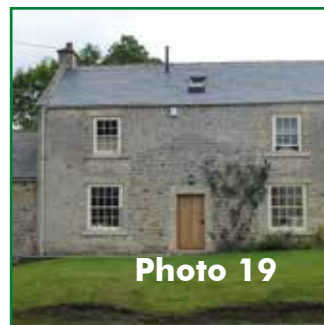
Numbers. 41/43 The Green - West View Cottage - (photo 17) also date from this time. Now one house, it is built of coursed rubble with a stone slate roof to the left and modern concrete tiles and stone eaves course to the right with some shaped kneelers, ashlar copings and end stacks. It is of two storeys with a lower extension to the right. Windows are four-pane sashes and there is a central door with all openings having dressed stone or quoins surrounds.

Number 24 is built of coursed rubble sandstone with a stone slate roof, ashlar copings and brick end stacks. The property is two storeys and has three bays with quoins to the left hand side. It has a central door with ashlar surrounds and 16-pane sash windows with projecting cills and deep lintels.

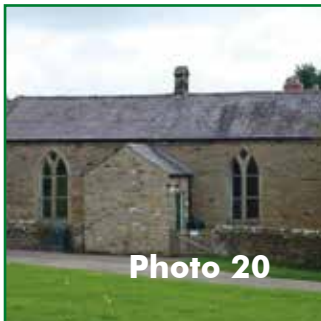
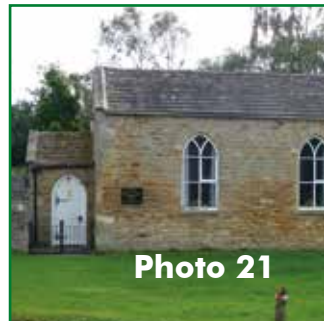
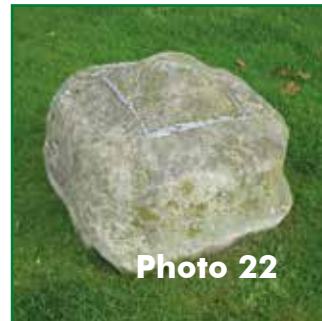
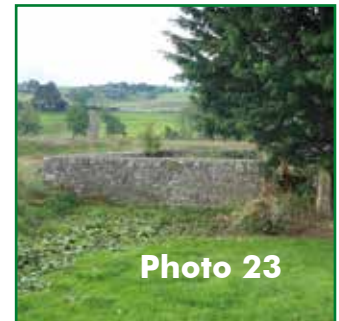
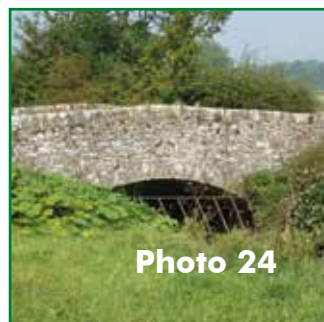
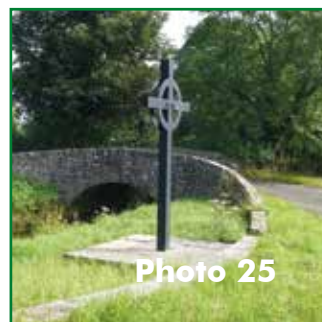
Other historic features and buildings in Ravensworth considered to be important and have been listed are :

- The village pound (photo 23) – thought to date from the 18th century in the form of an irregular oval enclosure of rubble stone with a monolithic gate post to the north-east.

- The footbridge over Holme Beck, 120 meters to the north-west of Mill Farmhouse (photo 24) – from the early 19th century a single segmental arch of dressed voussoirs and soffit with herringbone tooling. The bridge includes a Gothic window head and other carved stone thought to be from Ravensworth Castle.

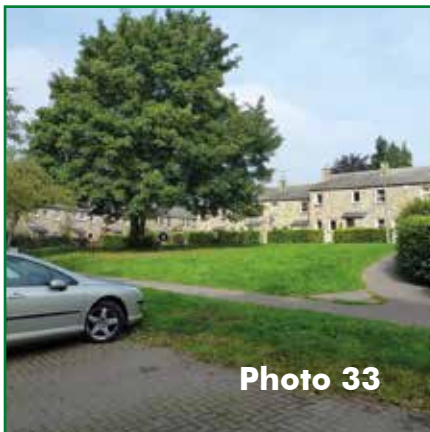
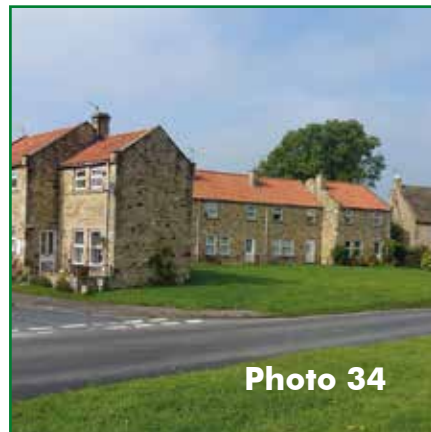
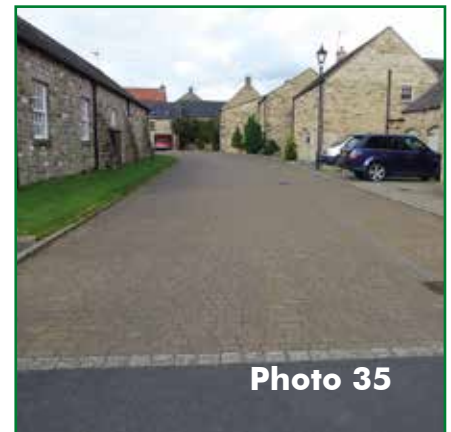
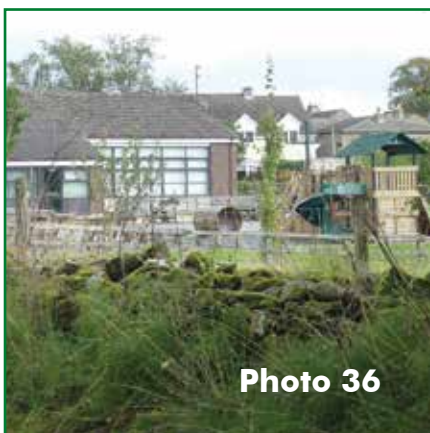
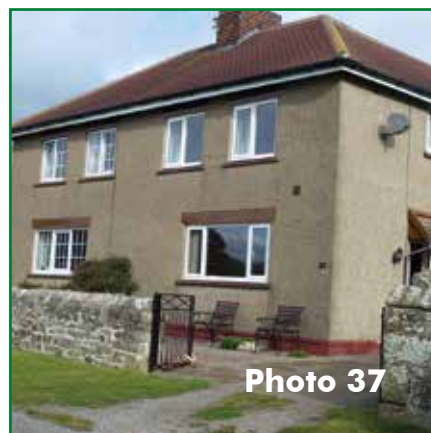
There are two parts of Ravensworth where twentieth century development dominates. These are around Mill Close and Mill Court/rear of Tofta House where both developments are in locations away from the main vantage points.

Mill Close (photo 33) – was built in the 1970s, substantially as a series of terraced properties around three sides of a green square set to the east. One other row of terraces and a detached property were built to the west of these which reinforces the enclosure of the Village Green (photo 34). The use of a pallet of local building materials (stone and pantiles) on the prominent properties helps to assimilate these comparatively new buildings into the grain of the village.

The school (photo 36) built in 1967 has little regard for the local vernacular character of Ravensworth, being more the 'house style' used at the time by the education authority. Fortunately its position behind the frontage of traditional properties means it has little impact on the character of the Conservation Area as a whole.

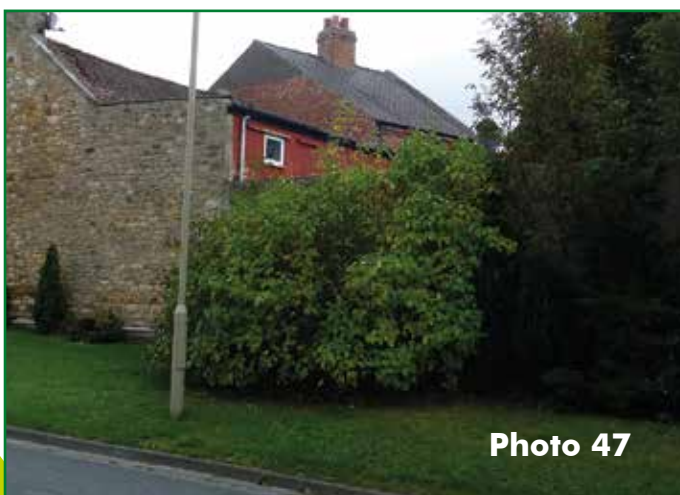
Brick is rare in Ravensworth and only appears notably in the chimneys and rear elevations, such as the back of the Bay Horse Inn (photo 47). It has also been used to construct a few small ancillary buildings and boundary walls - such as The Cedars (photo 48) - and chimneys, but these are less prominent in the Conservation Area. Brick has not been used for any significant external work on buildings in the village and, in a similar manner to render, brick should be resisted in its future use in the village in order to maintain the dominant use of natural stone which gives Ravensworth so much of its individual character.

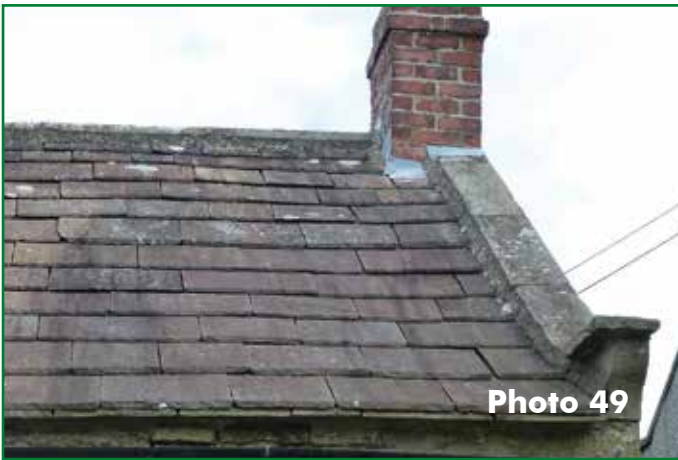
This has been historically used for domestic roofing in the area (photo 49). The stone slates will have been locally sourced. The sandstone slates are thick in comparison to other roofing materials and are laid in diminishing courses, narrowing from large slates at the eaves to small slates at the ridge, often finished with a dressed stone ridge piece. This produces a distinctive character to the roof very different from other natural slates, as the covering is notably thicker and the roof has a textured finish arising from the thick slate edges. Although when first quarried the sandstone slates are a pale grey/buff colour they weather in time to a deeper grey/brown colour slightly darker than walling stone. Good examples of stone slate roofs can be found on many of the listed buildings - 15 The Green (photo 50), 24 The Green, 26 The Green and 28 The Green. The stone slates are often combined with pantiles as an eaves course as referred to below.

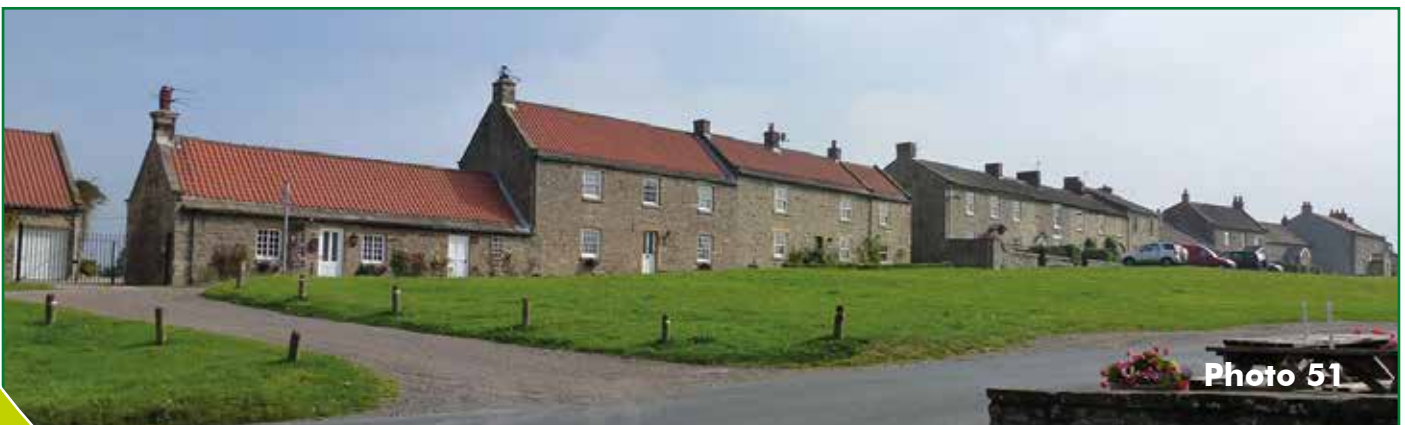
Pantiles are the most widely used roof covering in the village and appear to have been the dominant roofing material for many years. They vary greatly in age and character and their different ages and sources combine to produce a richly textured roofscape to the village when viewed from the village green. Several village properties have eaves courses of stone slates, a traditional and interesting vernacular feature which can vary in width from a simple single course to three or four courses of stone. Pantiles and a stone eaves course can be seen at 20 The Green (photo 51). Whilst it is important to maintain sound roof coverings to buildings and the use of modern pantiles is appropriate in the Conservation Area, it is also important to recognise older pantile coverings and to record and preserve them where they exist. Pantiles were often local products that would vary in shape, size and texture from one producer to another. Surviving historic roofs could provide examples of tiles from small local companies now long gone.

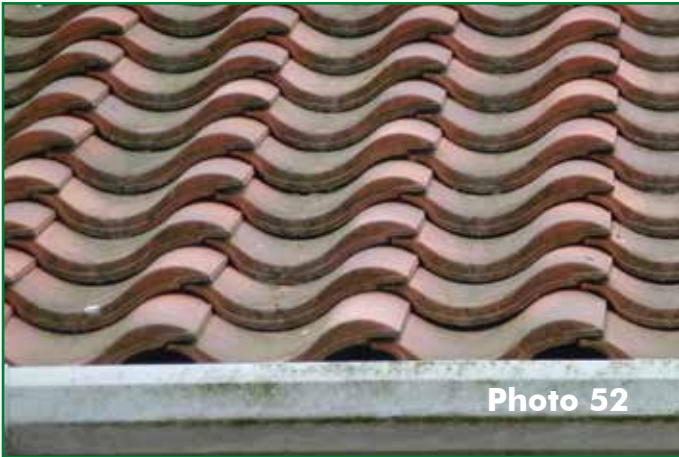
Some of the original roofs of the village have been replaced with interlocking pantiles (photo 52) and although they do not quite have the character of the original, they assimilate reasonably well into the overall street scene.

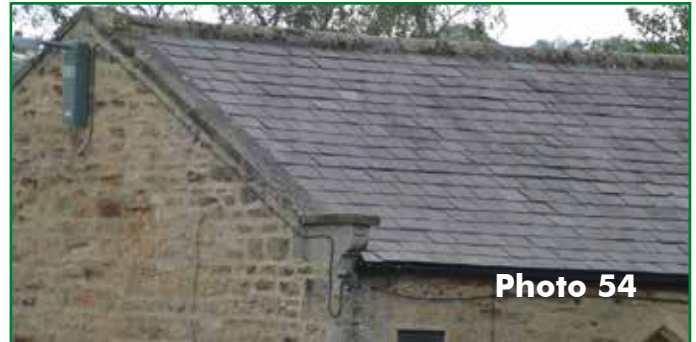
Photo 54

There are several types of slate used on village buildings. Welsh blue/grey slates are the most numerous and the earliest use of slate will date from the latter half of the 19th century when transport systems, particularly the railways, were sufficiently developed to allow slate to be imported to the area. The use of slate has continued alongside pantiles in both re-roofing buildings such as Tofta House (photo 53) and Sunset Cottage but also as a traditional alternative to pantiles. These are best seen at the Village Hall (photo 54) and 18 The Green.

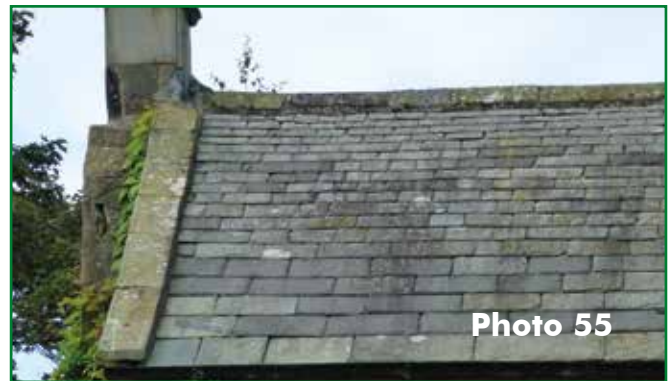
Photo 55

Westmorland slates are a grey/green colour and are rare in the area. Park House (photo 55) being the only house in the Conservation Area to be roofed with them. They are laid to diminishing courses in a similar manner to the local stone slates, but they are not nearly as thick and more akin to the Welsh slates. This is an unusual material to find in a location that is so well provided with good quality stone roofing slate and may be an indication of the high status that this prominent village house has always enjoyed.

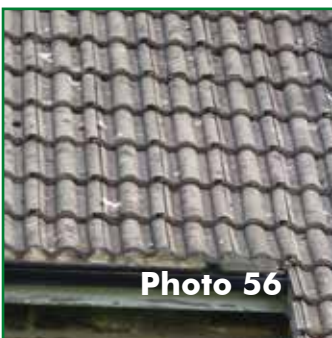
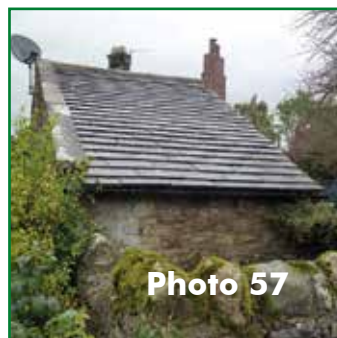
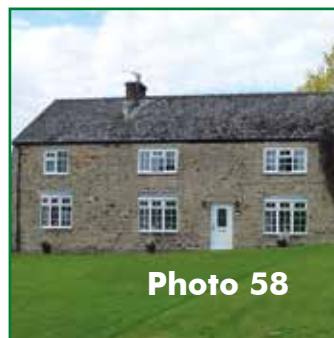
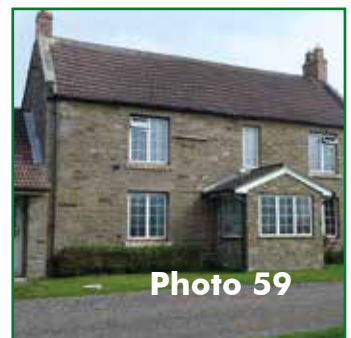
Recently - throughout Ravensworth - the traditional stone slate roofing materials have been supplemented with more readily available, cheaper alternatives including concrete tiles. They have been used extensively on village properties through the latter part of the 20th century to replace older traditional stone slate roof coverings. They come in a number of forms - both profiled (photo 56) and flat (photo 57). Although not ideal for traditional buildings due to the characteristics of the material itself and the regular mechanical appearance of the finished roof, which differs from the traditional slates or pantiles, the flat tiles have usually mellowed with weathering to blend into the street scene (photo 58). Unfortunately the same cannot be said for the profiled concrete tiles (photo 59). Ideally these will be replaced with more traditional alternatives as they become life expired.

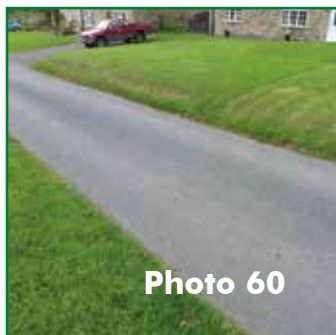
Photo 60

The village is dominated by the expanses of Village Green which in a lot of areas remains unbound by kerbs (photo 60). In some locations it appears to have been necessary to formalise the demarcation between the roads and the green and verges and a number of means have been used to achieve this, including the standard highways concrete kerbs (photo 61), granite setts (photo 62) and 'grasscrete' (photo 63).

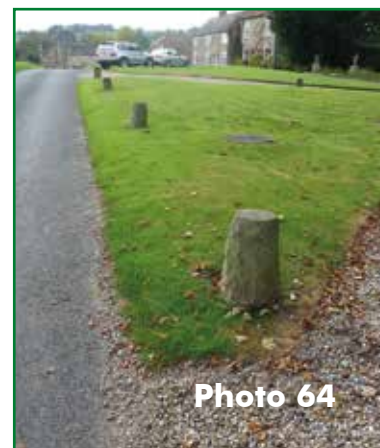
Photo 64

The informality in many places around the main part of the village green is very important to the character of the village and should be maintained to protect the quality of the Conservation Area. In a number of places both timber and stone bollards have been used to prevent overrunning (photo 64). Whilst these are unfortunate in terms of their appearance, they do serve a purpose.

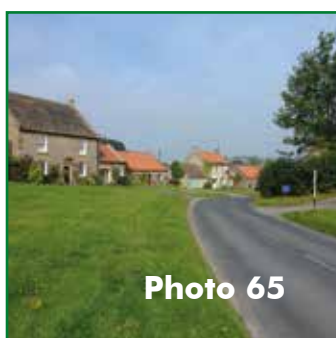
Photo 65

All areas of public road are finished in black tarmac (photo 65).

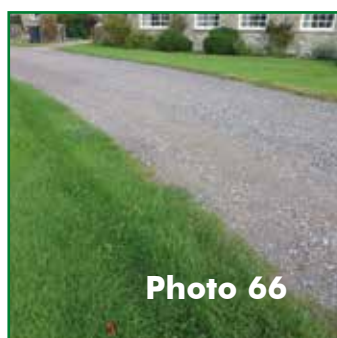
Photo 66

Accesses away from these roads to the properties on the village green remain un-metalled and are generally crushed gravel (photo 66). Private drives feature a range of surfacing from informal beaten earth paths and rough rubble, through a range of gravels and crushed stone, to concrete, tarmac (photo 67) and modern block paving (Photo 68). This last form of surfacing which is seen substantially on the modern developments of Mill Close and Mill Court/rear of Tofta House (photo 69) provides a very mechanical finish very much at odds with other aspects of the village.

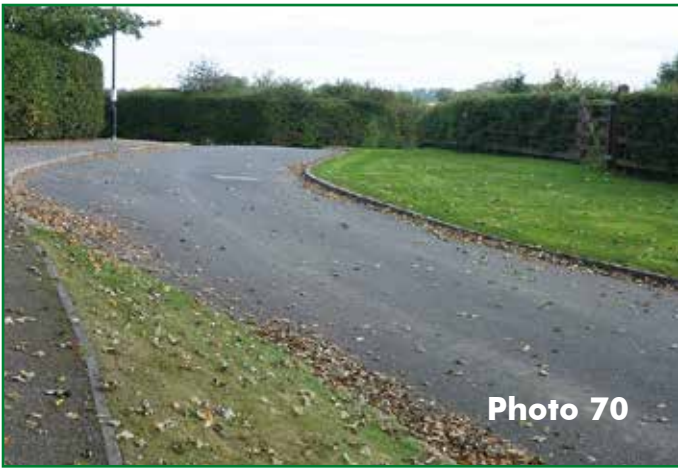
Photo 70

The village has very limited lengths of footpath which are constructed only around the modern developments of Mill Close (photo 70) and the rear of Tofta House (photo 71). These sections of modern highway-standard road layout are rather suburban in nature but fortunately they are only short lengths and hidden away in locations where they do not dominate the character of the village.

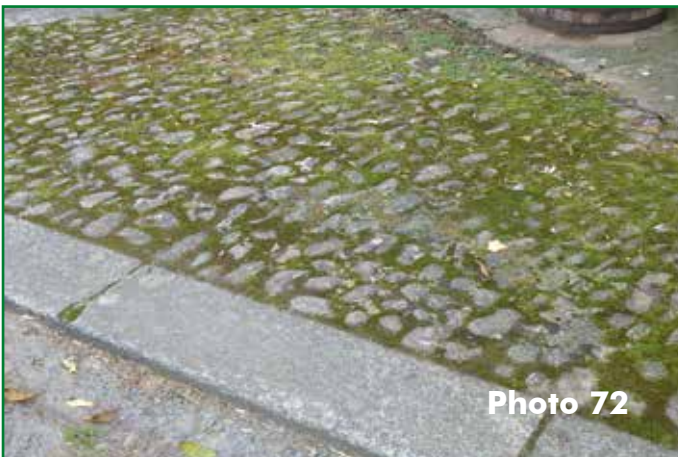
Photo 72

There is some evidence of cobbles being a traditional flooring material and these are best exemplified to the front of West View Cottage (photo 72) and 39 The Green. Stone flags also appear to the frontages of some properties such as 7 The Green (photo 73), where they have unfortunately been badly damaged, and at the rear of the Bay Horse Inn where there is a good example of stone setts (photo 74).

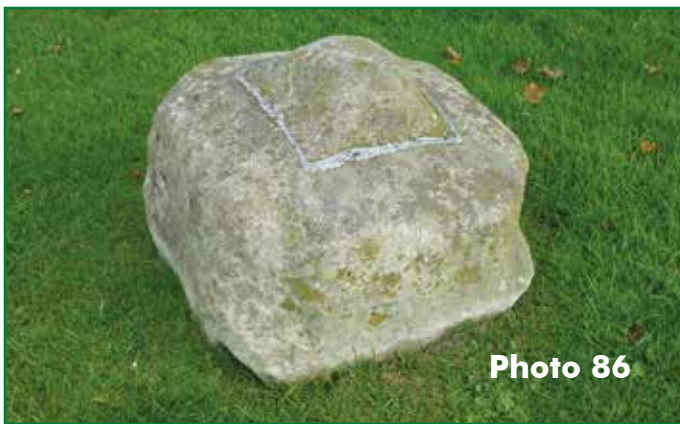
Photo 86

There is a limited amount of street furniture in Ravensworth but the range that exists includes several important items, which make a valuable contribution to the character of the Conservation Area. The most prominent item on the Village Green is the cross base (photo 86). Although the telephone kiosk (photo 87) positioned to the west of the Green is of a standard national design, it has an important place in the community and appears well cared for. It is an important landmark, though a little lost against the backcloth of houses. Slightly smaller, but similarly important, is the post box set in the wall of 58 The Green. A few bench seats are positioned at strategic points around the village often to take advantage of particular views (photo 88). These are usually serviceable but could benefit from some periodic maintenance. There are a few bins that are grouped by one of these seats. Away from the village on the approach from the north is a monument erected to celebrate the millennium (photo 89).

- The cross base (photo 22) – possibly from the 16th century and now badly worn, square in plan with the upper corners chamfered and broached stopped. A bump on the upper surface indicates the joint for the next section of the shaft.

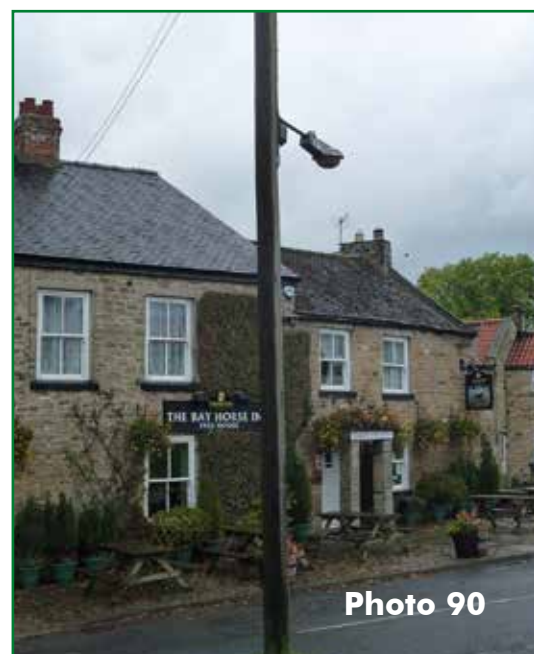
Photo 90

Street lighting is provided throughout the village on a series of modern brackets mounted on existing poles, these are quite sparse and their design is poor (photo 90) in a historic context.

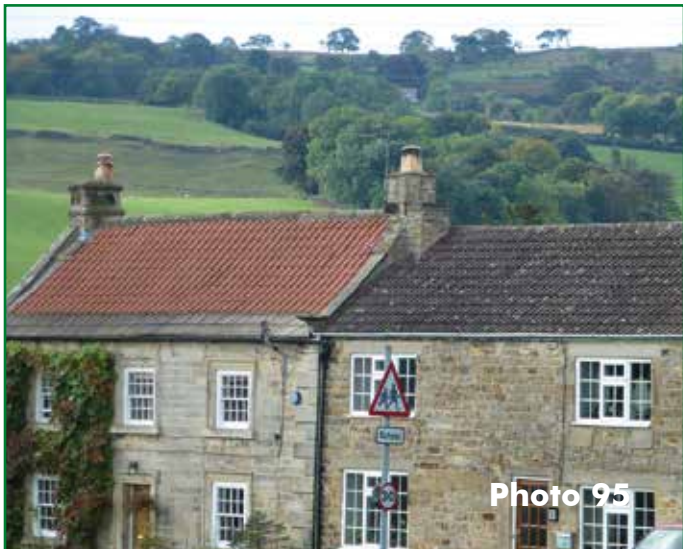
Photo 95

From within the Conservation Area the gentle slope of the land from north to south and the associated ridge of high land a mile to the south means that views can be enjoyed south to the surrounding countryside (photo 95 and 96). However, the position of the castle at close quarters to the south east is hidden by the buildings and hedges, shrubs and trees around the Green. As the majority of the properties front onto the Green the building frontages can be clearly enjoyed through 360°. Views of the Village Green cannot be appreciated from the access roads because of the hedging, narrow entry points and curves of the road (photo 97).

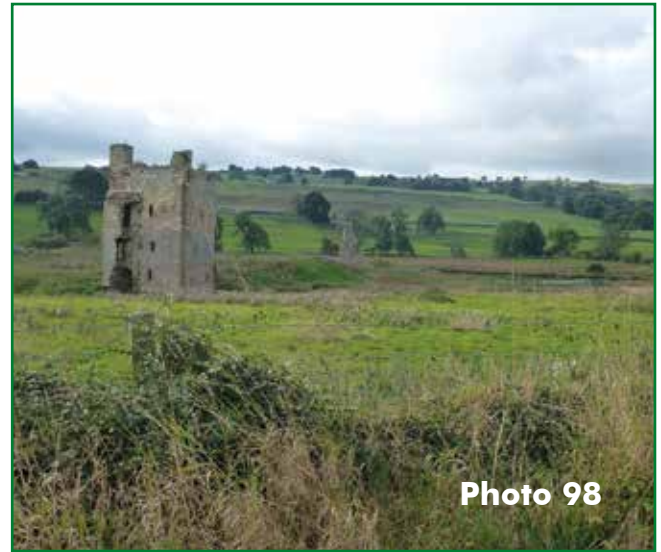
Photo 98

To the south east of the village within the Conservation Area are the low-lying ruins of Ravensworth Castle (photo 98). As described earlier these consist of an open scrub, pasture and wetland area with some standing ruins. This area is of high archaeological value and has been recognised as being both a Schedule Ancient Monument and a Listed Building. Though the castle's link with the village is beyond question, its physical impact on the village is limited to the robbed building materials from the ruins that can now be seen in some of the village properties. Views of the castle are appreciated through gaps in the hedges along the approaches from the east and south, but once within the village itself it is substantially hidden.

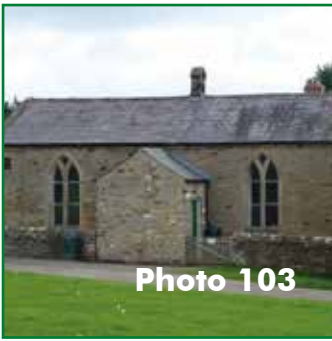
Photo 103

The Village Green is the dominant feature of Ravensworth village and the majority of the properties are to be found around it. It is roughly triangular in shape and gently slopes from its north east high point to the west and more steeply to the south. It is surrounded on all sides by buildings that consist mainly of two storey houses, either grouped in short terraces, semi-detached or occasionally detached (photo 99). These vary slightly in their relative position to the Village Green (photo 100). The gaps between the properties are small allowing access by foot and vehicles to the areas behind. The overall impression is of a continuous frontage. The lay of the land means that there is variation to the height of properties with roofs stepping to follow the contours of the land (photo 101). Where the gaps between buildings are larger, as they are around the Village Hall, the continuity of the frontage is maintained by the linking of the buildings with substantial walls, (photo 102) thus reinforcing the feeling of enclosure around the Green. The general unity in the colour of materials gives the impression of a homogeneous built form but on closer inspection there are unique differences between buildings - such as the pointed arched windows of the Village Hall (photo 103) and Chapel (photo 104), the deep flat lintels (photo 105) and the use of voussoirs (photo 106).

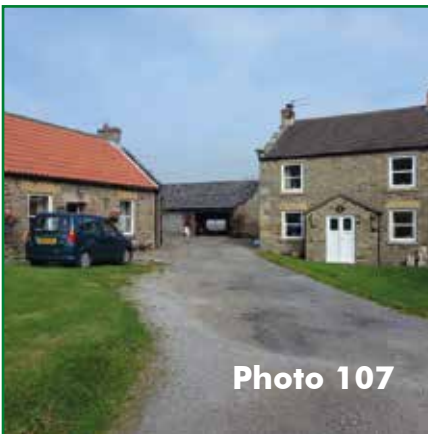
Photo 107

This area leads away from the Village Green on the approach road from the north (A66). It is a short stretch of road with houses dotted along both sides at various orientations. The majority are detached but there is one group of three. This area has a greater proportion of single storey properties (photo 107) than elsewhere in the village. To the rear of the properties on the west is a large range of agricultural buildings which are of no particular interest in conservation terms (photo 108 and 109).

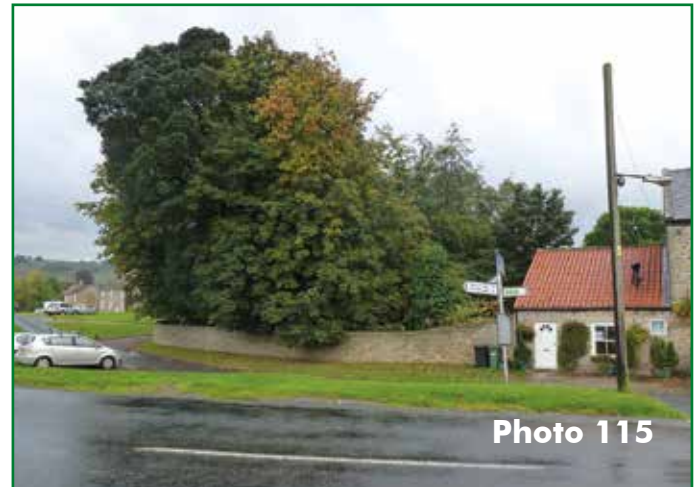
Photo 115

The fairly comprehensively built frontages around the Green mean that there is little other open space of interest. The one exception to this being the area of trees between the Bay Horse Inn and Park House which are protected by a Tree Preservation Order (photo 115).

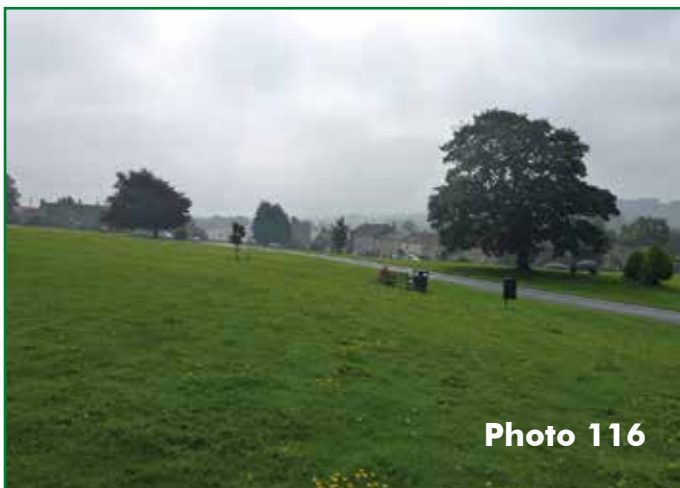
Photo 116

There is one particular mature tree near the cross base that forms a focal point within the Village Green (photo 116), but other more recently planted specimens (photo 117) should also be respected for their ability to contribute to the character of the Green in the future.
