RICHMOND HILL CONSERVATION AREA

CONSERVATION AREA APPRAISAL AND MANAGEMENT PLAN

Draft for consultation
September 2012

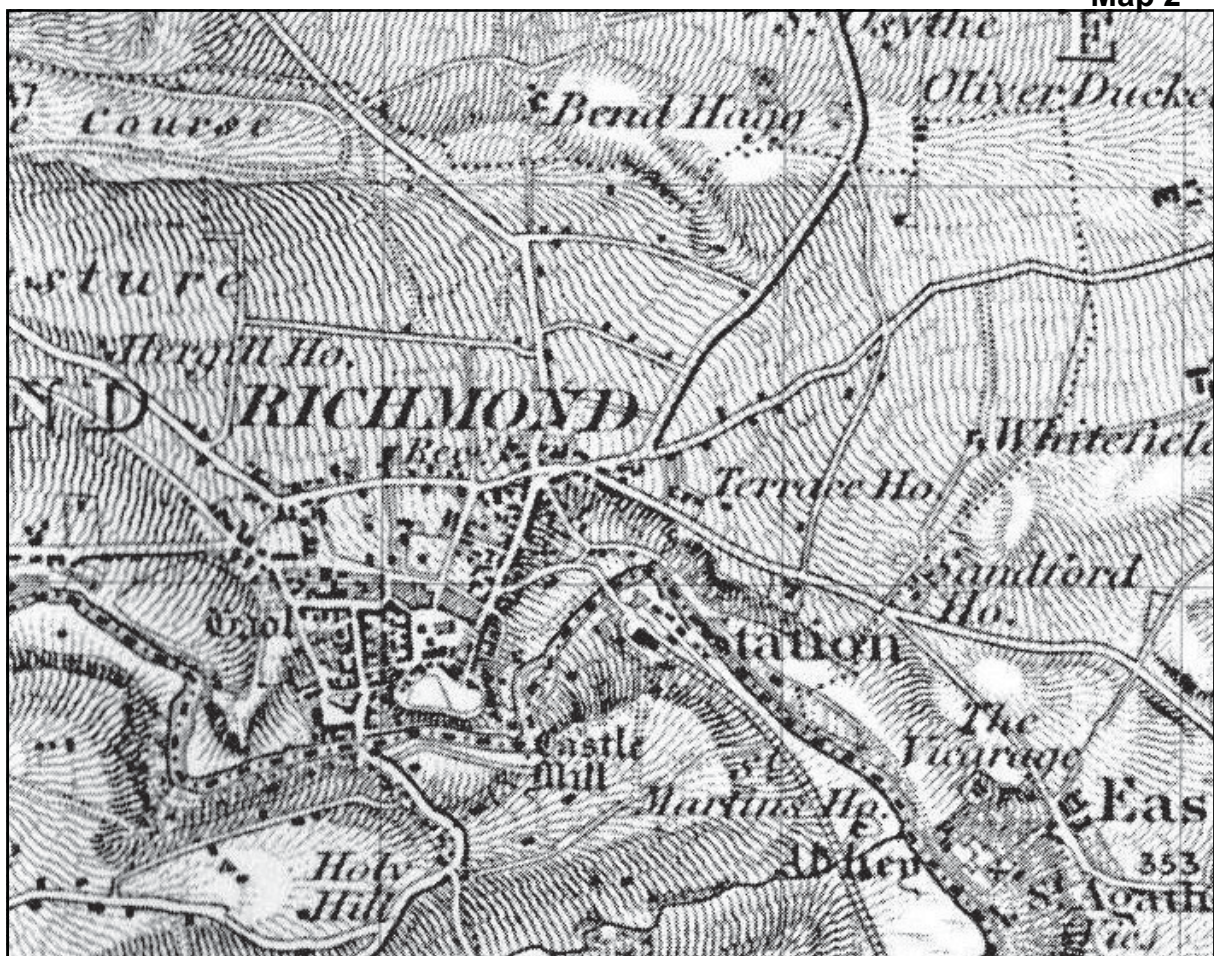
Map 2

The first edition of the Ordnance Survey maps dating from 1860 (**Map 2**) shows Gallowgate leaving the town from the junction with Pottergate and running northwards away from the town through an agricultural setting. Beyond a small cluster of houses around the junction little development is visible however the site of the Conservation Area is identifiable to the south of Cutpurse Lane. Buildings on the site in this mid Victorian period only appear to consist of two structures, one on Gallowgate and one on Cutpurse Lane. No evidence of these remains today and it is likely that they were demolished to build the barracks some 15 years later on a greenfield site.

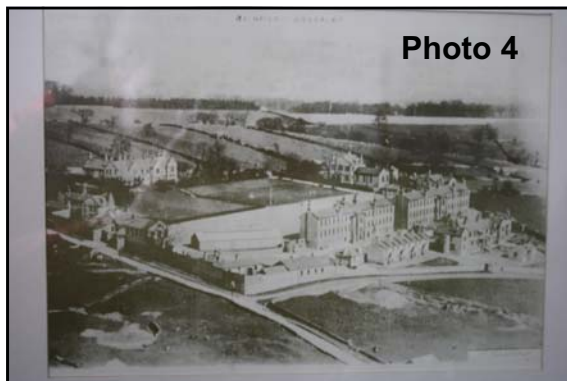
Photo 4

The military development of the site positioned substantial buildings around the central parade square oriented on a roughly north south axis. To the north of the parade ground the Officer's Quarters fronted onto the space and was set up in a raised position to the higher end of the site, whilst the southern side of the square was closed by the main barracks blocks. **(Photo 4)**

This was originally constructed as two separate blocks which were linked in 1939 with the construction of the central portion and later wings were added to both sides of the original buildings. The tall forbidding character of these buildings would have dominated the southern section of the parade ground and been the principle significant feature in the barracks. Ancillary buildings were added over the years including the gym in the south west corner of the site.

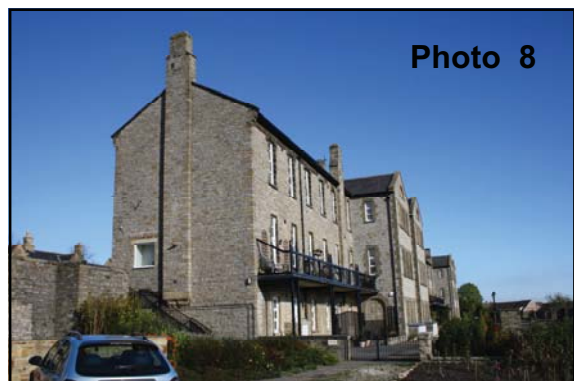
Internally the barracks block was originally constructed as two separate buildings, Hulse block and Howard block. These were simple massively constructed buildings of forbidding, almost industrial appearance (**Photo 8**) which remained separate buildings until the late 1930's when the national investment in the armed forces improved conditions for soldiers.

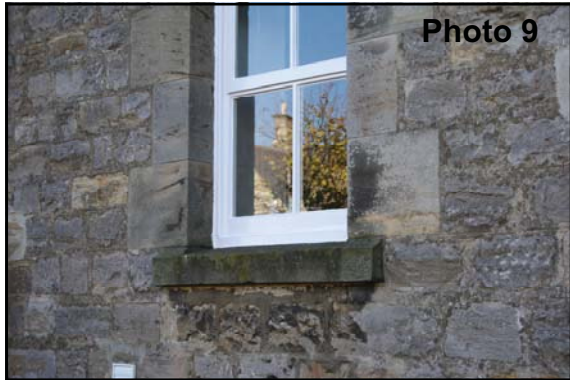
Photo 9

The detailing of the original blocks is simple and strong with well coursed stonework and simply detailed quoins in contrasting stone to window reveals. **(Photo 9)**

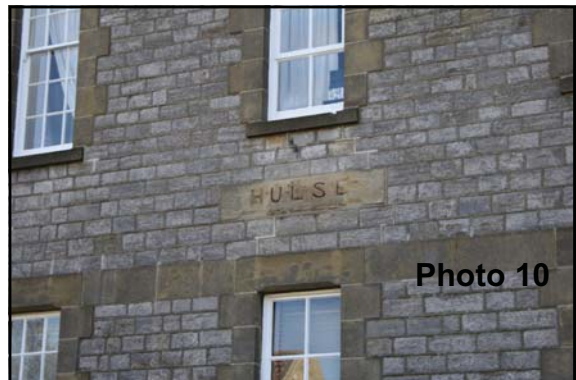
Photo 10

The only decoration is the block names to the north elevation of each of the original block. **(Photo 10)**

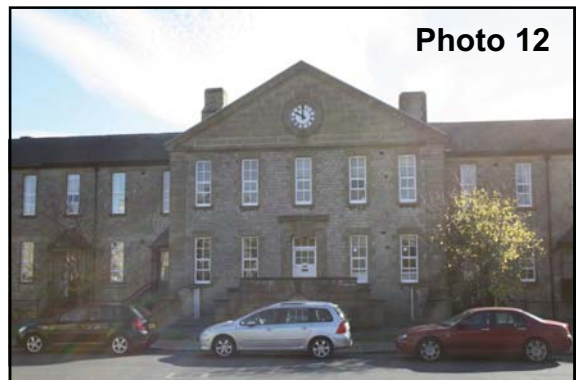
Photo 12

In 1939 the biggest change to this building took place with the filling of the space between the buildings with the imposing central structure **(Photo 12 and 13)** and the addition of two cross wings to each block **(Photo 14)**.

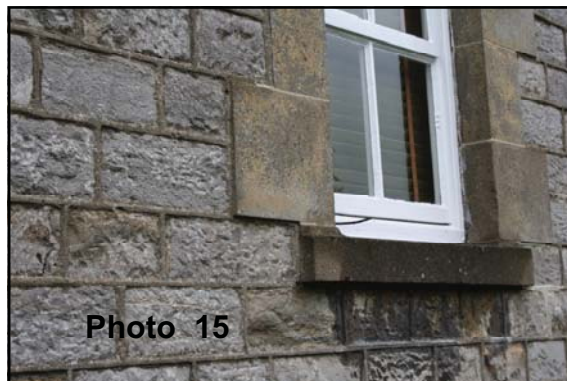
Photo 15

This created a palace fronted building with more sculptural form than the simple stark barracks. The detailing of the original buildings was continued through the new construction however instead of contrasting stonework a high quality compound concrete based block was used to create the quoins and details. **(Photo 15)**

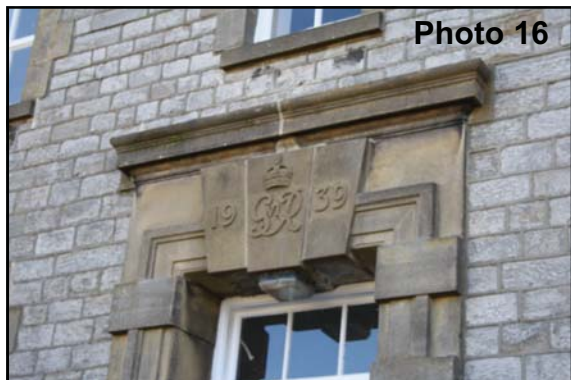
Photo 16

The more elaborate central door case **(Photo 16)** appears to be in carved stonework and is an illustration of the importance of the barracks at this time. In comparison to other military sites of the Second World War period the construction is of very good quality and well detailed. In other locations cheap brick and timber

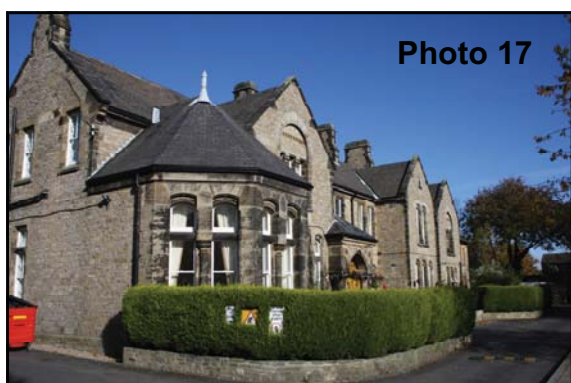
Photo 17

The Officers Quarters **(Photo 17)** is constructed more in the style of a large Victorian house and similar style buildings can be found around the edge of most towns and cities where industrial growth and trade created a wealthy merchant class of industrialists. It was designed for the site by Major H.C. Seddon, Royal Engineers

attached to the War Office and constructed between 1874 and 1877. The sides and rear of the building are not of particular note, being well detailed but functional and to the east end of the building having a later extension added in a much simpler style **(Photo 18)**. It is

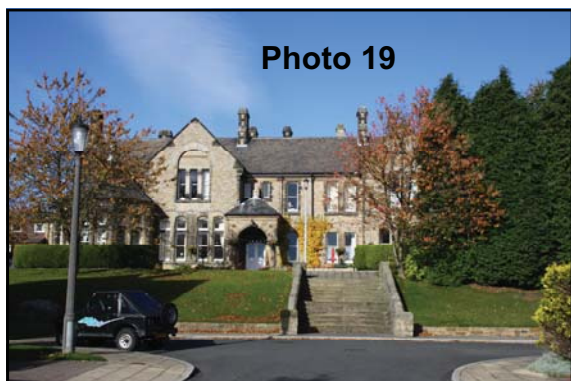
Photo 19

the south facing front elevation which is the design highlight of the exterior and this contributes significantly to the quality of the Conservation Area. **(Photo 19)**

Constructed of stone throughout and with a grey slate roof to a relatively steep pitch the asymmetric elevation is dominated by large features jostling for supremacy. Three gables break through the eaves line each with slightly differing arrangements of tall windows and blind arched features set in relief above the first floor. **(Photo 20)** A strong and massively constructed porch extends in front of the main building

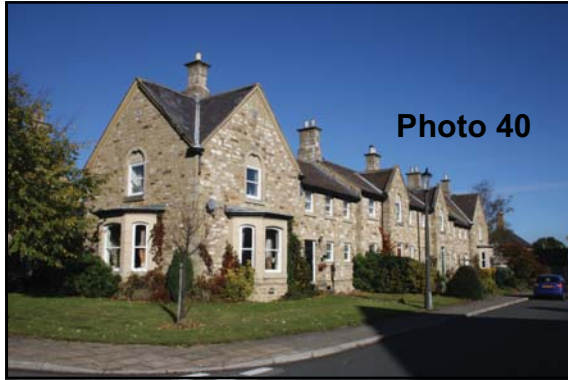
Photo 40

Larger buildings with feature gables to each external elevation define the corners of each block **(Photo 40)** whilst along Dresser Close the central unit is a prominent house stepping forward of the established line to create a well sculptured front to the elevation. The intervening houses are arranged with standard detailing to the windows and doors complimenting the prominent corner and centre blocks and it is critical that this uniformity of window and

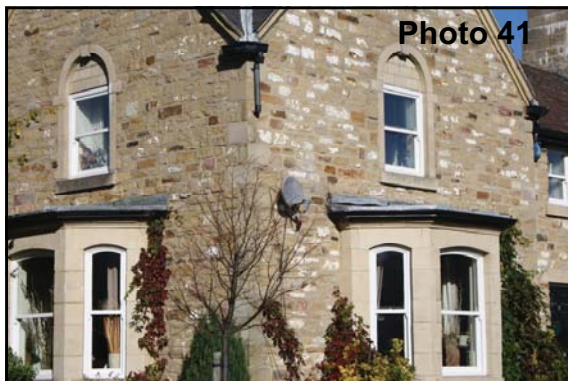
Photo 41

(Photo 41) Gables to each house define the entrances and break up the eaves line to provide a more interesting roofscape.

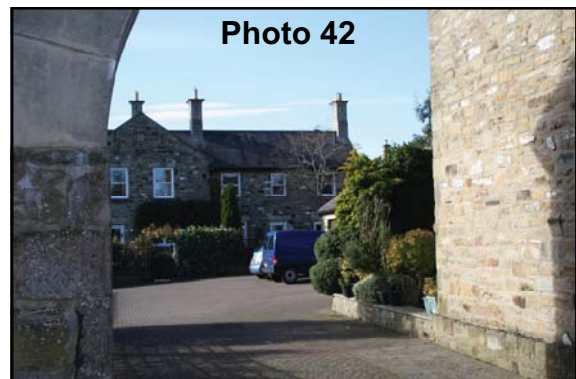
Photo 42

buildings and the fine proportions and intricate mouldings of historic stone and timberwork do not translate to modern building methods and styles. The provision of a rear service yard space is a major contribution to retaining the quality of the Conservation Area as it allows parking off street and without the creation of extensive garaging in visually important frontages. **(Photo 42)**

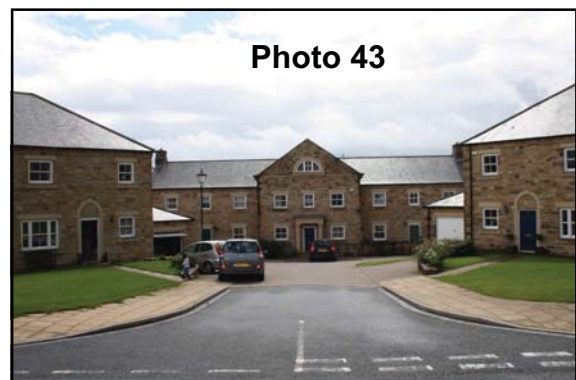
Photo 43

Other less strictly ordered housing is sited to the south of the barracks block and here the houses are more contemporary and conventional although the layout of the street has been engineered to reflect the symmetry and formality of the original military development. **(Photo 43)** This is a successful part of the Conservation Area combining as it does the historically important barracks and reflecting this with modern housing which respects the form and dominance of the main block but does not try to copy the detail or produce a shallow pastiche of the earlier buildings.

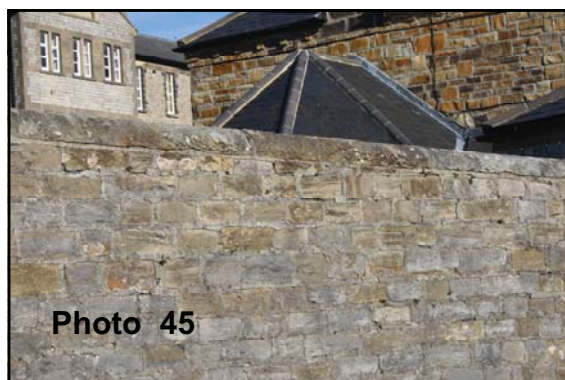
Although the dominant material throughout the site is natural stone there are a number of distinct variations in the style and form used for the individual buildings. The encircling wall is constructed of well coursed, roughly faced local sandstone with dense bedding planes and occasional inclusions of brown banding within the stone. **(Photo 45)**

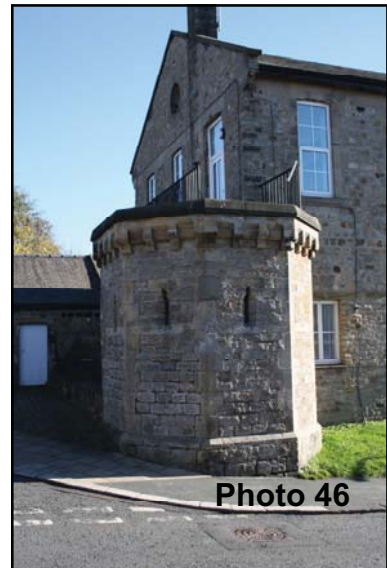
with good quality sawn stone details and a predominantly brown rough dressed sandstone to the masonry walls. This is laid in diminishing height courses and is banded through with

flush sawn string courses to visually heighten the building. **(Photo 47)** The quality and style of the stone decoration is typical of the late Victorian period and is found throughout many building types of this age, here giving an almost domestic feel to the focal building in the barracks. A later extension to the eastern end of the building has employed similar materials, however the less generous scale and proportions of the addition mark it out as later work. **(Photo 48)**

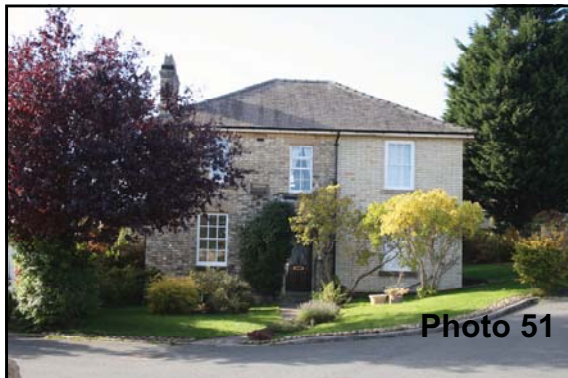
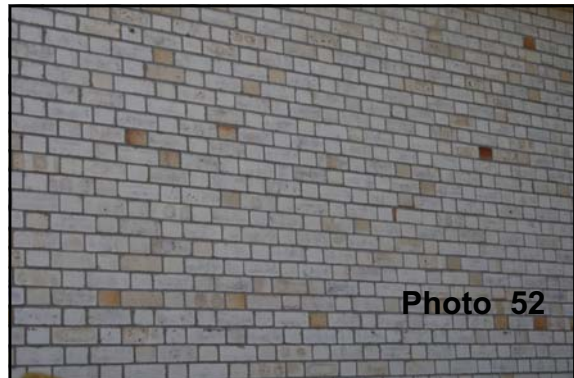
Only one building in the Conservation Area is built in brick and this uses pale cream stock bricks with occasional random darker headers. **(Photo 51)** Built in 1893 as a single house and subsequently extended in a similar style the pale colour brickwork is a very subtle addition to the predominant stonework of the site and does not detract from the uniformity of materials. **(Photo 52)**

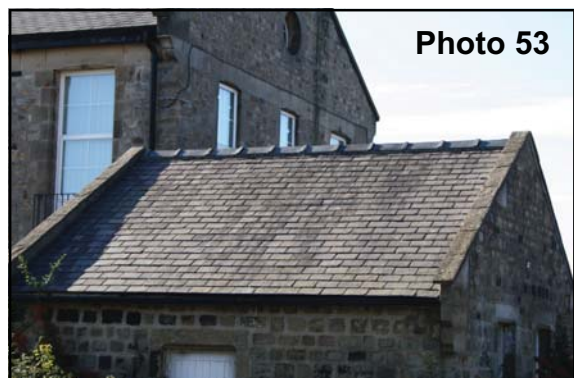
There is a strong uniformity throughout the site in the use of natural grey slate for the majority of roof coverings. **(Photo 53)** The historic buildings retain their regularly coursed natural grey slate which has weathered well and in some locations may have been re-laid to maintain its condition.

It is likely that this slate was sourced from North Wales as the more local roofing materials would be stone slates as used on more vernacular buildings or Westmoreland type green slates, both of which are laid in diminishing courses and produce a thicker and more textured roof covering. The repair and re-laying of the slates on these properties has generally been well undertaken and the results are appropriate to the buildings.

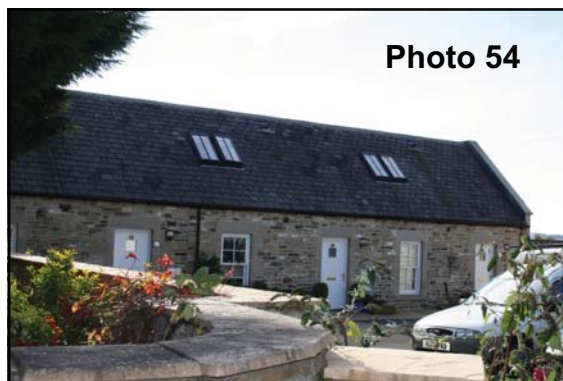
Photo 54

The later domestic buildings also use a grey slate for the roof covering although the precise source and form of these slates is unknown. **(Photo 54)** They retain a very dark colour at present and some appear to have a slight sheen, particularly in strong sunlight suggesting that manufactured slates have been used on some roofs. In time the colour will weather and the roofs will assimilate better with the older structures.

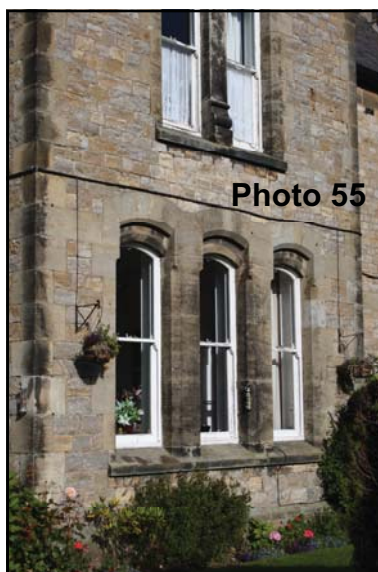
Photo 55

(**Photo 55**) and the main barracks block) (**Photo 56**). The majority of windows to the historic buildings would have been timber framed sliding sash windows and these have a distinctive and attractive appearance creating a deep reveal on a number of planes and a contrast between the colours of the stone, the white painted window frames and the usually dark glazing of the window. There are variations to the form of opening windows including casement windows and fixed panes however these usually are for a purpose and signify the use of rooms beyond or hierarchy of different elements of

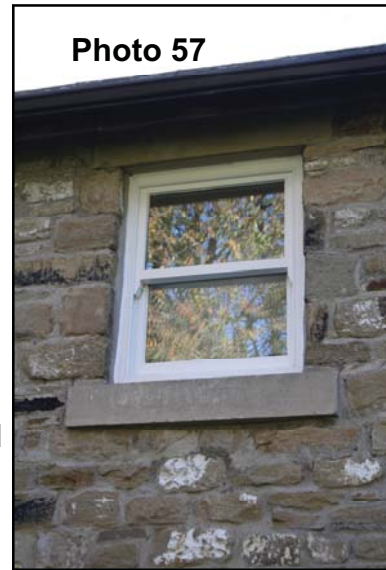
The late 20th century properties have differing designs to the windows with wider openings, particularly to the less tall first floor windows (**Photo 57**) and this change in proportions creates a different character to the building. Notwithstanding this the uniformity within the new developments and the hierarchy of window designs remains, although on a somewhat simplified level.

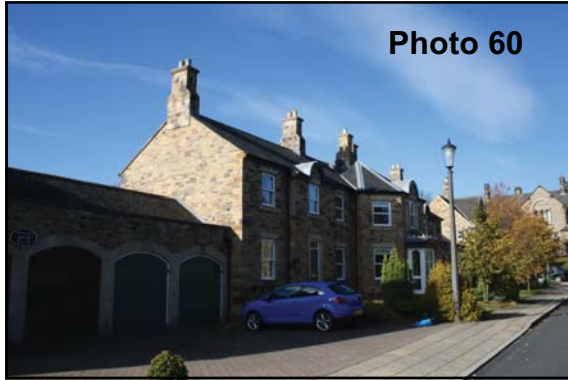
Photo 60

Most driveways have been constructed in modern sets (**Photo 60**) and the presence of shared ownership of surfaces has ensured a degree of uniformity appropriate to the development. Although there are some smaller areas of flag stones or contrasting surface finishes these are very minor in comparison to the prevailing formality of the estate roads which are considered entirely appropriate in the

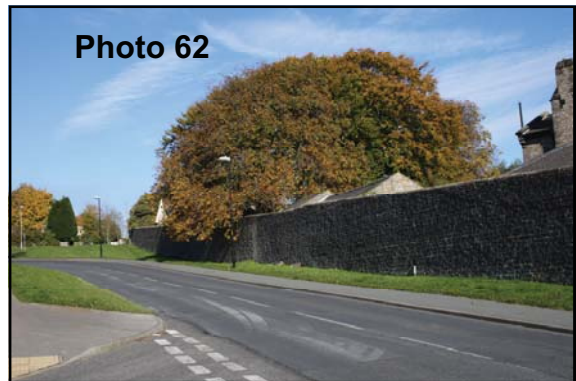
Photo 62

The principle enclosure is the defining boundary wall to the barracks which gives the Conservation Area its definition and expresses its important character to the surrounding town (**Photos 61, 62 and 63**). The design of this wall reflects picturesque antique military styling with symbolic features derived from medieval defensive structures and applied in a structured manner but at a much reduced and

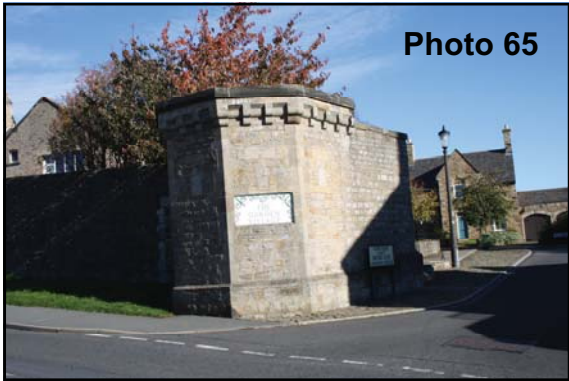
Photo 65

The arrow slit details (**Photo 64**), corbelled copings and entrance bastions (**Photo 65**) were not built to a defensive scale but rather to strongly suggest the military function of the buildings within the compound. The curtain wall features numerous blind openings at high level which have a decorative role whilst the encircling wall itself is breached by a number of former access doors for military use clearly designed as part of the building but now blocked, ironically to prevent access to the domestic properties (**Photo 66**).

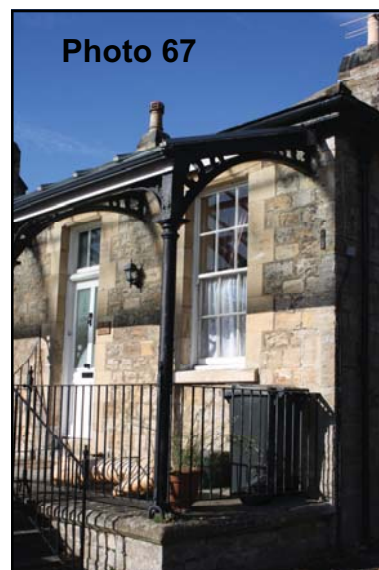
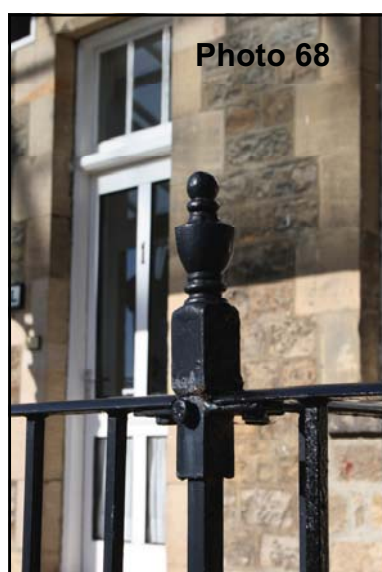
There are relatively few formal boundaries within the site with railings being restricted to protecting drops and changes in level. Examples of this are the front of Luttrell House where the short canopied terrace has a simple railing to separate it from the roadside (**Photo 67**), and the north front of the principle barracks block to protect the drop to the lower area. The railings are mostly modern replacements of earlier items and this can be discerned by the methods of fixing, the style and type of welding employed and the modern and sometimes clumsy sections of metal used to create inauthentic replicas.

Victorian railings would have been substantial but well proportioned items, fixed with hot rivets or bolts and any welding would have been forge welded by a blacksmith. The modern replicas employ standard rolled steel sections which are gas or electric welded into panels before being bolted to fixed stanchions. In some cases the decorative finials are insubstantial or out of scale to the rest of the railing and appear as add-ons rather than a part of the design of the railing itself. (**Photo 68**)

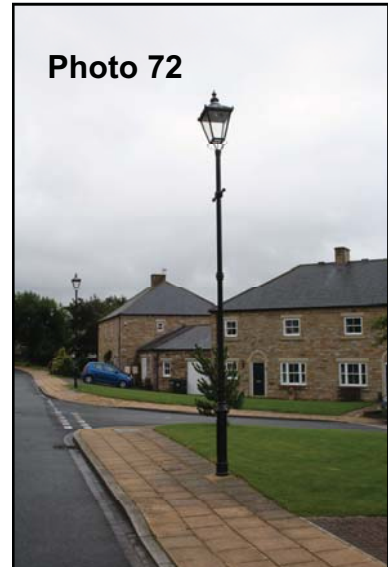
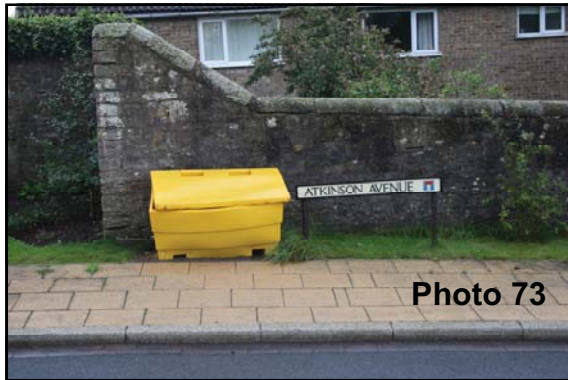
Street furniture is very limited within the Conservation Area possibly because there has not been an extended period over which incremental additions to the streetscape can be accumulated. Lamp posts are of two main types, a discrete and simple grey column with a cylindrical lamp (**Photo 71**) or a replica historic lamppost with a lantern top and painted black. (**Photo 72**) Fortunately these two styles of column are set in distinct areas of the site and therefore

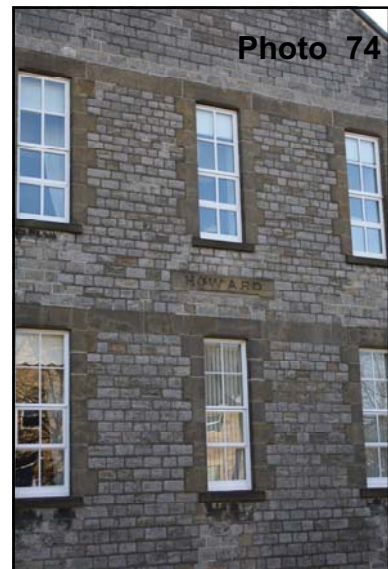
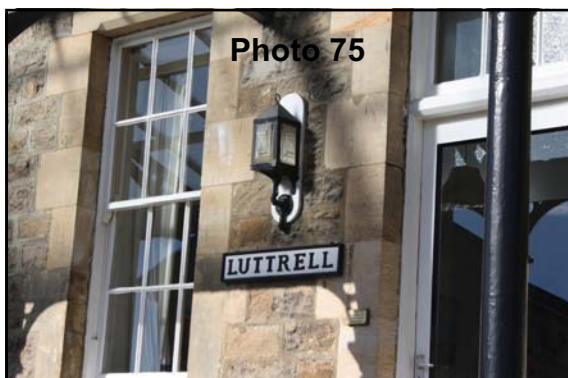
Road signage is limited in the barracks area and comprises mostly standard street names on simple black posts. (**Photo 73**) There are a number of other signs remaining from the period of army use of the buildings and these include barrack block names (**Photo 74**), a coat of arms above the principle entrance and occasional smaller plaques identifying individual properties (**Photo 75**). Of particular note are the identification points situated around the outer walls of the barracks noting the positions of turrets and corners to the defensive wall. (**Photo 76**)

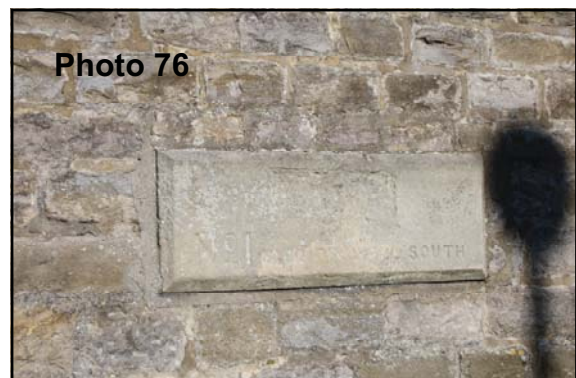
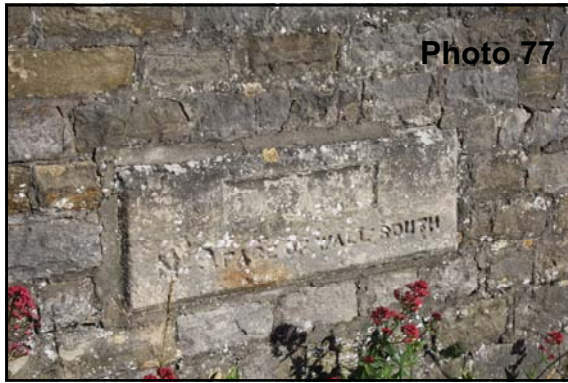
Photo 77

These are letter cut stones and in many cases have had descriptions deliberately erased (**Photo 77**) or have eroded significantly to the point that much of the lettering is illegible. A final important and prominent sign is that at the main entrance identifying the barracks as Richmond Garden Village, a clear indication that the revived buildings have found a new, viable use in the 21st Century. (**Photo 78**)

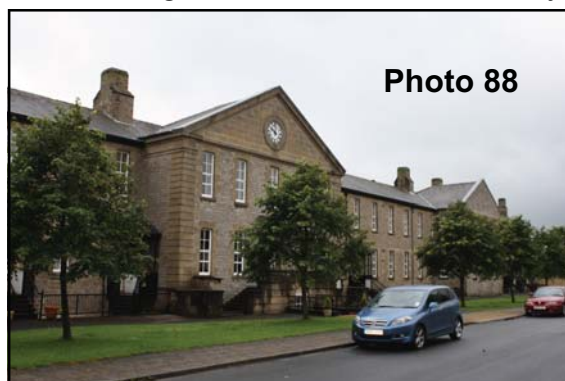
Photo 88

trees along the frontage of the houses on Lyons Road and the Silver birch which denotes the corner of the street. Perhaps the most important group of trees are the row of limes which are now well established to the northern front of the barracks building (**Photo 88**). These establish a formal layout to the space and soften the stark character of this large block when seen in views through the Conservation Area. It should also be noted that on the northern boundary of the site three large mature trees contribute to both the Conservation Area and the surrounding housing estate, these being the large Ash tree to the east of the nursing home, the Horse Chestnut at the north east corner of the Conservation Area (**Photo 89**) and the Beech tree to the rear of 10 Atkinson Avenue which is covered by a specific Tree Preservation Order.

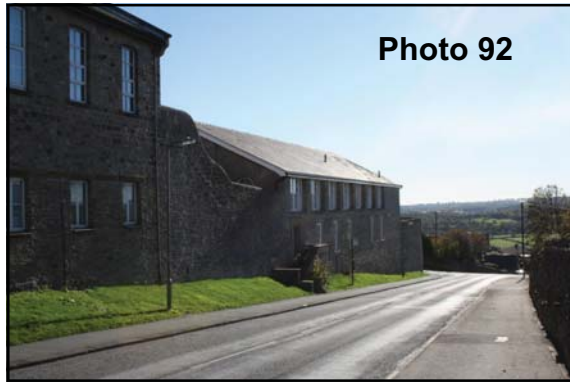
Photo 92

The southern section of the wall is broken by the gym building and the adjacent two storey block where the lower windows and domestic door openings somewhat detract from the defensive character of the Conservation Areas encircling wall. **(Photo 92)**. This elevation nevertheless provides an important introduction to the site and defines views through this part of the town, particularly looking south down Gallowgate from where the new developments at

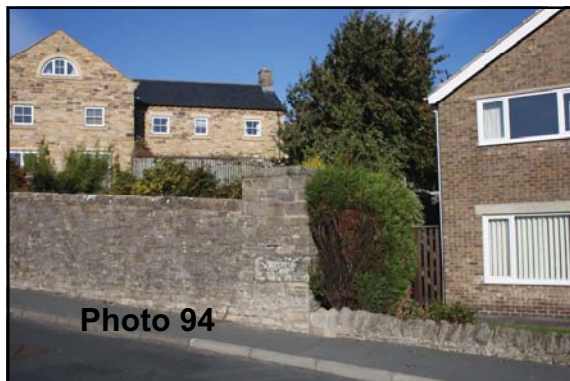
Photo 94

domestic setting lying to the south **(Photo 94)**. It is important to note here that the domestic buildings within the walled complex are constructed at a higher level than their neighbours immediately to the south and thus enjoy open views across the town from the back gardens, something

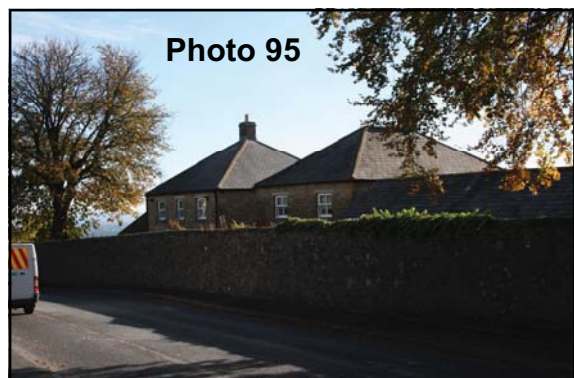
Photo 95

Along Cutpurse Lane the military quality of the encircling wall is much diminished and the wall appears as no more than a stout boundary to the estate **(Photo 95)**. It is important in this context as it turns Cutpurse Lane into a single sided street however the quality of the Conservation Area does not extend beyond the wall and the surrounding housing is of modest character. Similarly the eastern boundary all but disappears in to the general development surrounding the site. It provides a substantial boundary for the rear gardens of Pikepurse Lane and doubtless gives these private areas a distinct quality however this is not evident in the wider surroundings.

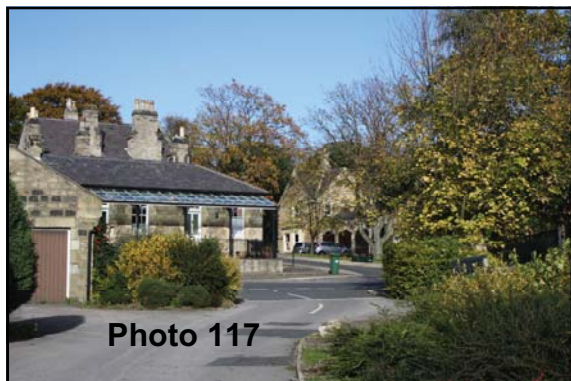
Photo 117

development which respects its older setting (**Photo 117**). The formality is useful in retaining something of the almost military sense of order to the Conservation

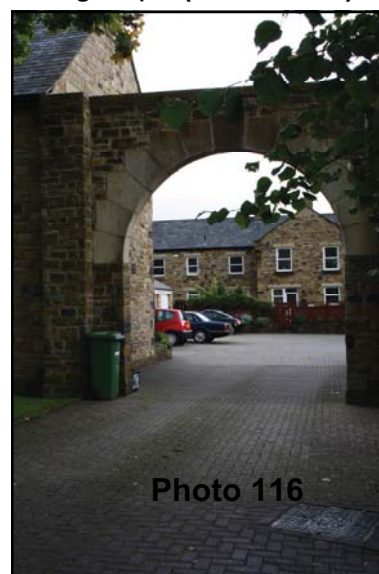
Photo 116

This part of the Conservation Area has an established formality lacking in other areas and benefits from wide open plan streets and well controlled car parking enclosed within garage courts to the internal yards of the modern house groups (**Photo 116**). Combined with the carefully considered and established planting which creates and frames linear views through the site the effect is of a well cared for and settled

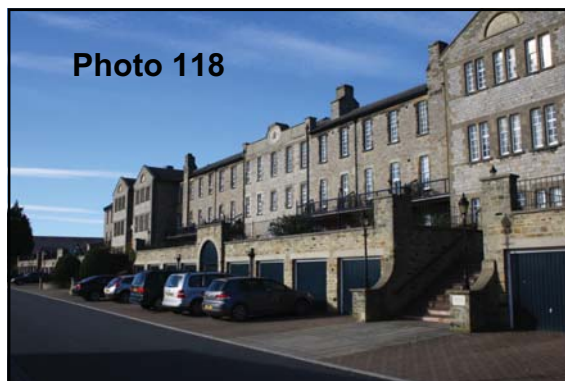
Photo 118

Once again a formally planned layout has been used to create a distinctive character to this part of the Conservation Area which is dominated by the massive construction of the south elevation to the main barracks block (**Photo 118**). The 1930's additions have given a relieved form to the solid mass of the earlier blocks and the terraced gardens extending over the garage block helps to provide a counterpoint to the tall building, moving the observer away from the foot of the block and reducing the apparent mass of the structure to a degree. With a full elevation exposed to the south this side of the building is an altogether lighter and less formidable character when compared to the north face of the block and this is reflected in the openness of this character area. The open character is further exaggerated by the fall of the land and the contrast in scale between the early military block and the modern domestic housing.

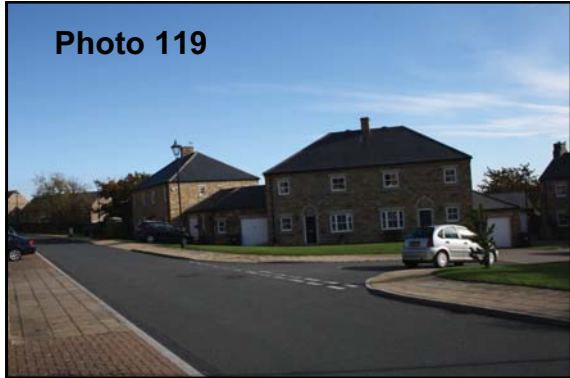
Photo 119

Although these are large houses (**Photo 119**) they are very much supporting elements to the historic buildings. The layout is formally arranged and focussed to create a view to the focal point of the main block and this continued formality is a theme which runs through much of the development of the site. Their style and form are consistent with other modern domestic buildings on the site and the use of matching materials continues the

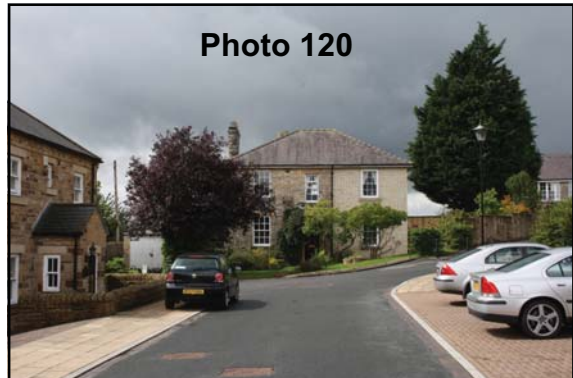
Photo 120

At the west end of the street the view is terminated by Hillside House (**Photo 120**) the only brick building within the Conservation Area. This property stands alone surrounded by a number of significant trees which add significantly to the character of the site the whole of which provides an attractive termination to the view along the open wide street. Behind this the substantial stone buildings of the former gymnasium, the rear of Rowan House (**Photo 121**) and the small range of houses which sit on the encircling walls have a more random and informal layout much of which is dominated by access roads, car parking, service areas and well designed bin stores (**Photo 122**).
