# SPENNITHORNE

## Conservation Area Appraisal and Management Plan

Adopted July 24, 2018

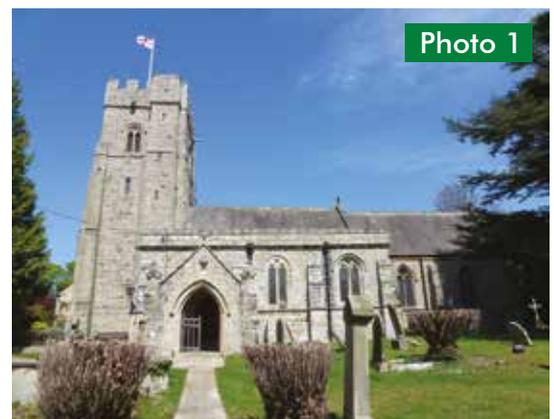
Photo 1

- The Church of St Michael (**photo 1**) has building work from the 12<sup>th</sup>, 13<sup>th</sup>, 14<sup>th</sup>, 15<sup>th</sup> and 17<sup>th</sup> Centuries. It is built of sandstone rubble with a Westmorland slate roof. It has a three stage 14<sup>th</sup> Century tower with stepped diagonal buttresses and a projecting south stair turret. The openings have trefoil heads and the embattled parapet is corbelled out on heads with gargoyles on which goblins hold the spouts. The main body of the church dates from the mid 12<sup>th</sup> Century through to 1620 in the north nave aisle. The detailing is an array of Gothic styles of the various periods including three trefoiled windows, plate tracery, perpendicular windows, barrel vaults, 'green men' and more. It houses a number of tombs, memorials and medieval paintings.

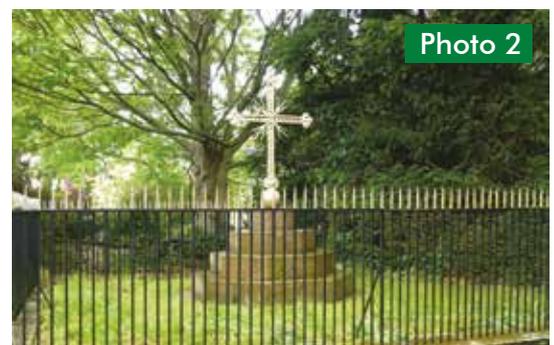
Photo 2

- The Sebastopol Cross (**photo 2**) and base is a memorial from the mid 19<sup>th</sup> Century and earlier. It is built from ashlar stone and wrought iron and consists of an octagonal stone base of five steps surmounted by the Sebastopol Cross. It is enclosed within a low rubble wall with ashlar copings supporting plain wrought iron railings. The cross was originally on the roof of the chapel of White Barracks in Sebastopol - it was taken during the Crimean war in 1854 and brought back to Spennithorne by General Sir Charles van Straubenzee of Spennithorne House. It is now mounted above the van Straubenzee family vault.

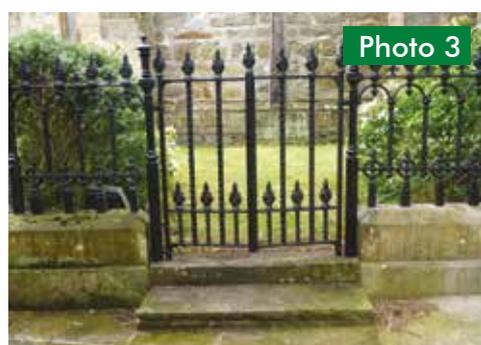
Photo 3

- The ornate cast iron railings and gates enclosing the Chaytor memorial (**photos 3 and 4**) and abutting the west tower of the Church of St Michael date from the 19<sup>th</sup> Century and form a five sided enclosure.

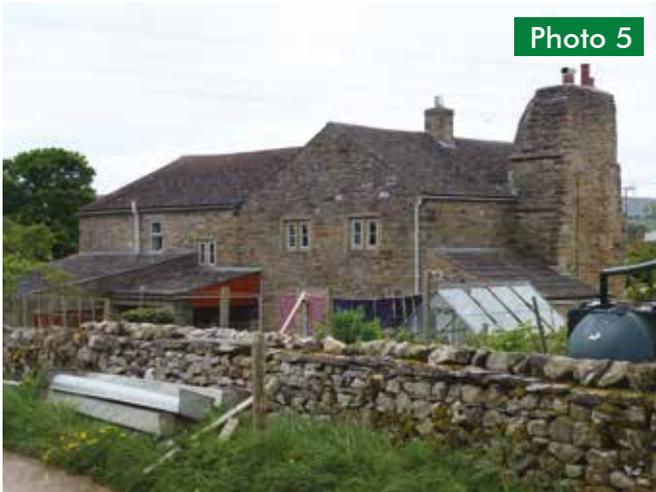
Photo 5

- Pippingill (**photo 5**) forms part of the medieval complex of Spennithorne Old Hall and is now a house. The current property substantially dates from the late 17<sup>th</sup> Century with later alterations. Built of rubble and with an artificial slate roof, it is two storey in an 'L' shaped plan. The south elevation has three first floor windows dating from the 20<sup>th</sup>. Century. The rear elevation contains three, two light single chamfered mullioned windows. The west side has a very large projecting chimney breast containing two fire windows.

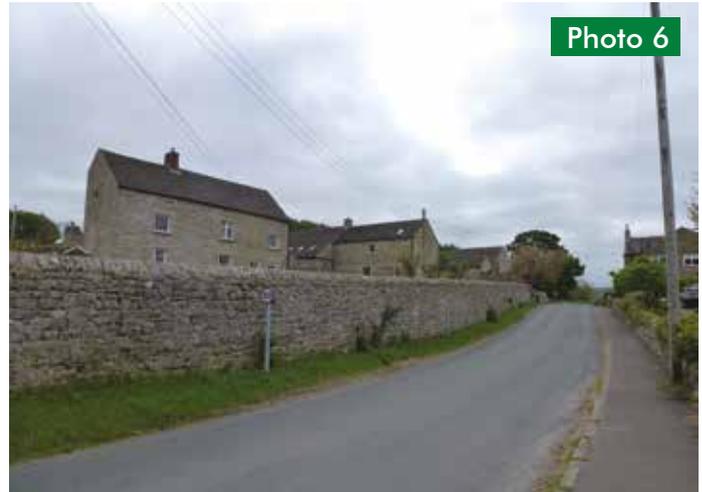
Photo 6

- Old Hall Farmhouse (**photo 6**) also forms part of the medieval complex forming Spennithorne Old Hall. It dates from the 16<sup>th</sup> Century or possibly earlier with extensive remodelling. The house is built of rubble, has an artificial tile roof and two ranges in a 'T' shaped plan. The main range is two and a half storeys with some quoins. The front elevation faces west and has three first floor openings with 20<sup>th</sup> Century windows. At loft level is a blocked chamfered mullion window and there is a two storey rear wing with outshot.

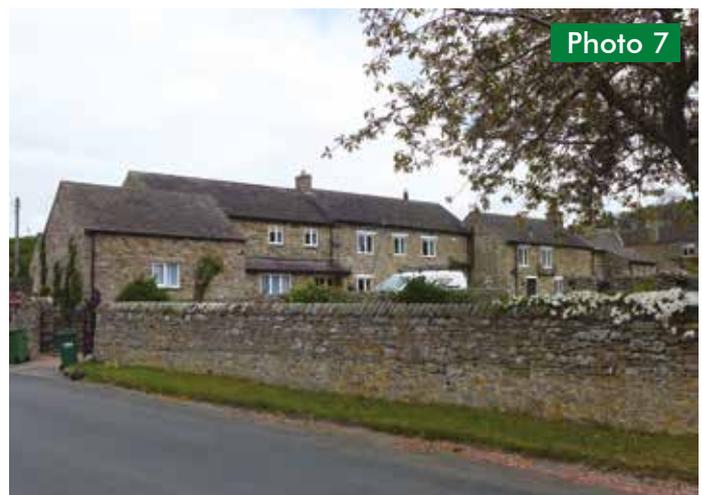
Photo 7

- Abbey Cottage (**photo 7**) is also part of the medieval complex of Spennithorne Old Hall. The house dates from the 14<sup>th</sup> Century, but with extensive remodelling. It is two storey built of rubble sandstone with an artificial slate roof and is in two ranges.

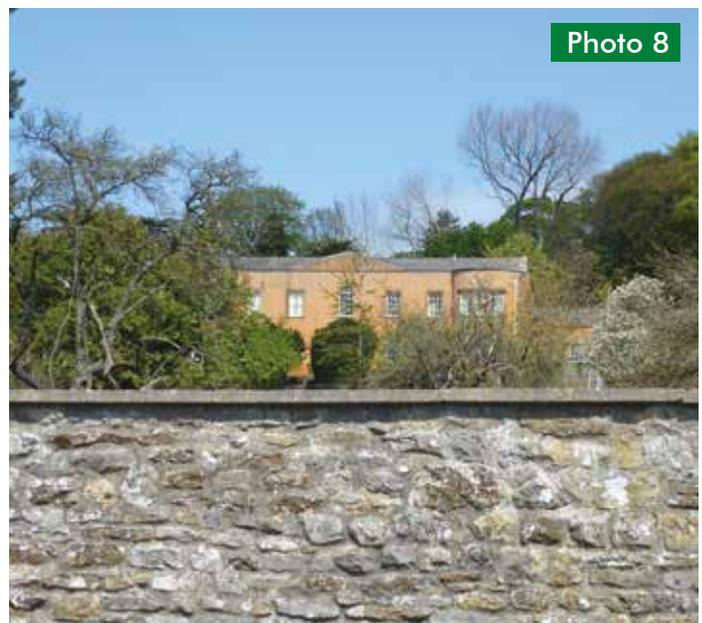
Photo 8

- Spennithorne Hall (**photo 8**) was built in the 18<sup>th</sup> Century possibly with 19<sup>th</sup> Century alterations for the Chaytor family. The house was built as two ranges at right angles - of roughcast rendered rubble and now has an artificial slate roof. The garden front faces south and may have been created by John Foss of Richmond. The house is two storeys and has proportioned 1:5:1 bays. There are rusticated quoins to the right with ashlar surrounds to openings. The central doorway is in a Roman Doric pedimented portico. Windows are sash with glazing bars and a particular feature are the end bays with semi-circular bows with tripartite sash windows separated by Roman Doric columns. The rainwater goods have embossed details. The rear range is of two and a half storeys with five bays facing west. A projecting chimney breast is to the north and in the angle between the two ranges there is a late 19<sup>th</sup> Century projecting porch with two ashlar Doric columns.

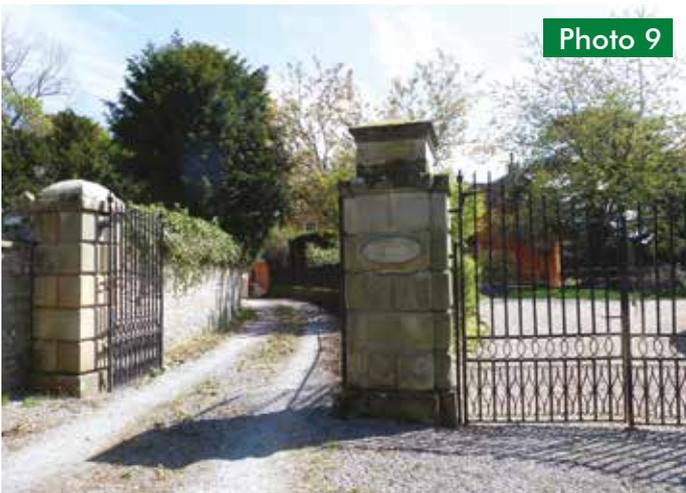
Photo 9

- The railings, gates gate piers and boundary wall (**photo 9**) accessing Spennithorne Hall to the south of the church date from the early 19<sup>th</sup> Century - with the railings and gates of decorative wrought iron and the piers of ashlar stone. There are three pairs of gates and four gate piers with a low rubble wall that has ashlar saddleback copings separating the back from the front drives. This includes the rubble walls to the south of the churchyard and the south of the gardens.

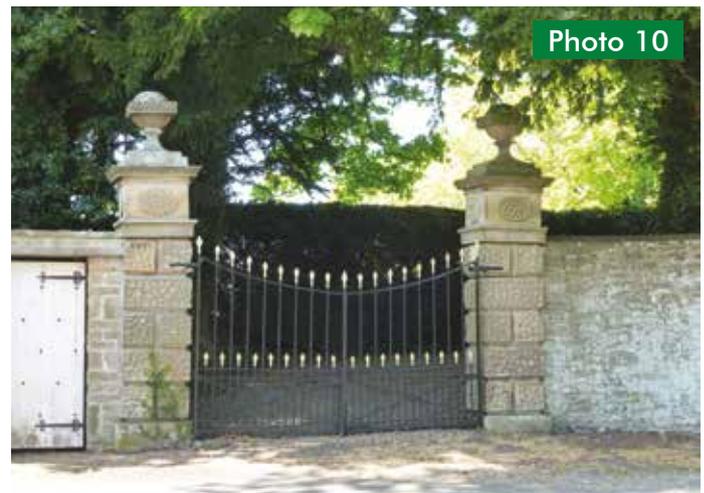
Photo 10

- The gates and gate piers to Spennithorne House (**photo 10**) are situated opposite the church and date from the 19<sup>th</sup> Century. These accessed the late 18<sup>th</sup> Century house which burnt down and was replaced with the current property. The gates are decorative wrought iron and the two gate piers are of ashlar stone with vermiculated rustification, topped by entablature with vermiculated ovals on frieze surmounted by pedestals carrying ball finials with vermiculated box.

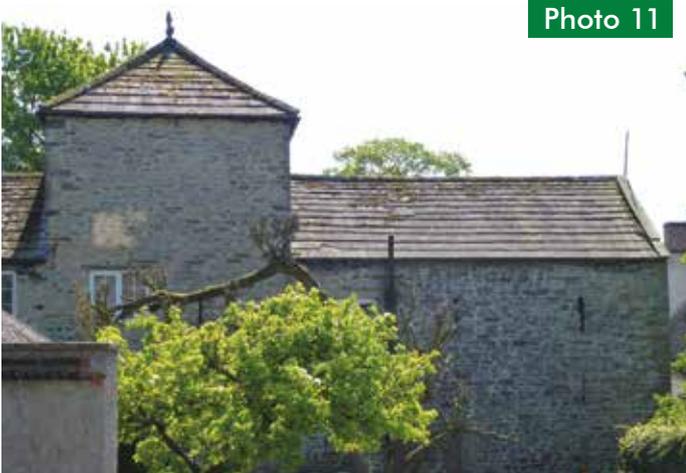
Photo 11

- The coach house to Spennithorne House (**photo 11**) dates from the early 19<sup>th</sup> Century and is composed of rubble with a stone slate roof. The building is both two and three storeys. The left side has a tall carriage opening with round arch of ashlar voussoirs. There are vents above to the hayloft. The right hand side has a door to a stable with a nine pane window. Above this is a vent and window - and above that a circular dovecote opening with keyed ashlar surround. This section has a hipped roof with a finial on the apex.

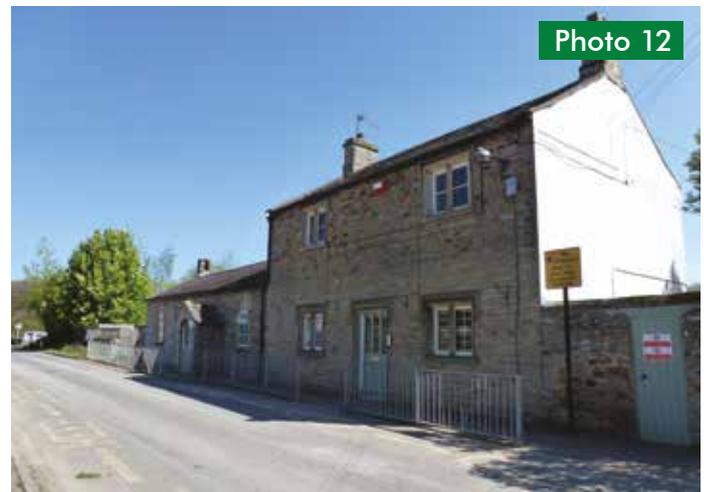
Photo 12

- The School (**photo 12**) dated 1833 is single story built of coursed rubble with a modern artificial slate roof. Originally of two bays it now has a third added to the left. There are sandstone ashlar surrounds to openings which have pointed arches and small keystones and impost. Between the two original bays is a projecting gabled porch. To the left gable are copings and it is surmounted with a small bell cote.

- The School House (**photo 12**) was built early to mid 19<sup>th</sup> Century of coursed rubble with a stone slate roof with stone copings and end chimney stacks. The house is two storey and in two bays with a central door. Openings have hollow-chamfered moulded surrounds and hoodmoulds with urn stops. The windows have a central stone mullion.

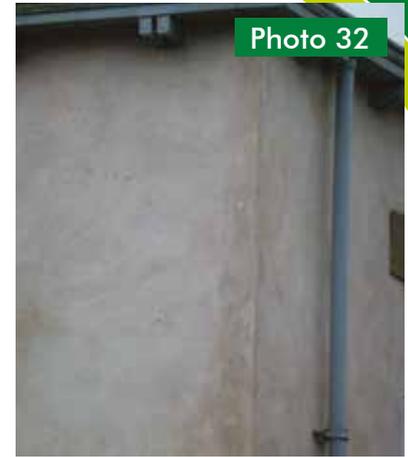
Photo 32

Render comes in a number of forms - traditional smooth (**photo 32**), rough cast render (**photo 33**), modern cement render (**photo 34**) and pebble dash.

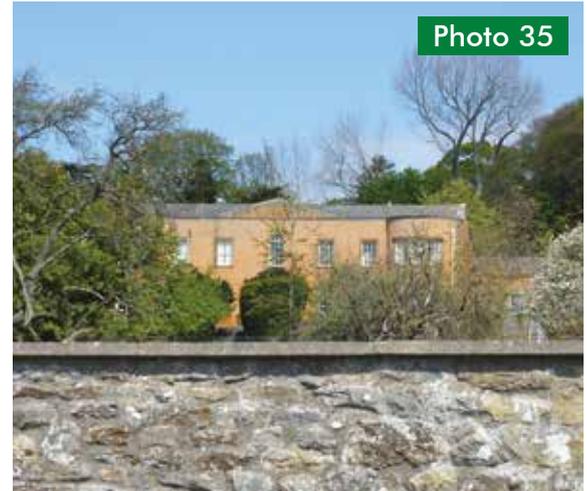
Photo 35

Around 25% of properties in Spennithorne are rendered and this includes a number of the large houses (**photo 35**). It is likely that this number may have been higher at one point but the fashion for stone facades in recent decades has encouraged some owners to remove the traditional render and expose the stonework underneath. Often such stonework was never intended to be seen and can be poor quality. The rendered buildings contribute significantly to the character of Spennithorne and are dispersed throughout the village. Render is the only material used for the houses at Sycamore Close.

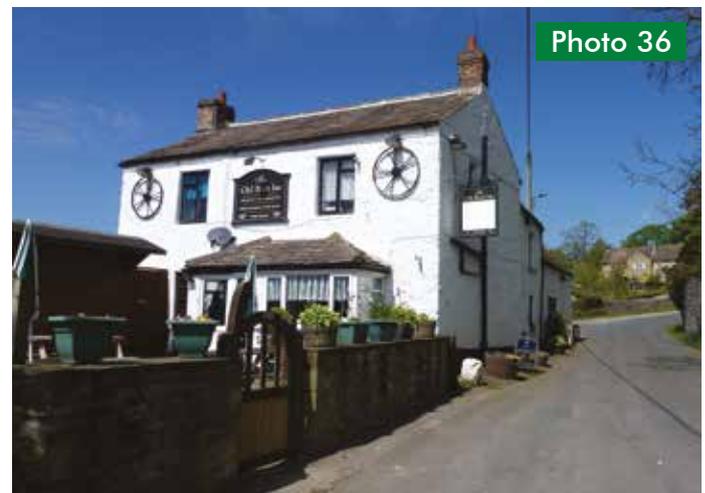
Photo 36

Lime wash (**photo 36**) was a traditional way to weatherproof the poorer quality stone and would have appeared as a colour finish to a property. The Old Horn Inn is the only property in Spennithorne that appears to have been treated this way.

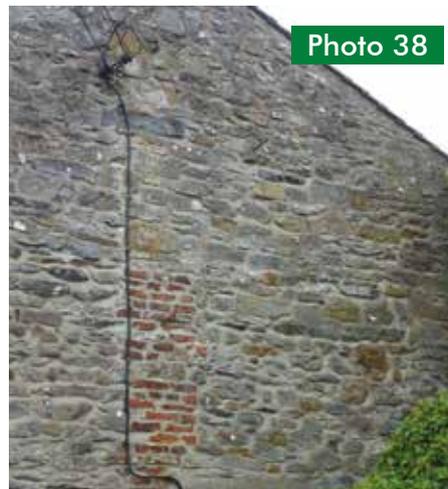
Photo 38

There is only one substantial brick structure in Spennithorne - the building adjacent to Beckside (**photo 37**) that was originally a chapel. Elsewhere brick is rare and appears in small areas such as chimney stacks (**photo 38**), rear elevations and outbuildings (**photo 39**).

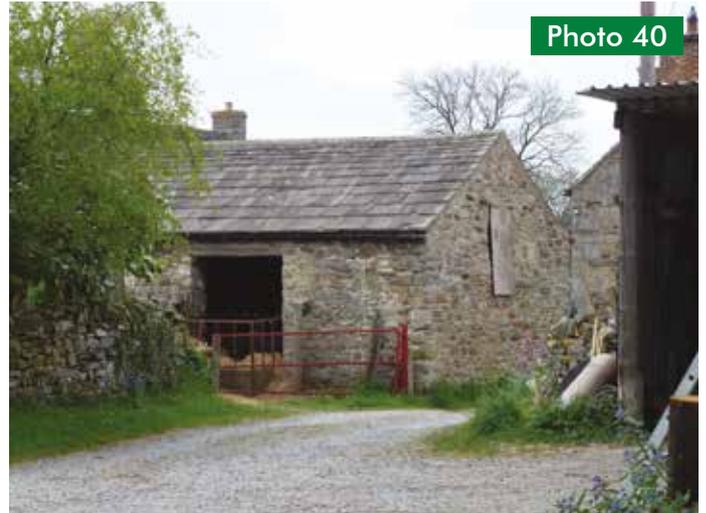
Photo 40

Stone slate (**photo 40**) has historically been used for domestic roofing within Spennithorne with the stone slates locally sourced. The sandstone slates are thick in comparison to other roofing materials and are laid in diminishing courses, narrowing from large slates at the eaves to small slates at the ridge and often finished with a dressed stone ridge piece. This produces a distinctive character to the roof very different from other natural slates, as the covering is notably thicker and the roof has a textured finish arising from the thick slate edges. Although when first quarried the sandstone slates are a pale grey/buff colour they weather in time to a deeper grey/brown colour slightly darker than walling stone. Around 21% of the properties at Spennithorne are roofed with stone.

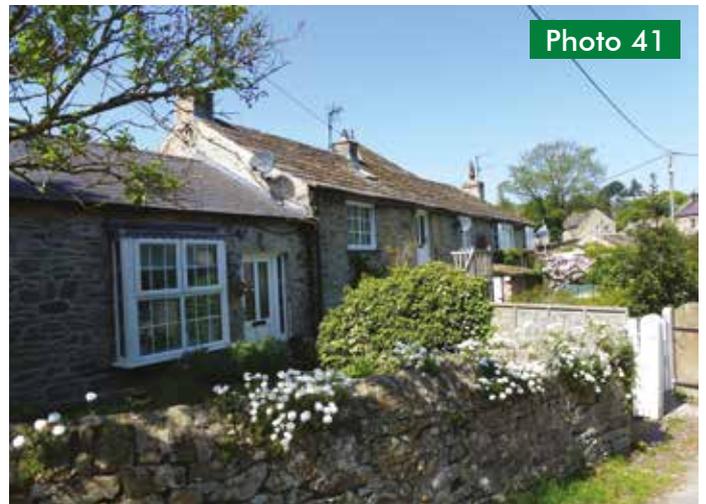
Photo 41

Welsh blue/grey slates (**photo 41**) are found on around 27% of properties in the village. The earliest use of slate dates from the latter half of the 19<sup>th</sup> Century when transport systems, particularly the railways, were sufficiently developed to allow slate to be imported to the area.

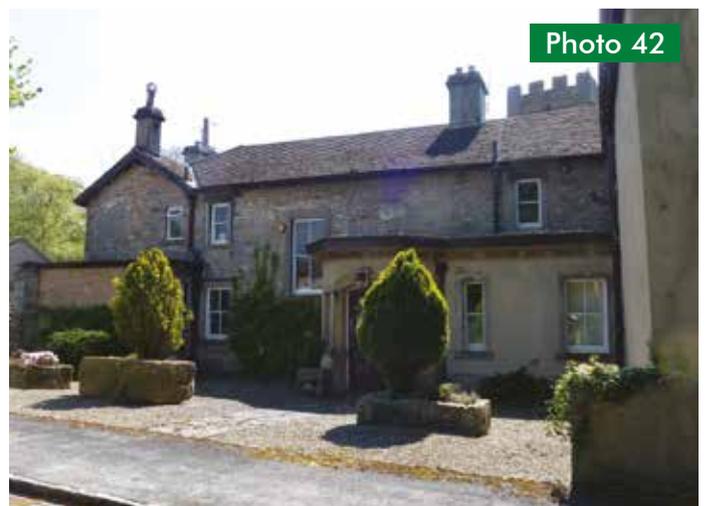
Photo 42

More recently traditional stone slates have been replaced with more readily available, cheaper alternatives - mostly flat concrete tiles (**photo 42**). Concrete tiles now make up around 35% of the roofs on village properties - they have been used through the later part of the 20<sup>th</sup> Century to replace older traditional stone slate roof coverings. Concrete tiles come in a number of forms - flat (found on around 30% of properties) and profiled (featuring on only 3% of properties). Profiled tiles only occur occasionally but look out of place. Flat concrete tiles are not ideal for traditional buildings due to the characteristics of the material itself and the regular mechanical appearance of the finished roof which differs from the traditional slates - but the flat tiles have usually mellowed with weathering to blend into the street scene. The profiled concrete tiles, often used to mimic pantiles, are so visually different they should not be used. Ideally these should be replaced with more traditional alternatives as they reach the end of their life.

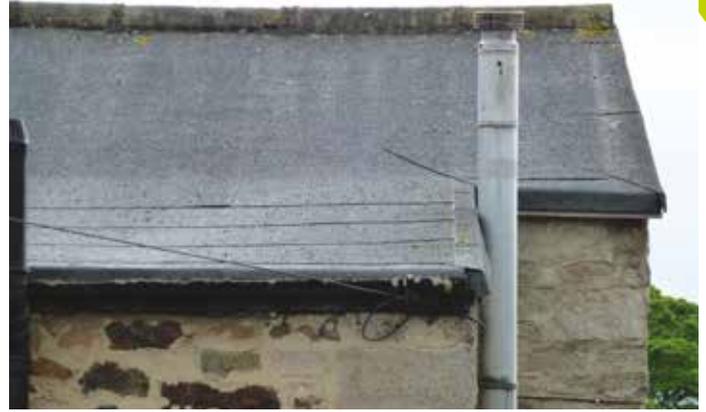
Photo 44

There are a few instances of other modern roofing materials - bituminous felt (**photo 43**), asbestos tiles and corrugated asbestos (**photo 44**), and corrugated iron (**photo 45**) all of which are out of keeping with the character of the Conservation Area and the local vernacular architecture. Ideally over time these should be replaced with traditional materials.

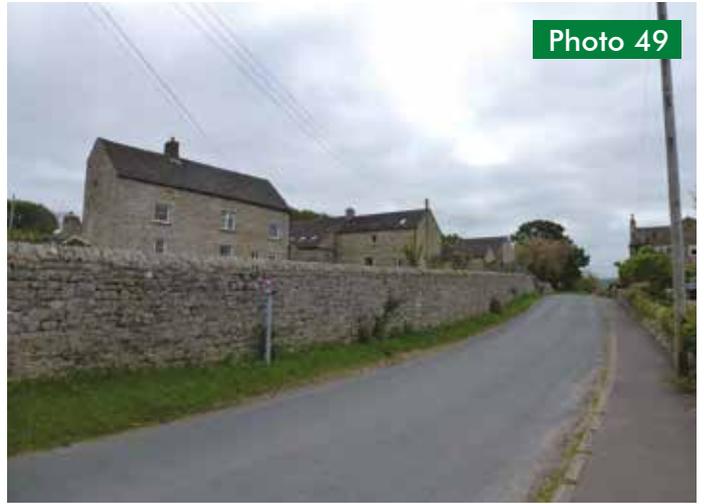
Photo 49

The main road through the village is black top macadam with any pedestrian areas similarly surfaced (**photo 46**), although some appear to have a surface treatment on part of the footpath to try and reduce this expanse (**photo 47**). The stone boundary walling is at the back of most of the highway areas so there is little space for other flooring materials. A narrow grass verge does run down parts of the west side of the street (**photo 48**) and in the initial approaches to the core area (**photos 45 above and 49**). At the church access there is a small area of stone paving (**photo 50**).

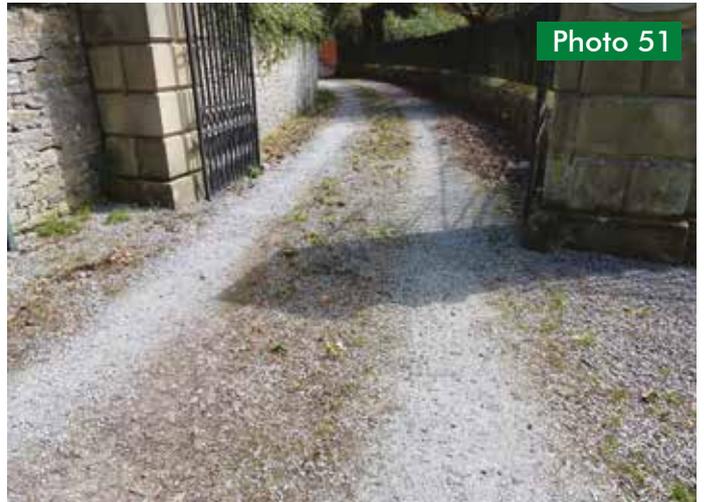
Photo 51

It appears that private access drives originally used crushed stone/gravel (**photos 51 and 52**). More modern solutions have included concrete block paviors (**photo 53**) which look out of place.

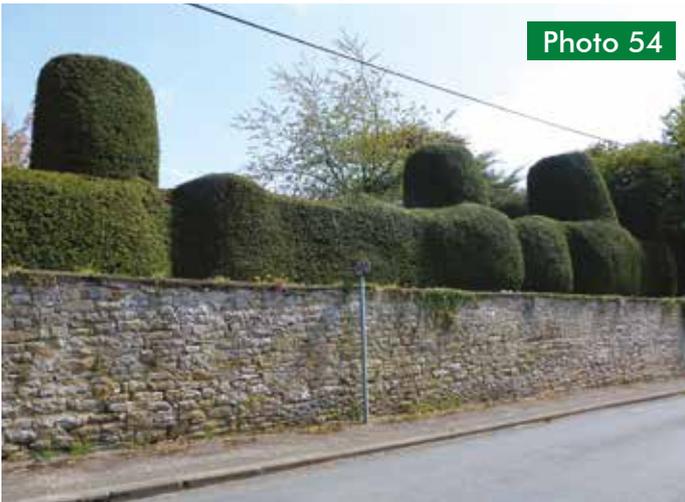
Photo 54

The main type of boundary treatment used throughout Spennithorne is stone walling, supplemented with hedges/planting of various types (**photo 54**).

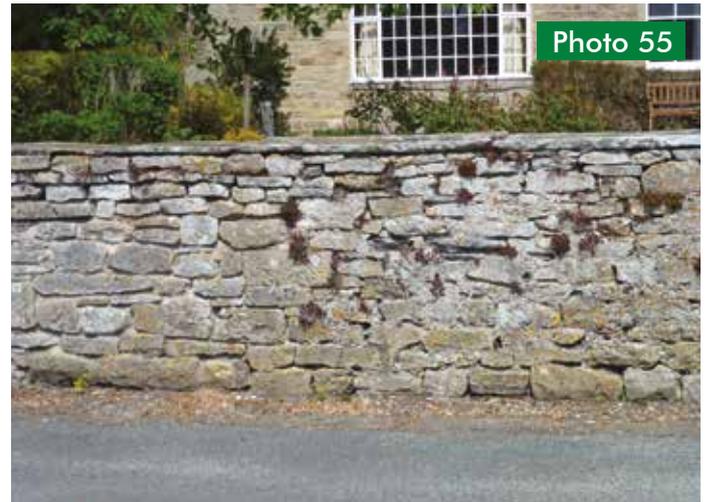
Photo 55

The stone walling is mostly coursed rubble stone (**photo 55**) with ashlar stone being used only as gate piers - generally for the larger properties (**photo 56**). Many of the gate piers have such exceptional architectural qualities that they have been 'listed' in their own right (**photo 57**), but many others also remain of interest (**photo 58**). The height of the walling varies, with tall walls running along the highways adjoining the larger houses (**photos 59 and 60**), and lower walls around the smaller properties (**photo 61**). The variety in form of copings is worth noting with pyramidal dressed stone (**photo 62**), curved dressed stone and stone flags (**photo 55**) all featuring. Occasionally the stone walling is accompanied with railings - which can be found throughout the Conservation Area. Access through the walls is by gates in a myriad of designs - in either timber (**photo 63**) or iron (**photo 64**), but none of which have any particular quality.

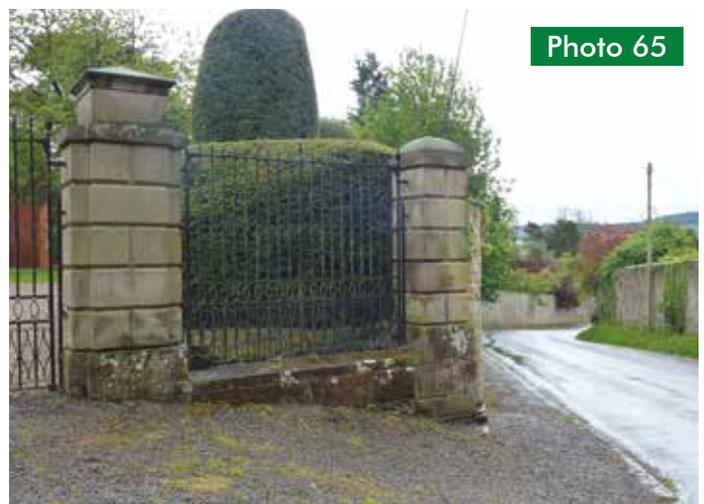
Photo 65

There are a number of important ironwork features dispersed through the village - most of which are 'listed' including the gates at the access to Spennithorne Hall (photo 65) and the railings to the Chaytor Memorial (photos 66 and 67).

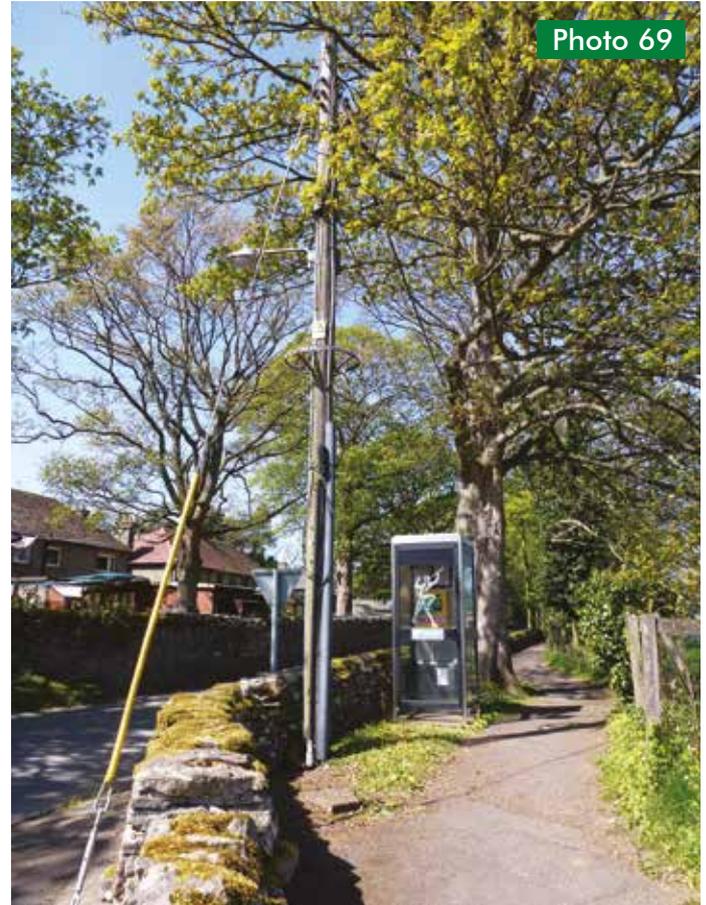
Monuments within the village are all found within the churchyard (**photo 68**). Similarly there is little street furniture - and what there is, is of poor quality. The telephone box (**photo 69**) near the school is a modern structure of no quality and the lighting shares the poles (**photo 70**) with the various wires being particularly unsightly.

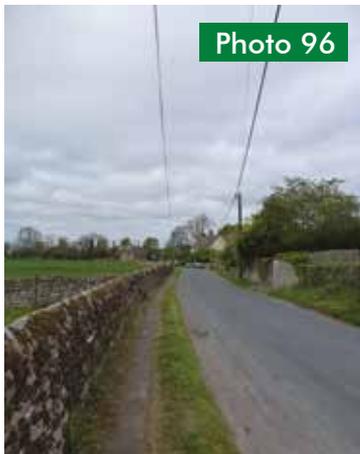
Photo 96

This is a loosely grouped set of six buildings (**photo 96**) at the base of the steeper slope as it rises north into the main part of the village (**photo 97**). The buildings are all detached and set within varying amounts of private grounds. None are listed. Four of the properties appear to date from around the 19<sup>th</sup> Century. They all have details relevant to the period of construction and are built of local materials (**photos 98 and 99**) - although Orchard Cottage has been extensively altered with artificial roofing materials, hard cement render and the addition of a front porch (**photo 100**). The two properties adjacent to the Old Horn Inn appear to be of late 20<sup>th</sup> Century, although one seems to have been developed from a smaller single storey building, Both tend to compromise the setting of the older Inn which must have originally commanded an 'entrance' position at the base of the hill.

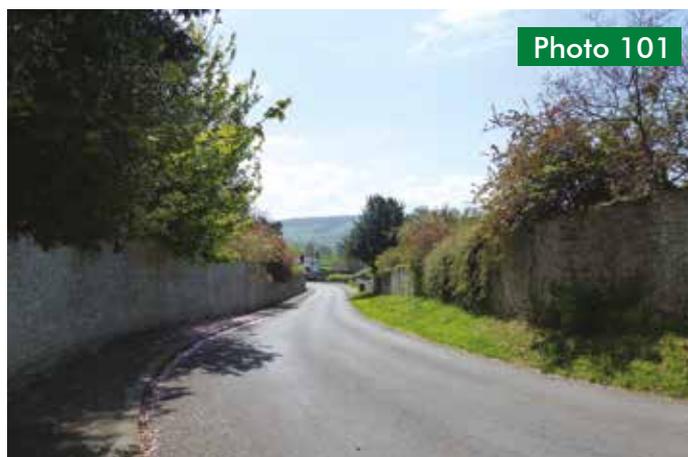
Photo 101

The stone walling between these properties, part of which is the formal boundary wall for Spennithorne Hall (**photo 101**), acts to tie the buildings together and link them back to the settlement so that they are not isolated from the main core of the village.

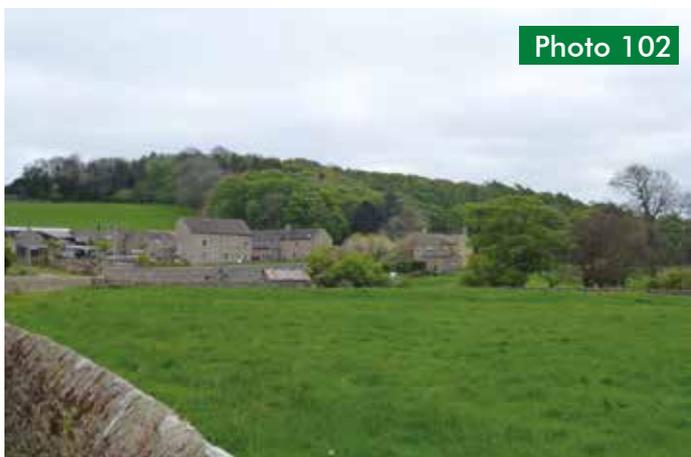
Photo 102

This group of properties is the oldest in the settlement (**photo 102**), being part of the medieval complex of Spennithorne Old Hall. They are the most southern buildings on the access road to the river crossing at Cover Bridge. There are four main properties. Jubilee Cottage (**photo 103**) to the west side of the road appears to date from the 19<sup>th</sup> Century - far later than the origins of the properties on the east side of the road. The latter appear randomly positioned (**photo 104**) and have been the subject of piecemeal alterations and extensions over the centuries with little of their medieval details immediately evident - although closer inspection does reveal more historic fabric (**photo 105**).

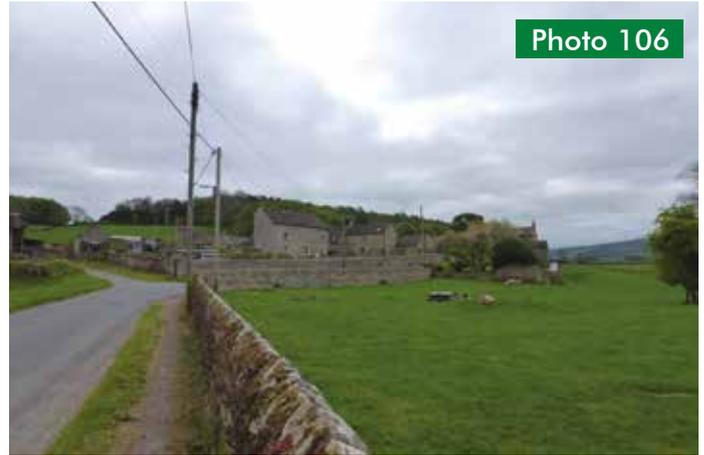
Photo 106

These buildings are separate from the rest of the settlement. A stone boundary wall links to the group (**photo 106**) but the informality of the wall blends with the surrounding countryside ambience and gives the group the feeling of standing apart from the rest of the village.

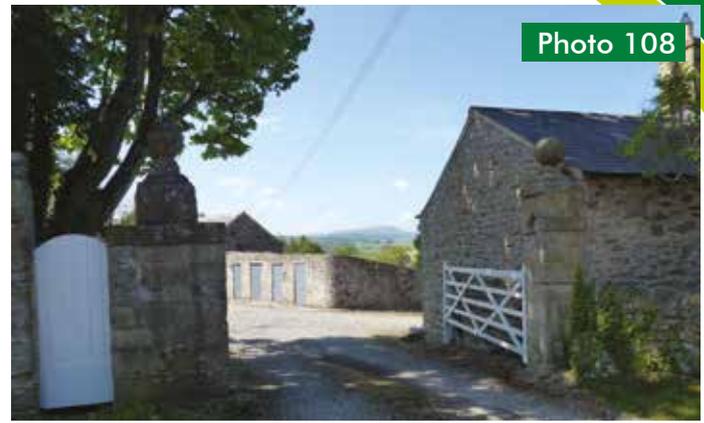
Photo 108

- Gate piers at Spennithorne House (**photo 108**)
- Gate piers at Glebe House (**photo 109**)
- Wall and entrance at Spennithorne House (**photo 110**)
- Gates and piers at Spennithorne House (**photos 112 and 111**)
- Gates and piers at Spennithorne Hall (**photos 113 and 114**)
- Gates and walls at St Michael's Church (**photos 115, 116 and 117**).

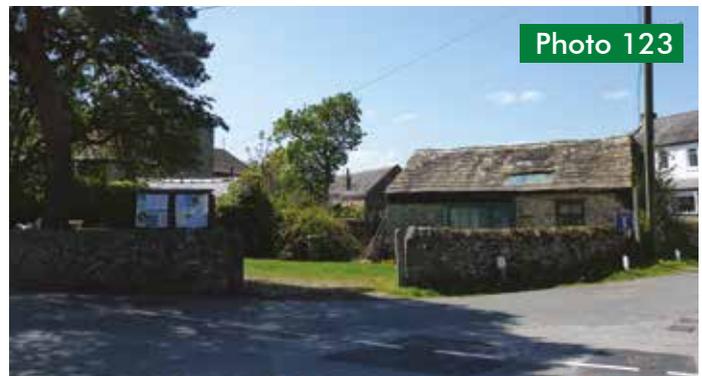
The buildings in Spennithorne appear to be in good condition. The only buildings that might be considered to be at risk are outbuildings (**photo 123**) and subsidiary elements such as walls and gate piers. Such buildings do contribute to the character of the Conservation Area and should be maintained in a decent state of repair.

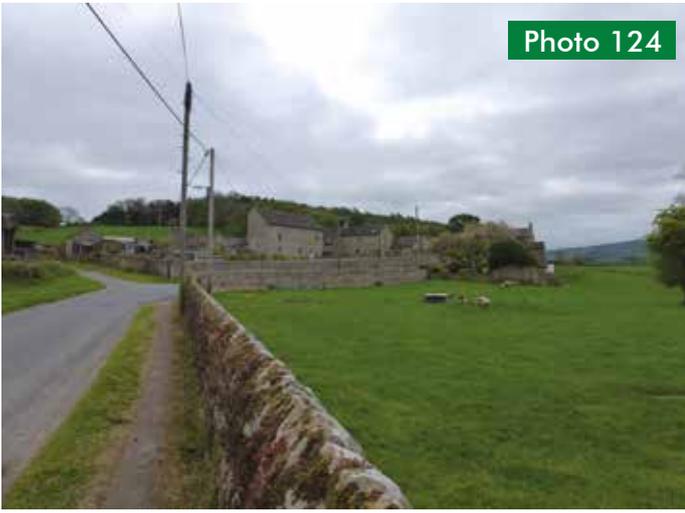
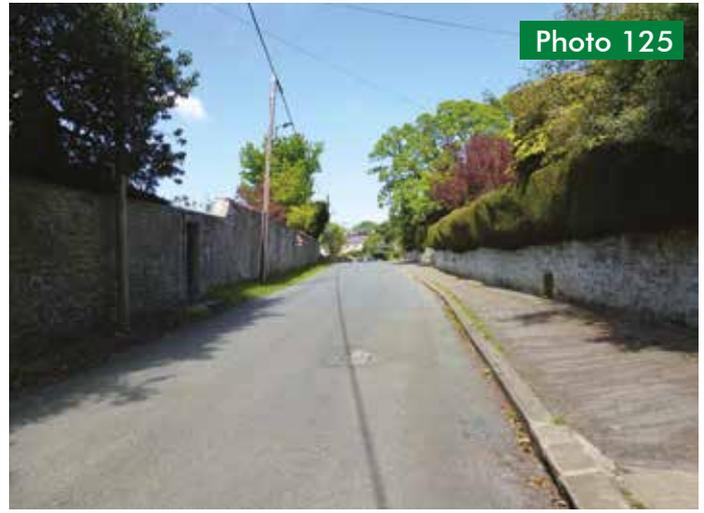
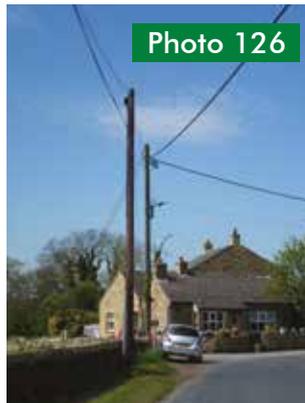
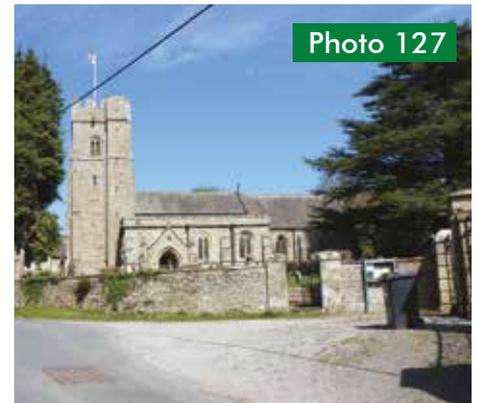
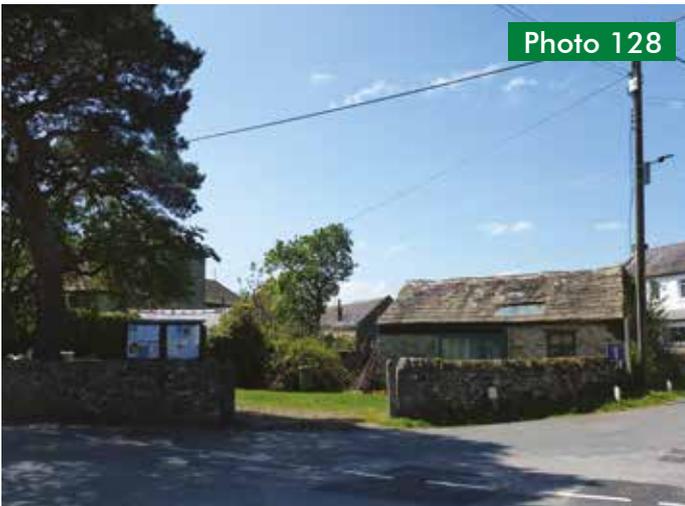
Overhead wires intrude extensively throughout the village (**photos 124, 125, 126, 127 and 128**). The village would benefit from the reduction in overhead cabling and poles, particularly around the central area at the junction with the minor side road where the undergrounding of services and the removal of surplus poles would be beneficial. The disadvantage to their removal is that an alternative support would be required for street lighting (**photo 129**).

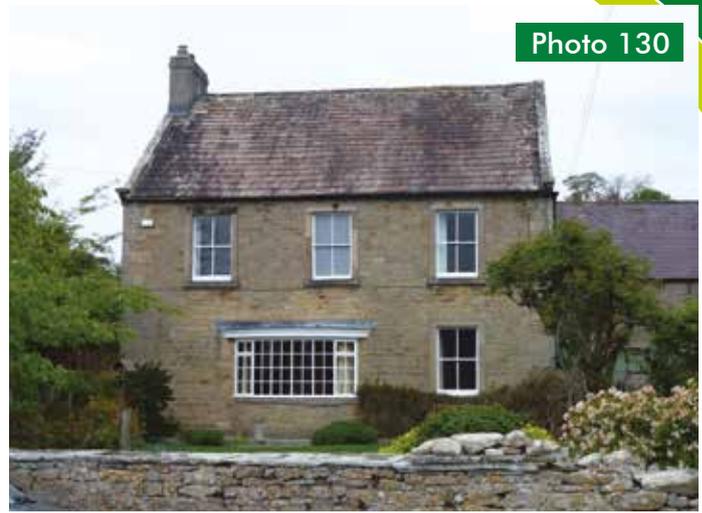
Photo 130

Small scale alterations that can be undertaken to individual properties without the need for planning permission, can have a cumulative harmful effect on the character of Conservation Areas. When carrying out alterations to windows (**photo 130**), doors and roofs care needs to be taken to ensure works are sympathetic to the character of the area. There are, however, other small changes which can have detrimental effects - gas bottles, wheelie bins and oil tanks (**photo 131**) can be visually intrusive and should be obscured from view and not within the setting of buildings wherever possible. Other examples include insensitively sited satellite dishes (**photo 132**).
