VERIFICATION REQUIREMENTS FOR GAS PROTECTION SYSTEMS

Technical Guidance for
Developers,
Landowners and
Consultants

Yorkshire and Lincolnshire
Pollution Advisory Group

Version 1.1 – December 2016

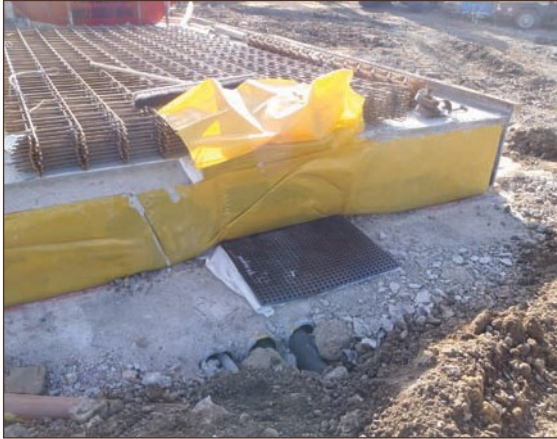
Figure A4.7 Geovent protruding out of the frontage of the unit. Gas membrane along the sides of the slab preventing lateral gas ingress (courtesy Alderburgh Group)

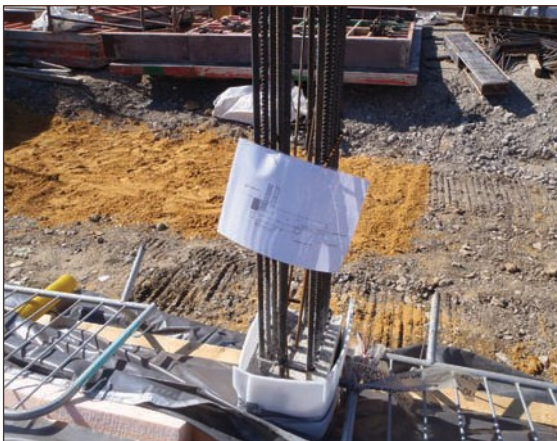
Figure A4.9 On site schematics to aid construction workers build the gas protection system (courtesy Alderburgh Group)

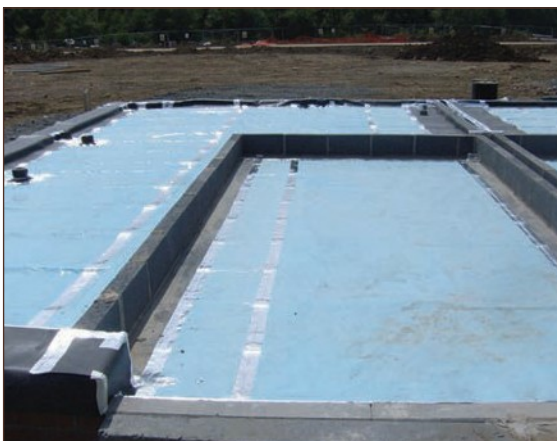
Figure A4.11 Gas membrane continued through cavity wall and above air bricks (courtesy Hydrock)

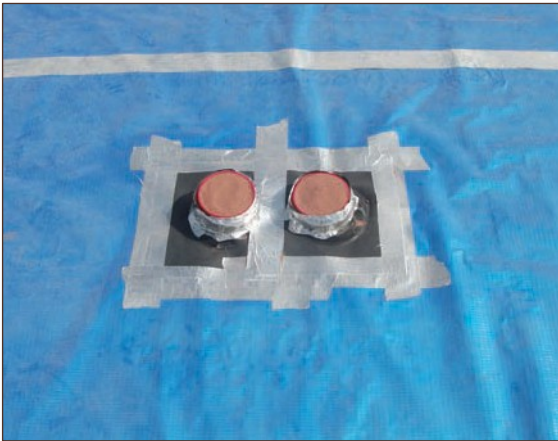
Figure A4.27 Top hats placed around service entries secured with jubilee clip seals. Top hats secured to gas membrane with double sided butyl tape (courtesy Hydrock)

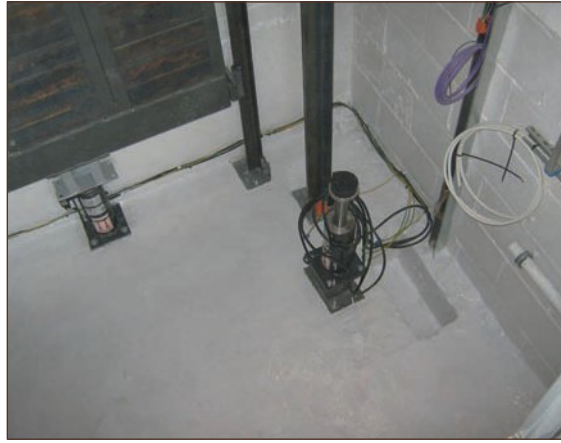
Figure A4.32 *High quality installation of liquid gas membrane to lift pits, including resin gas protection on all screw penetrations (courtesy Card Geotechnics Limited)*

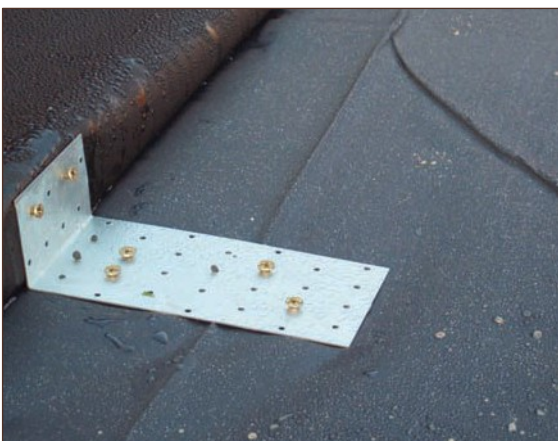
Figure A4.47 Follow-on works purposefully penetrating gas membrane (courtesy Card Geotechnics Limited)

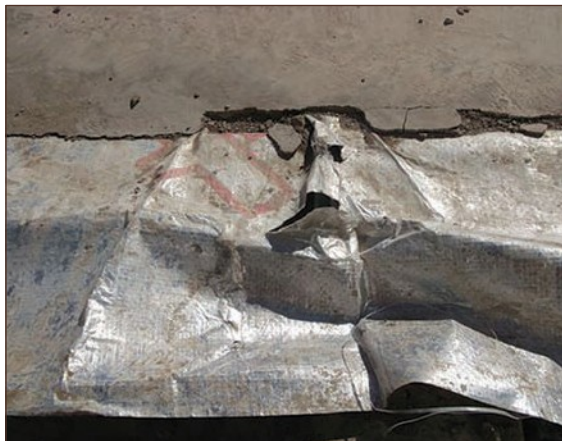
Figure A4.54 *Gas membrane damage/tearing at edge of ground floor slab screed layer where it was left exposed to elements for period of time (courtesy NHBC)*

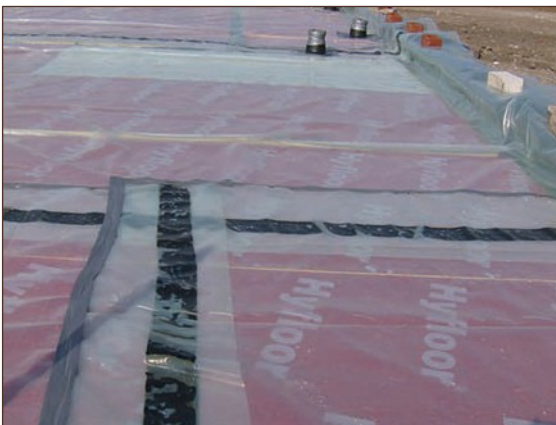
Figure A4.65 Wrinkling of gas membrane over joint has resulted in gaps (only visible due to the use of a transparent gas membrane) and the secondary seal uses ordinary gaffer tape rather than a proprietary product (courtesy Smith Grant)

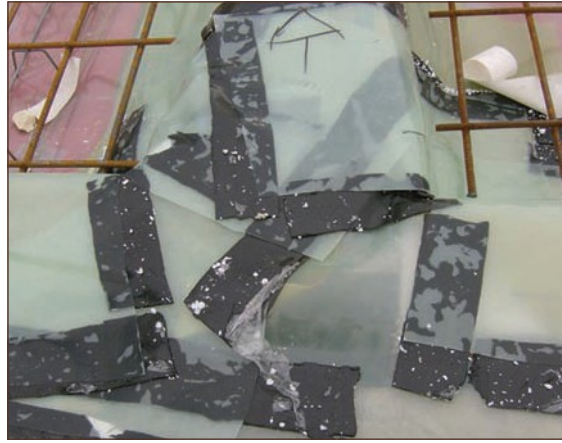
Figure A4.68 A pre-formed corner unit would have been preferable. The installer could not produce sufficient quality despite the amount of tape applied (courtesy Smith Grant)

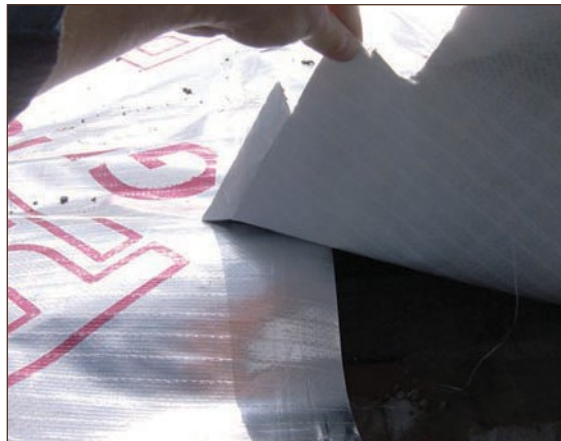
Figure A4.76 No double sided tape used in joints (courtesy Smith Grant)
