# EASBY

## CONSERVATION AREA APPRAISAL AND MANAGEMENT PLAN

Adopted as supplementary planning  
guidance 22.11.07

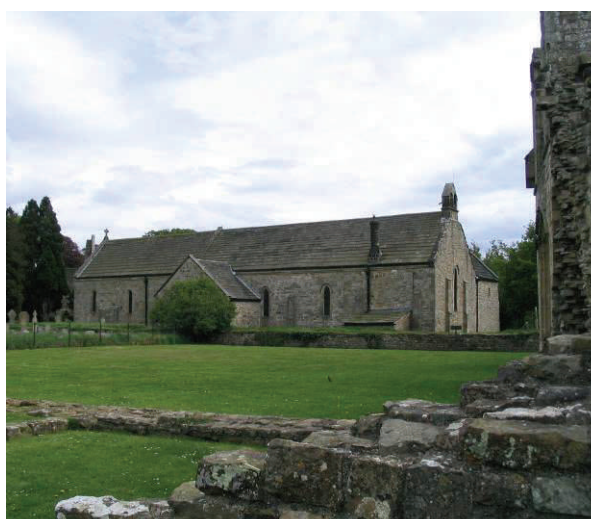
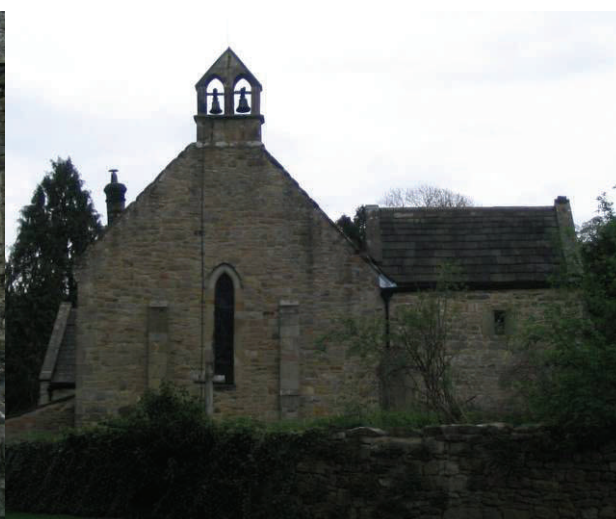
Photo 6

The Church of St Agatha was founded in the 12<sup>th</sup> century (photos 6 & 7), although only a small amount of fabric survives from the original structure. The church underwent alterations at various stages throughout its history, most notably during the 13<sup>th</sup> and late 14<sup>th</sup> centuries. For example, the entrance porch was added in the

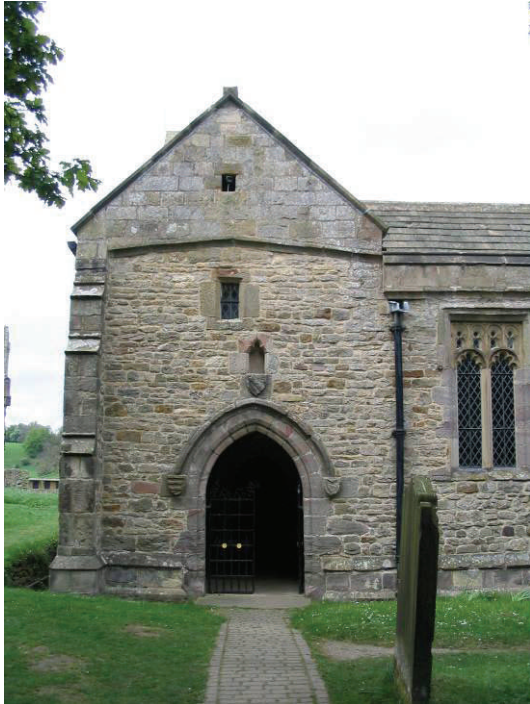
Photo 8

late 14<sup>th</sup> century (photo 8). The most major renovations to the building were completed in 1868 by Sir G.G. Scott, and created the structure we see today. The gateway to the church grounds was provided as part of this renovation scheme (photo 9). The church is built of the local vernacular materials, which are rubble walling with stone slate roofing. Lead and artificial slates have also been used, although these are not prominent from public view.

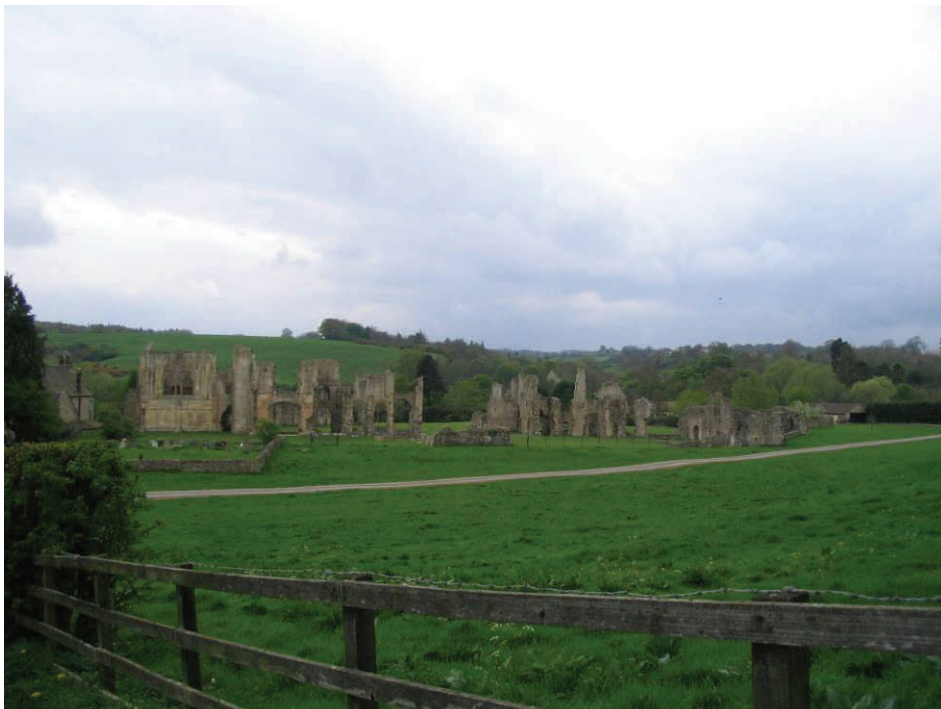
Photo 10

The Abbey was also founded in the 12<sup>th</sup> century (1152 -1537), and is today a consolidated, roofless ruin privately owned but under the guardianship of English Heritage (photo 10). The Abbey enclosure abuts the grounds of the church, and

was obliged to fit around the church in order to make the most of the riverside location. A further concession was made to the local topography, in that the west range is not of standard monastic plan, due to the steep fall of the land.

The Abbey is the central feature of the area and the boundary is currently marked with a metal post and wire fence topped with barbed wire. This is more akin to an industrial/business estate than a tranquil rural location. It would be of visual benefit to the area for this to be replaced.

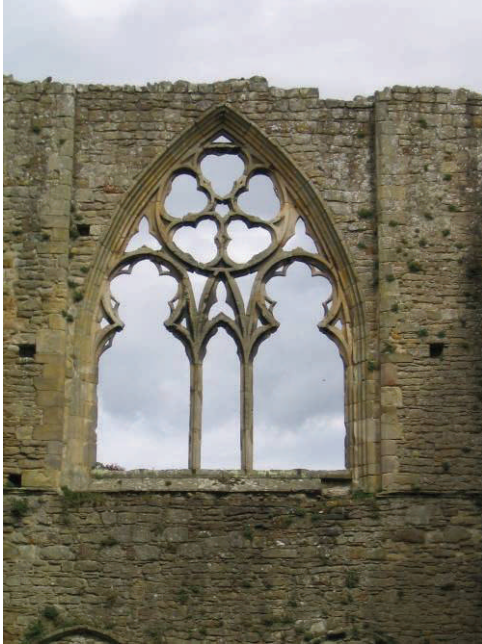
Photo 11

Nearest to the church stands the Refectory. At the east end is a large pointed window, whose beautiful tracery remains intact (photo 11). The Abbey remains are extensive, despite plunder for stone and deterioration caused by exposure to the elements. The fabric that is left demonstrates a structure of status and fine craftsmanship.

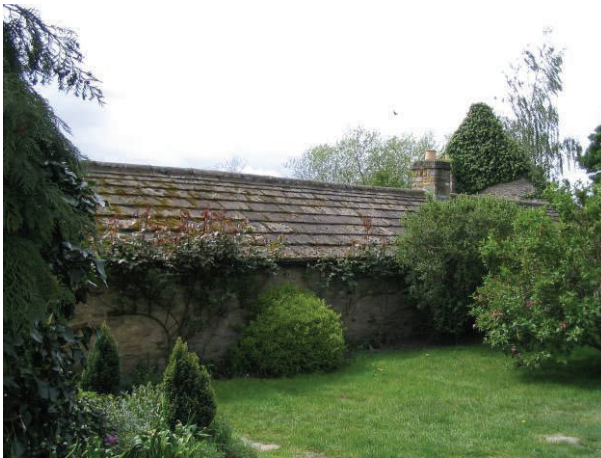
Photo 12

The 14<sup>th</sup> century was a time of wider building activity in Easby. For example, the development of the Abbey gatehouse and the monastic barn (now Abbey House) (photos 12 & 13) took place during this era. The gatehouse (photo 14) is a two

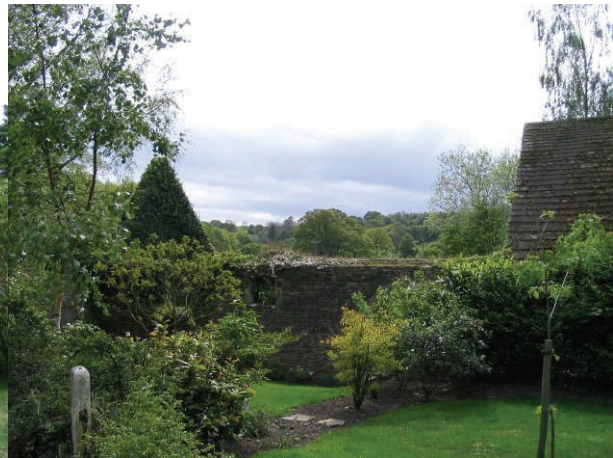
Photo 13

storey structure of sandstone rubble with ashlar dressings, and had external steps giving access to the first floor chamber. It is considered to be the best preserved monastic gatehouse in Yorkshire. The monastic barn is now part of the structure converted into a house and part stands as ruins. The building is rubble sandstone with a stone slate roof. The corn watermill and mill house have now also been converted to a residence (photo 15). The two storey building is of coursed rubble with a stone slate roof.

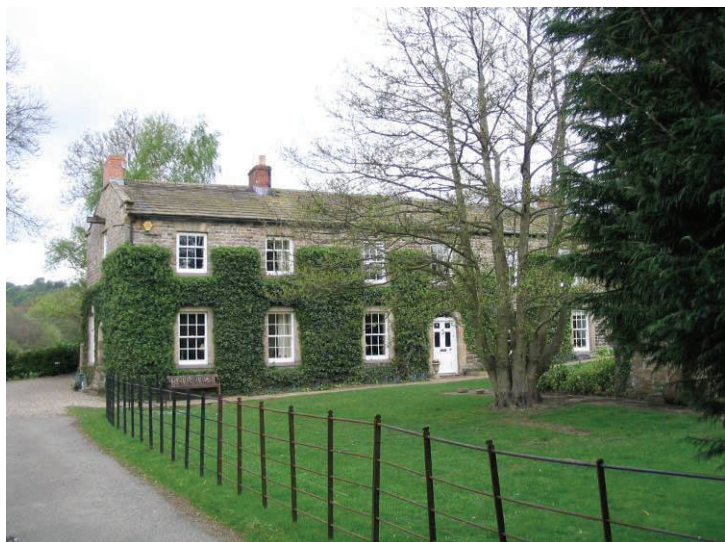
Photo 15

Although the existing building dates from the late 18<sup>th</sup> to early 19<sup>th</sup> century, it rests on much older foundations, and it seems reasonable to assume that the earlier mill would have been contemporary with the monastic barn.

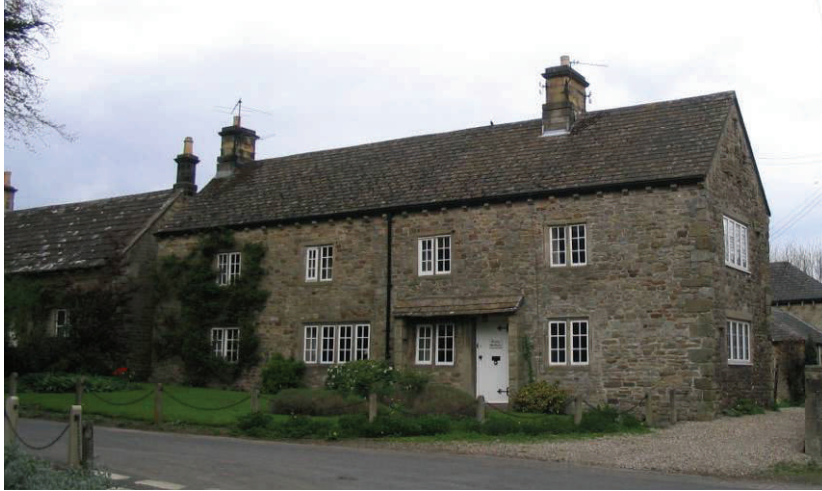
Photo 16

The buildings on the ridge developed later in the history of Easby. The oldest building amongst this cluster is Easby Mullions, and this is the clearest example of the typical vernacular style that had developed in the area (photo 16). The existing structure dates from the late 17<sup>th</sup> century, and is of rubble with quoins. The roof would originally have been of

stone slate, but has now been replaced with artificial roofing material. This façade would previously have been symmetrical, and is fairly plain in character. The board door shows that this was a building of lesser status. The chamfered and mullioned windows would have been typical of the local vernacular style.

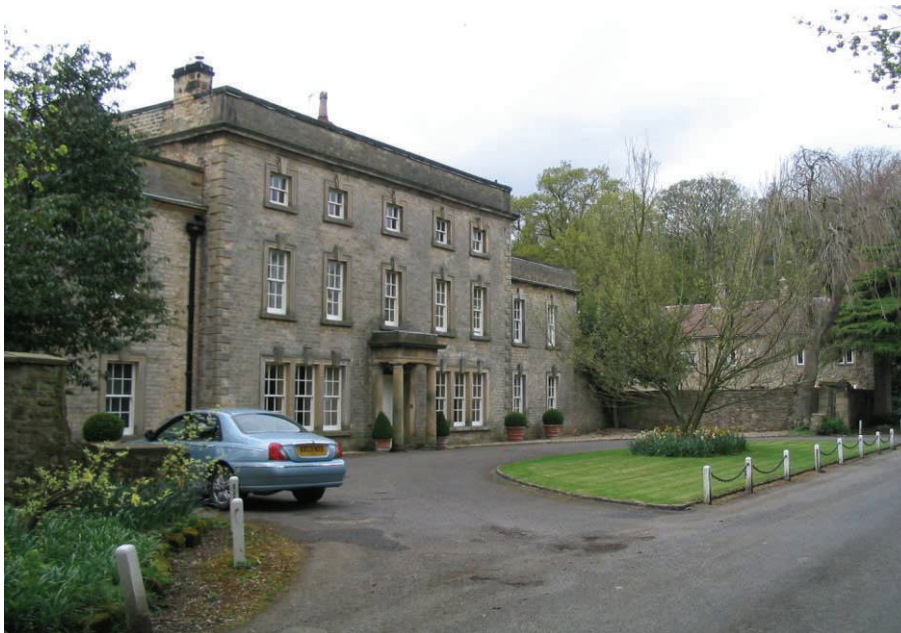
Photo 17

Easby Hall is a fine 18<sup>th</sup> century country house (photo 17), built of coursed rubble and brick, with ashlar dressings, lead and Westmorland slate roofs. The central block is three storeys with five bays, and the wings are both two storey with two wings. Easby Hall dominates the core of the village, and, at three storeys high, is the tallest

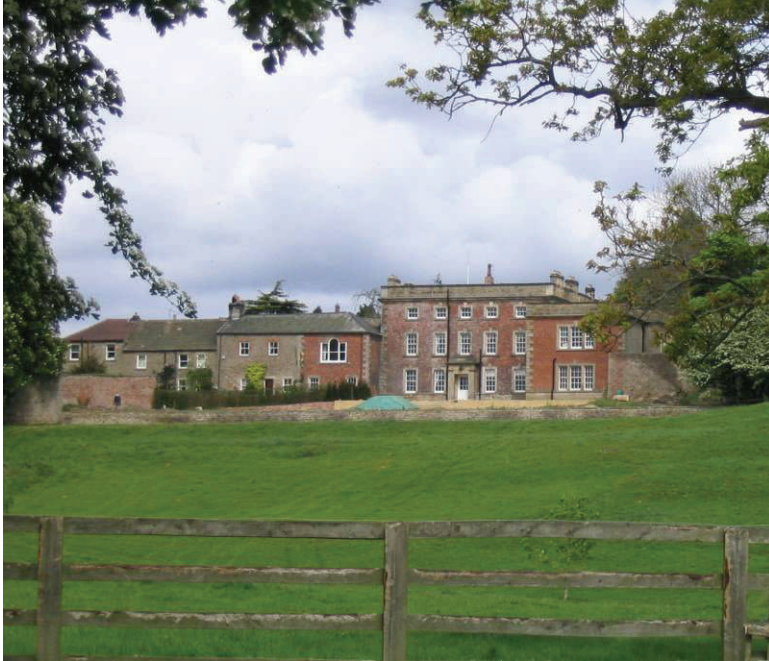
Photo 18

The most notable departure from the prevailing materials in the Conservation Area is the striking brick frontage of Easby Hall (photo18), which faces south-west across the garden towards the river. This is the only incidence of brick in the Conservation Area, and is located where the façade will be publicly visible for quite some distance.

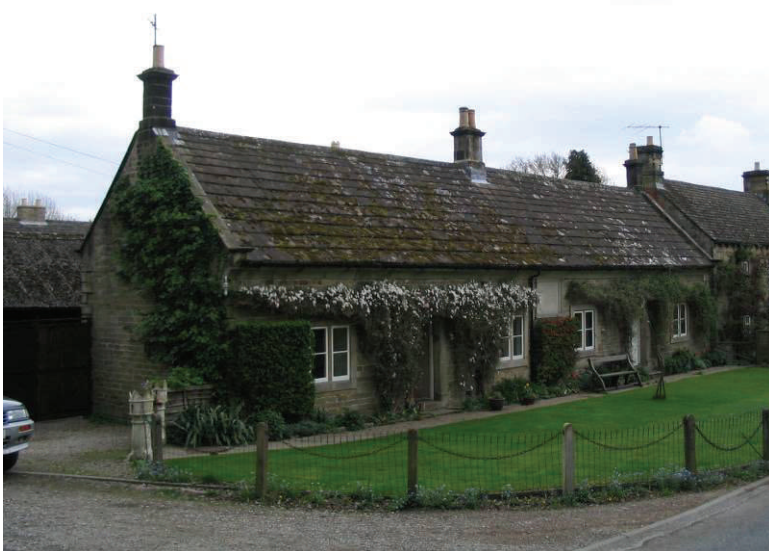
Photo 19

The Almshouses (photo 19) were also built for Rev William Smith, their prominent location in the village demonstrating his benevolence alongside his personal wealth. Now a single dwelling, the Almshouses were originally built as a series of four single cells. The principle façade is symmetrical and ordered, and the overall effect is one of modest refinement. Elements such as the cavetto cornice show attention to detail, and demonstrate that, although far from ostentatious, the building was not cheaply constructed.

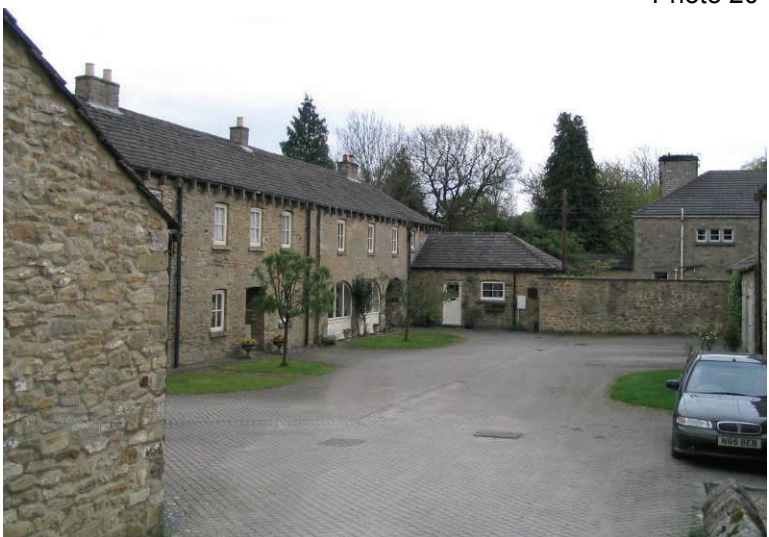
Photo 20 The Easby Mews (photo 20), which are now private housing, was a C19 stable block .

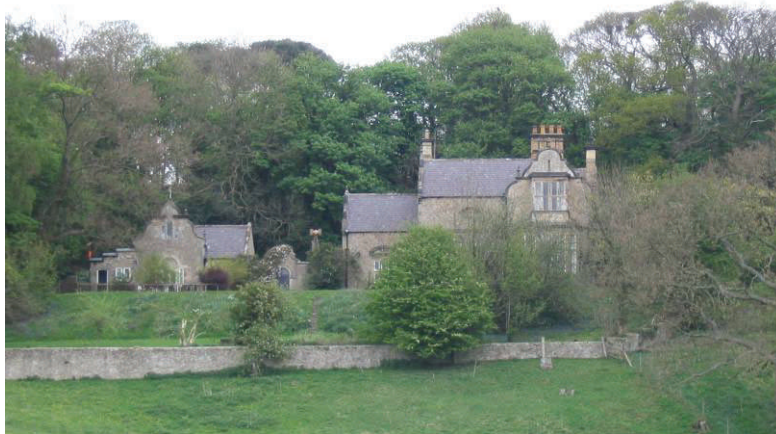
Photo 21

Vicarage, built c.1868 with associated coach-house (photo 21). The Vicarage is built of rubble with ashlar dressings, and a Welsh slate roof.

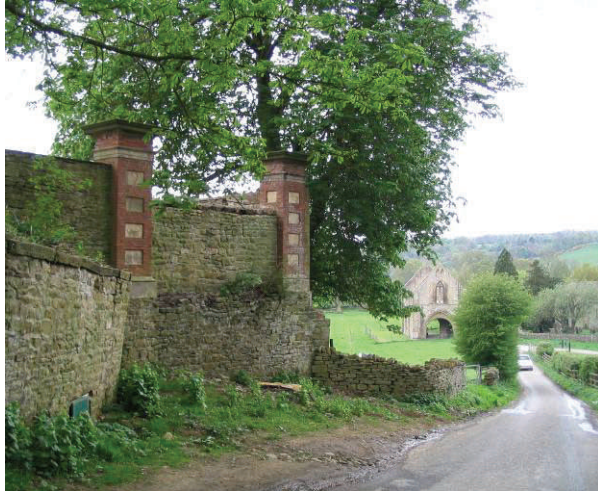
Photo 31

In Easby there is a clear division between what is public and what is private. For example, Easby Hall is has two facades of equal importance but contrasting architectural treatments, with the brick façade looking out over the Abbey and the river, and the stone façade stamping its status and authority in the small village cluster. However, the functional areas and ancillary buildings associated with the Hall are behind high walls, and so not visible to the public (photo 31 & 32). The main façade of Easby Hall is set back from the road creating an open private space

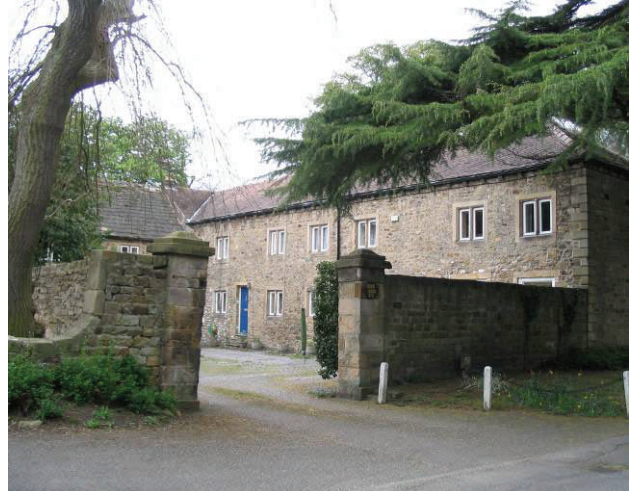
Photo 32

around the entrance. An area of grass separates the private driveway from the public road with the change being denoted by a different surface material.

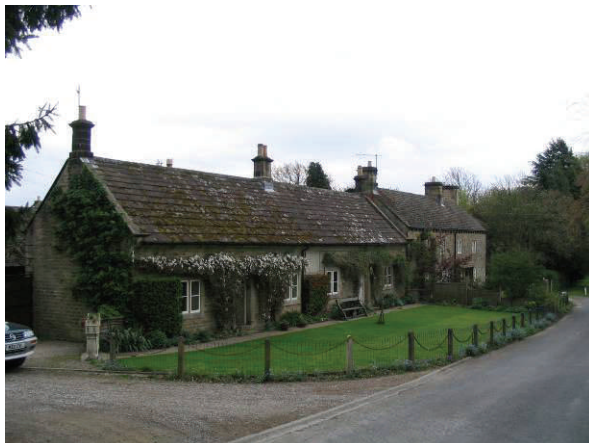
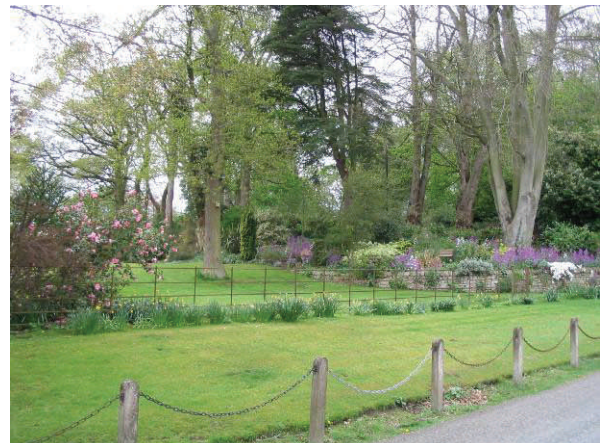
Photo 33

The Almshouses/Mullions is a calm, ordered, symmetrical facade, sober yet attractive. It is set back from the road behind private gardens. Post & chains demarcate the private gardens in front of these buildings (photo 33 & 34).
